Pre-Demolition Asbestos Survey Report

**Erwin Elementary School
301 South 10th Street
Erwin, North Carolina**

October 2, 2019
Terracon Project No. 70197439

Re: Pre-Demolition Asbestos Survey
Erwin Elementary School
301 South 10th Street
Erwin, North Carolina 28339
Terracon Project No.: 70197439

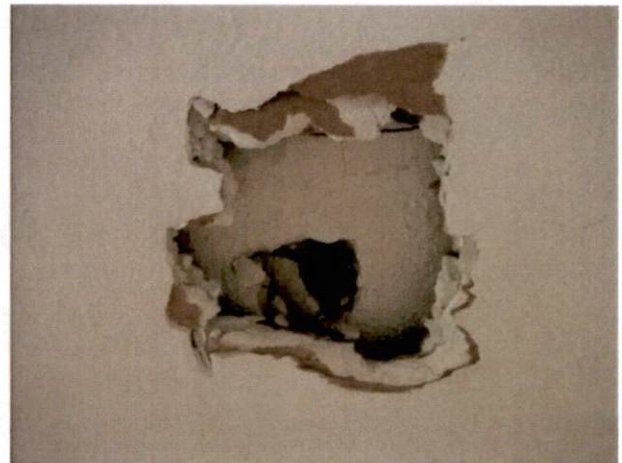
Photo #8 View of HA 2, OSHA-regulated asbestos containing drywall and joint compound over HA 3, non-asbestos containing plaster with drywall lathe.

Terracon recommends removal of drywall and joint compound and CMU surface filler materials containing <1% asbestos prior to demolition. These materials should be removed generally whole and intact. It is recommended that disturbance / removal of these materials during demolition activities be performed by a licensed asbestos abatement contractor in accordance with applicable provisions for OSHA Class I or Class II work.

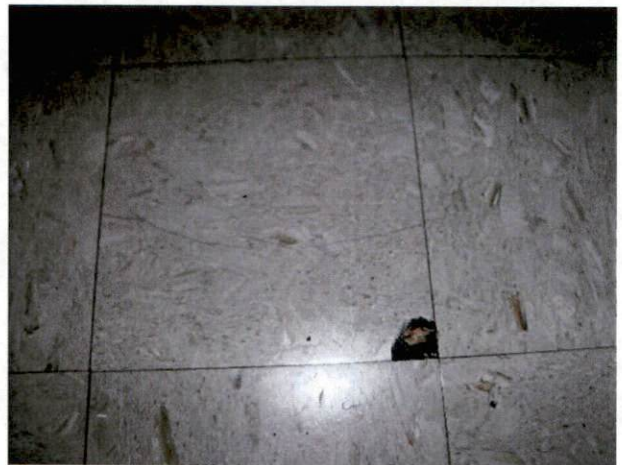
Photo #21 View of HA 17, asbestos-containing 12" x 12" tan with brown dots floor tile with non-asbestos containing mastic.

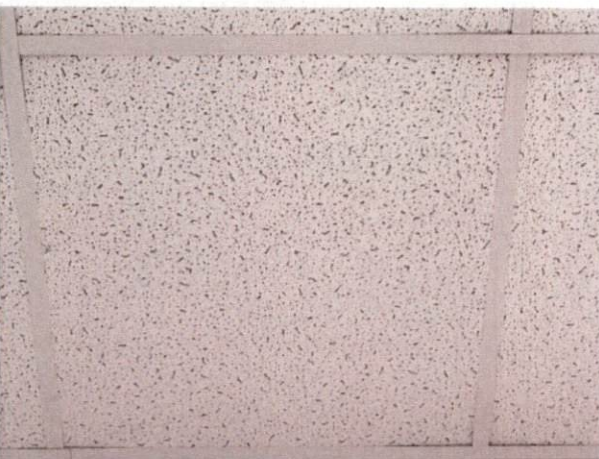
Photo #22 View of HA 18, asbestos-containing mastic with OSHA-regulated asbestos-containing 12" x 12" beige with tan splotches floor tile.

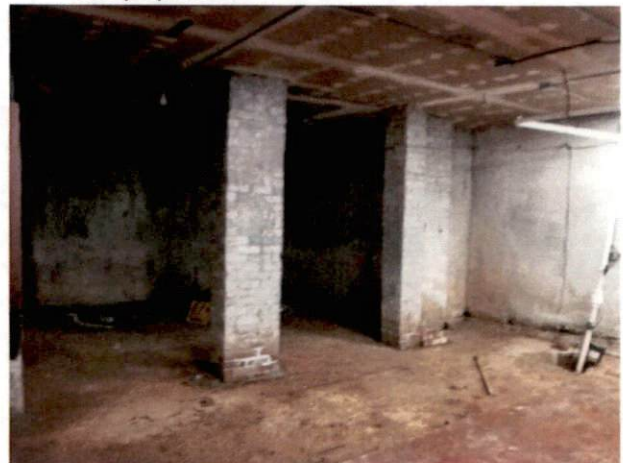
HA	Sample No.	Description	Material Location	NESHAP Classification	Percent/Type Asbestos	Condition	Estimated Quantity*
24	1-80 1-81 1-82	Drywall and Joint Compound - Boiler Room	Boiler Room	N/A	Composite: <0.25% Chrysotile (EPA Point Count) Drywall: None Detected Joint Compound: 2% Chrysotile	Good	400 Square Feet

Photo #28 View of boiler room with HA 24, OSHA-regulated asbestos-containing drywall and joint compound in boiler room.

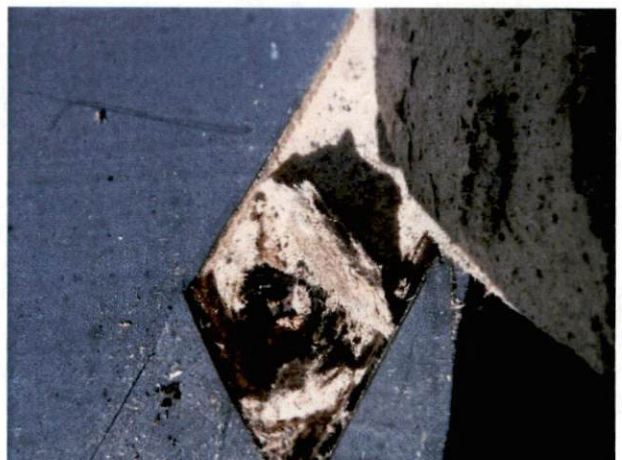
Photo #35 View of HA 31, asbestos-containing black roof mastic on brick.

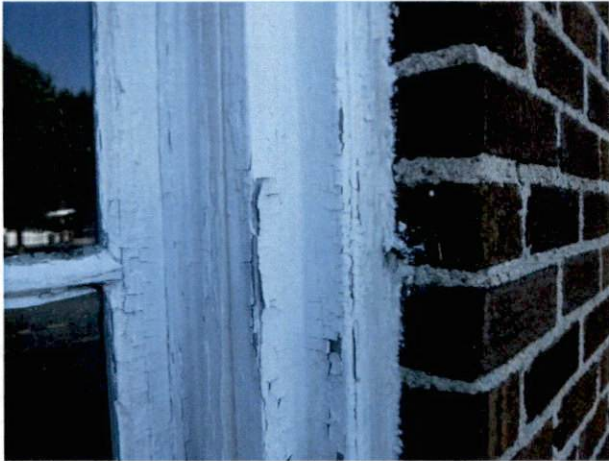
Photo #37 View of HA 33, asbestos containing exterior caulk.

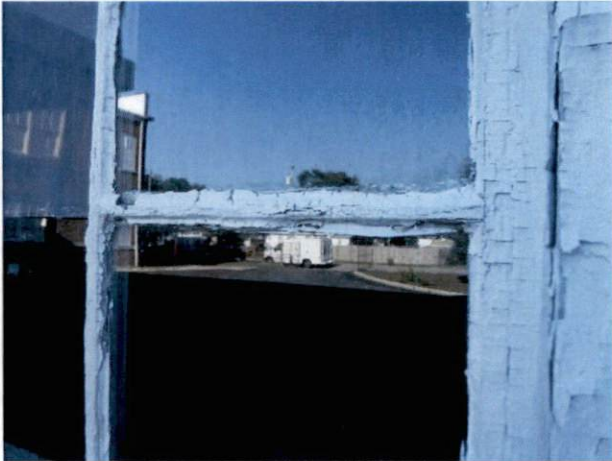
Photo #38 View of HA 34, asbestos containing exterior window glazing.

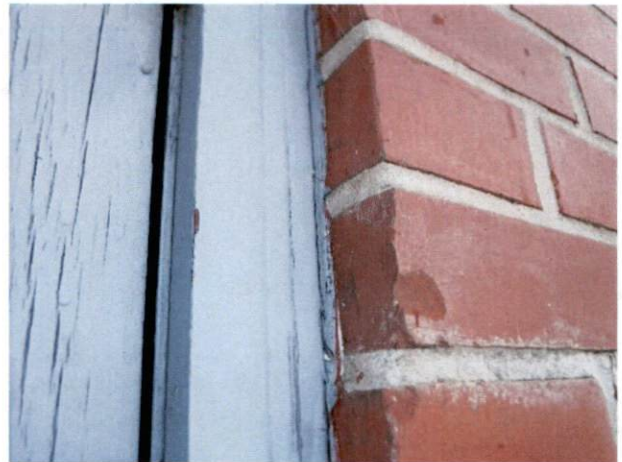
Photo #16 View of door frame with HA 9, asbestos-containing white exterior door caulk.

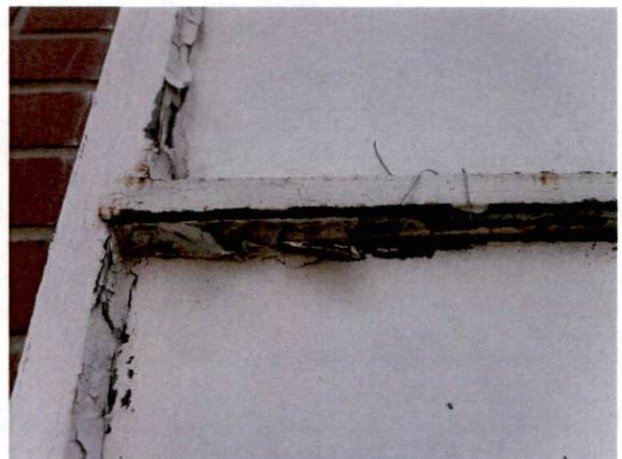
Photo #18 View of windows with HA 11, asbestos-containing white exterior window glazing.

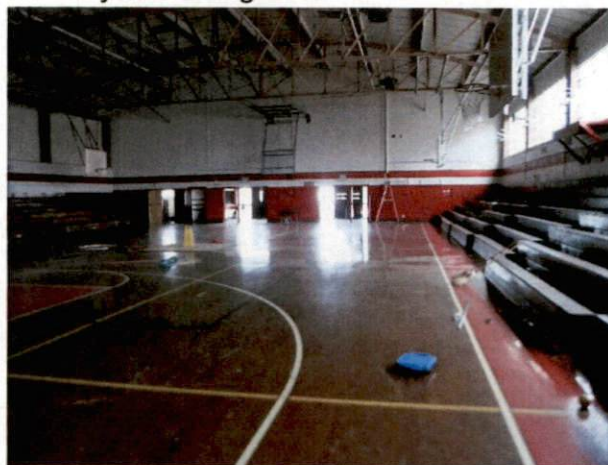
Photo #28 View of gym with HA 24, asbestos-containing interior window caulk.

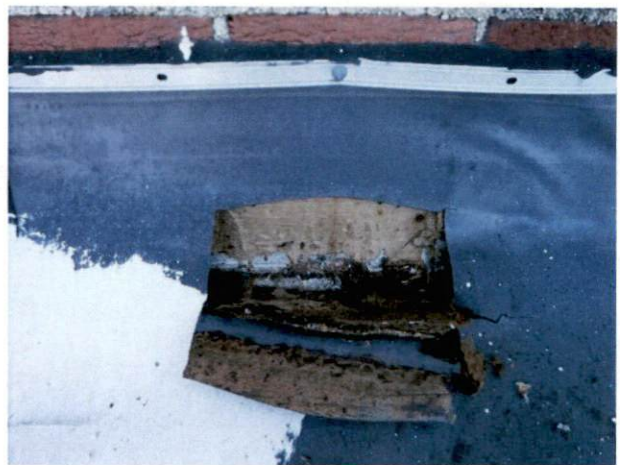
Photo #14 View of HA 7, asbestos-containing silver paint and black flashing on west roof.

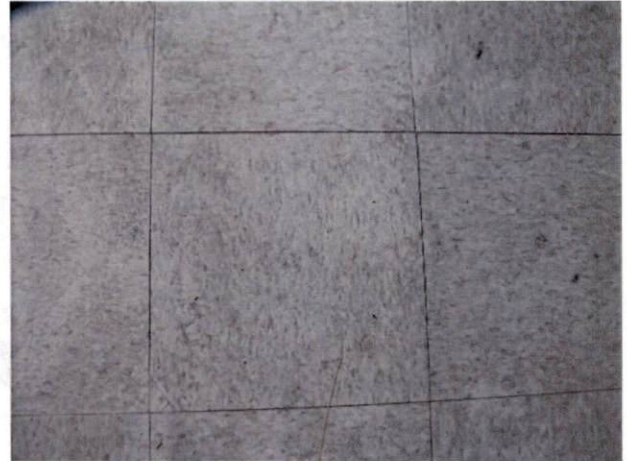
HA	Sample No.	Description	Material Location	NESHAP Classification	Percent/Type Asbestos	Condition	Estimated Quantity*
25	3-78	CMU Block Filler	Chemical Storage, Office, Dry Storage	N/A	<1% Chrysotile	Good	800 Square Feet

Photo #31 View of HA 25, OSHA-regulated asbestos-containing CMU block filler.

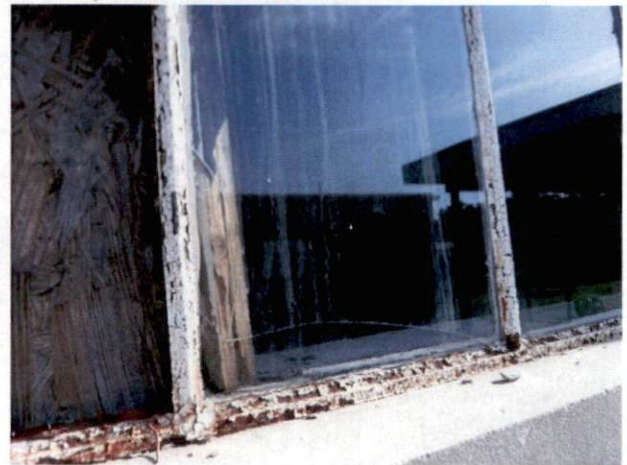
Photo #34 View of HA 28, asbestos-containing exterior window caulk.

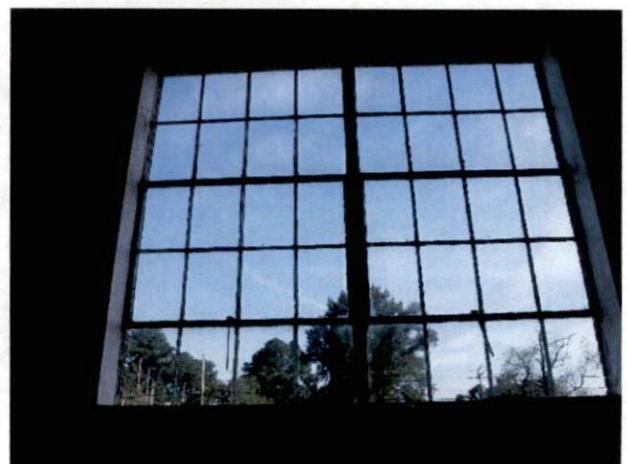
Photo #36 View of HA 32, asbestos-containing white with gray interior window glazing.

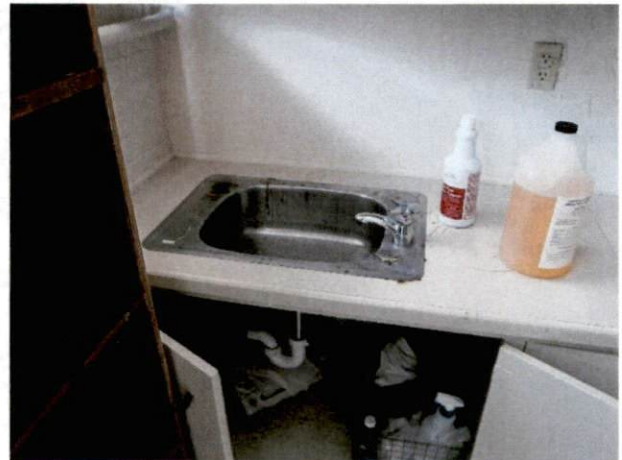
Photo #14 View of sink with HA 8, asbestos-containing black sink mastic.

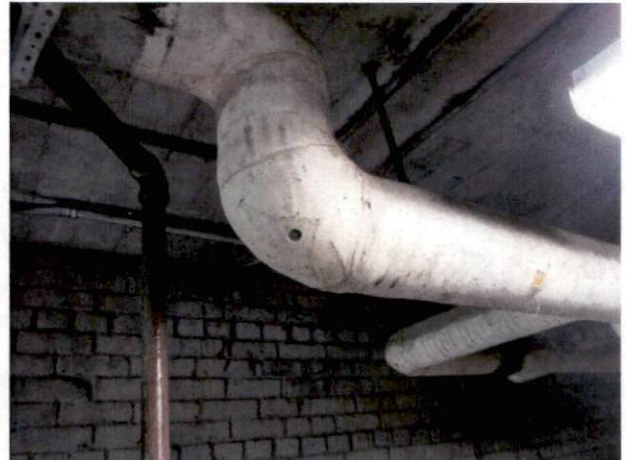
Photo #7 View of HA 1, asbestos-containing air-o-cell pipe insulation.

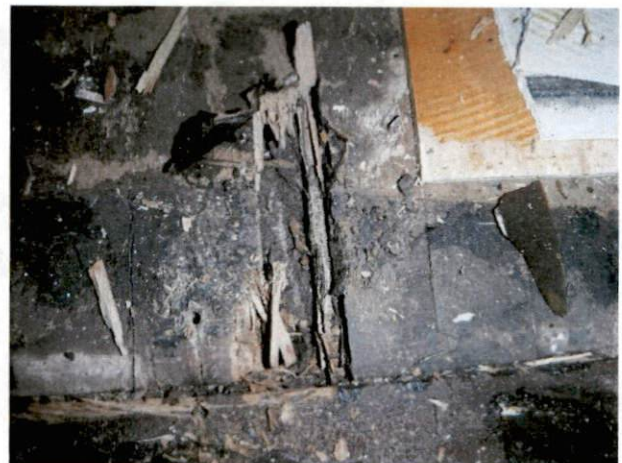
Photo #25 View of HA 17, asbestos-containing tan floor tile and mastic and HA 18, non-asbestos containing blue floor tile with asbestos-containing mastic.

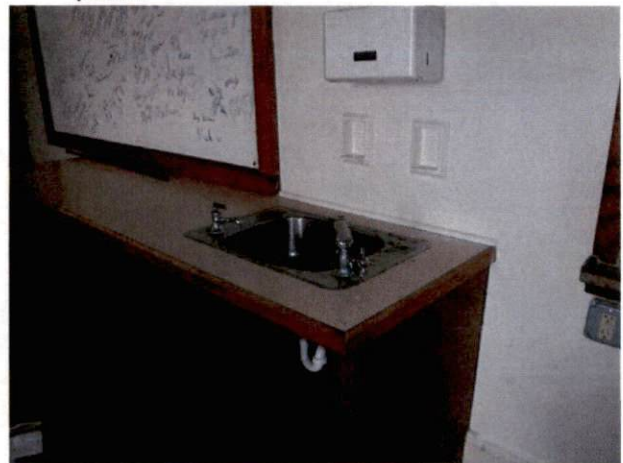
Photo #34 View of sink with HA 29, asbestos-containing black sink mastic.

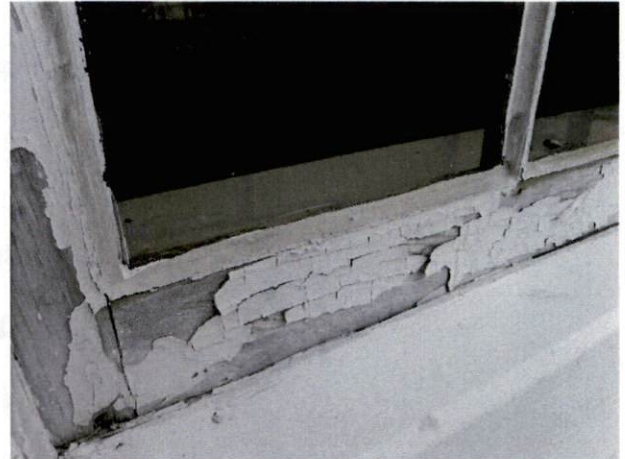
Photo #37 View of HA 32, asbestos-containing exterior caulk.
