PROOFROLLING OBSERVATION REPORT

Report Number: 70211165.0001A
Service Date: 09/09/21
Report Date: 09/16/21
Task: Soils-Utility Backfill Observations-Testing

Johnsonville ES Phase 1
18495 NC Highway 27 West
Cameron, NC

Project Number: 70211165

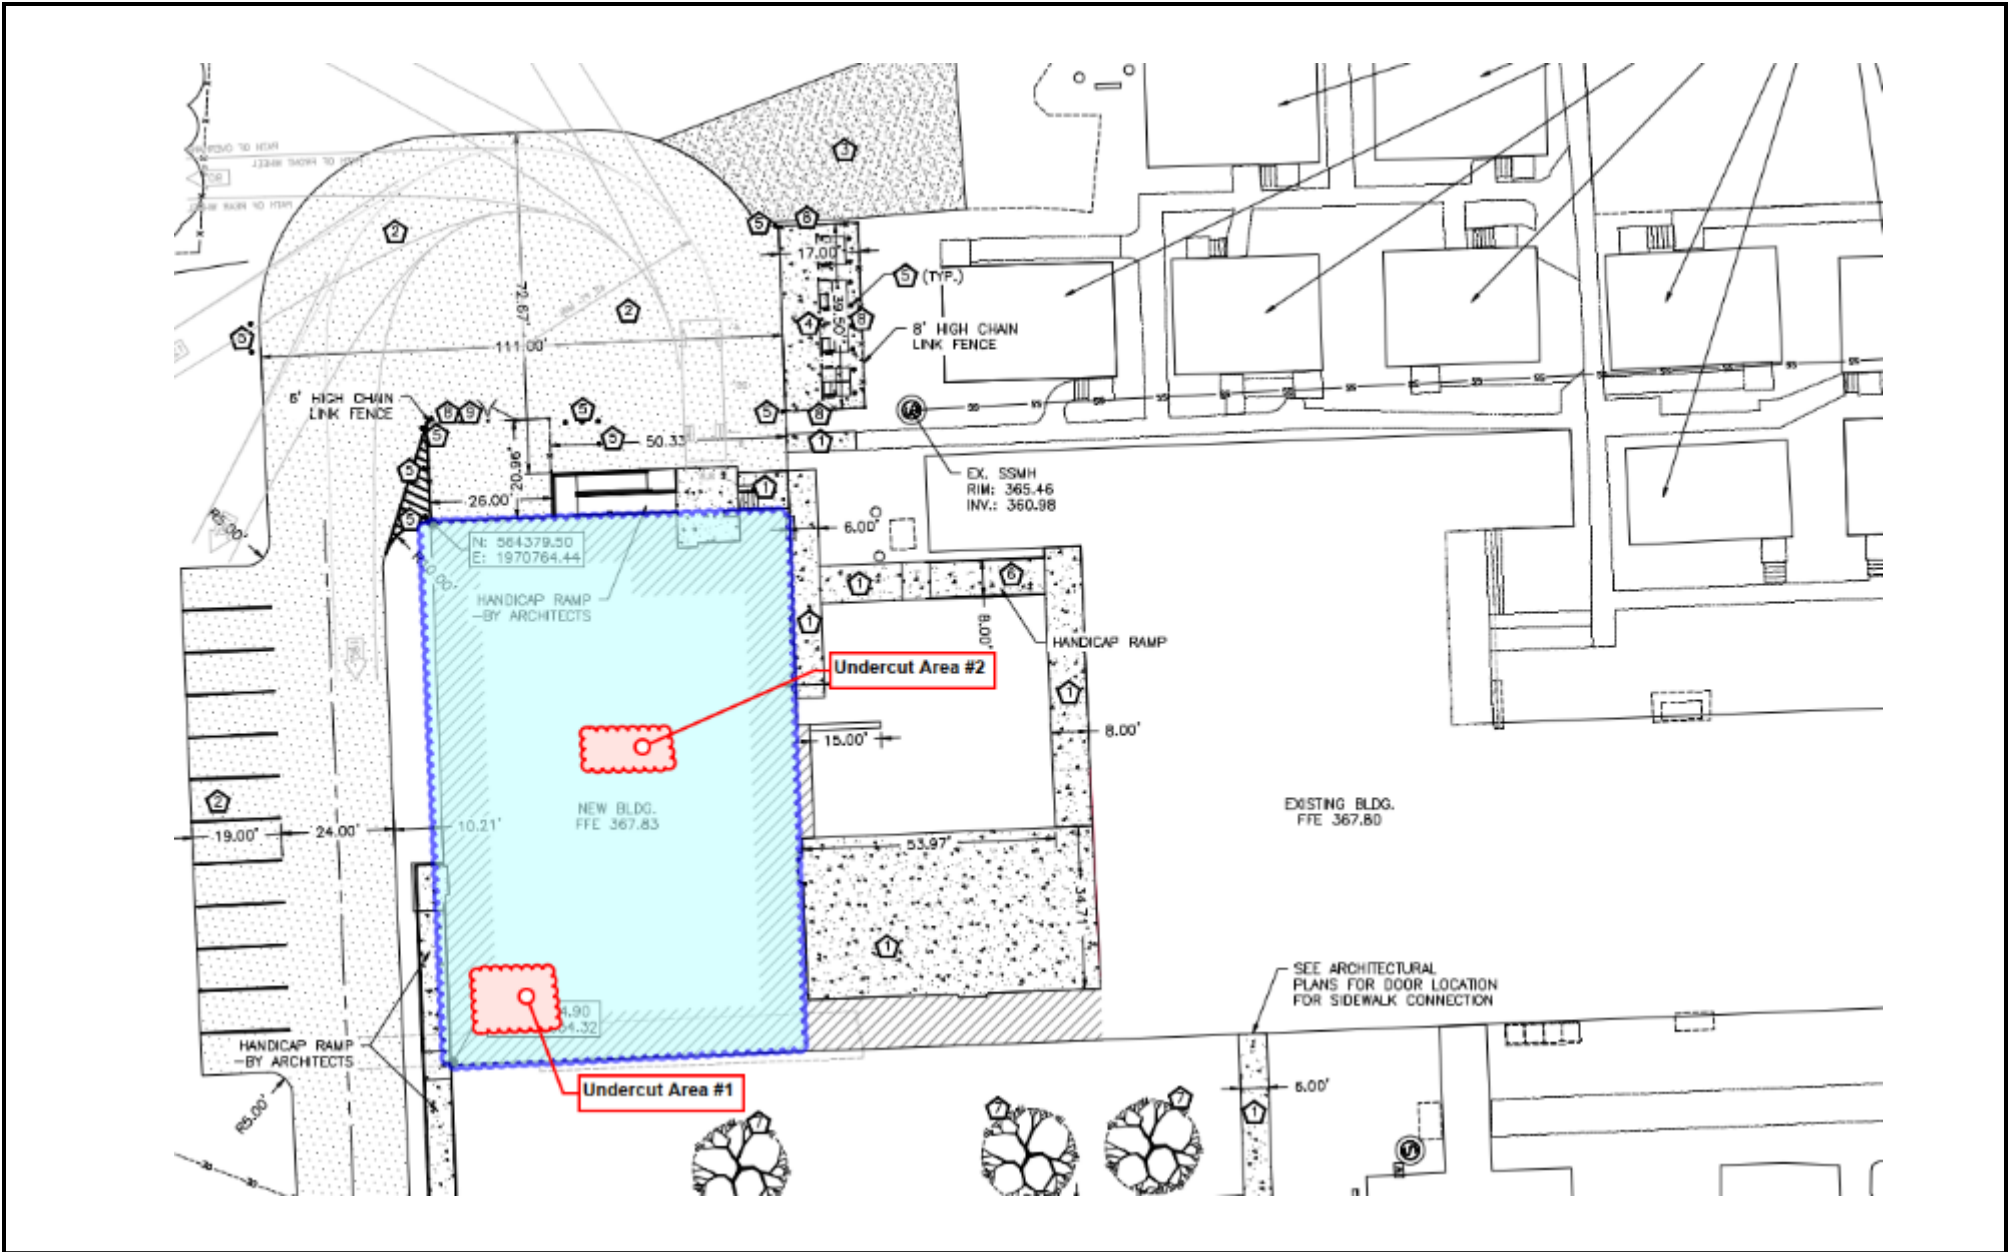
Johnsonville ES Phase 1	Site Plan: Undercut Locations

Summary: Based on our observations, the subgrade soils appeared firm and stable during the application of compactive efforts except in two isolated locations. Terracon recommends undercutting two isolated locations 4 inches and backfilling with suitable material. Please see below for quantification of undercut recommended. Recommendations were reported to Mike Johnson with East Coast Civil at the completion of today's activities.

Area #1: 20' (length) x 15' (width) x 4" (depth) = $100 \text{ ft}^3 / 27 = 3.7 \text{ yd}^3$

Area #2: 15' (length) x 9' (width) x 4" (depth) = $45 \text{ ft}^3 / 27 = 1.7 \text{ yd}^3$

Total Area: 5.4 yd³

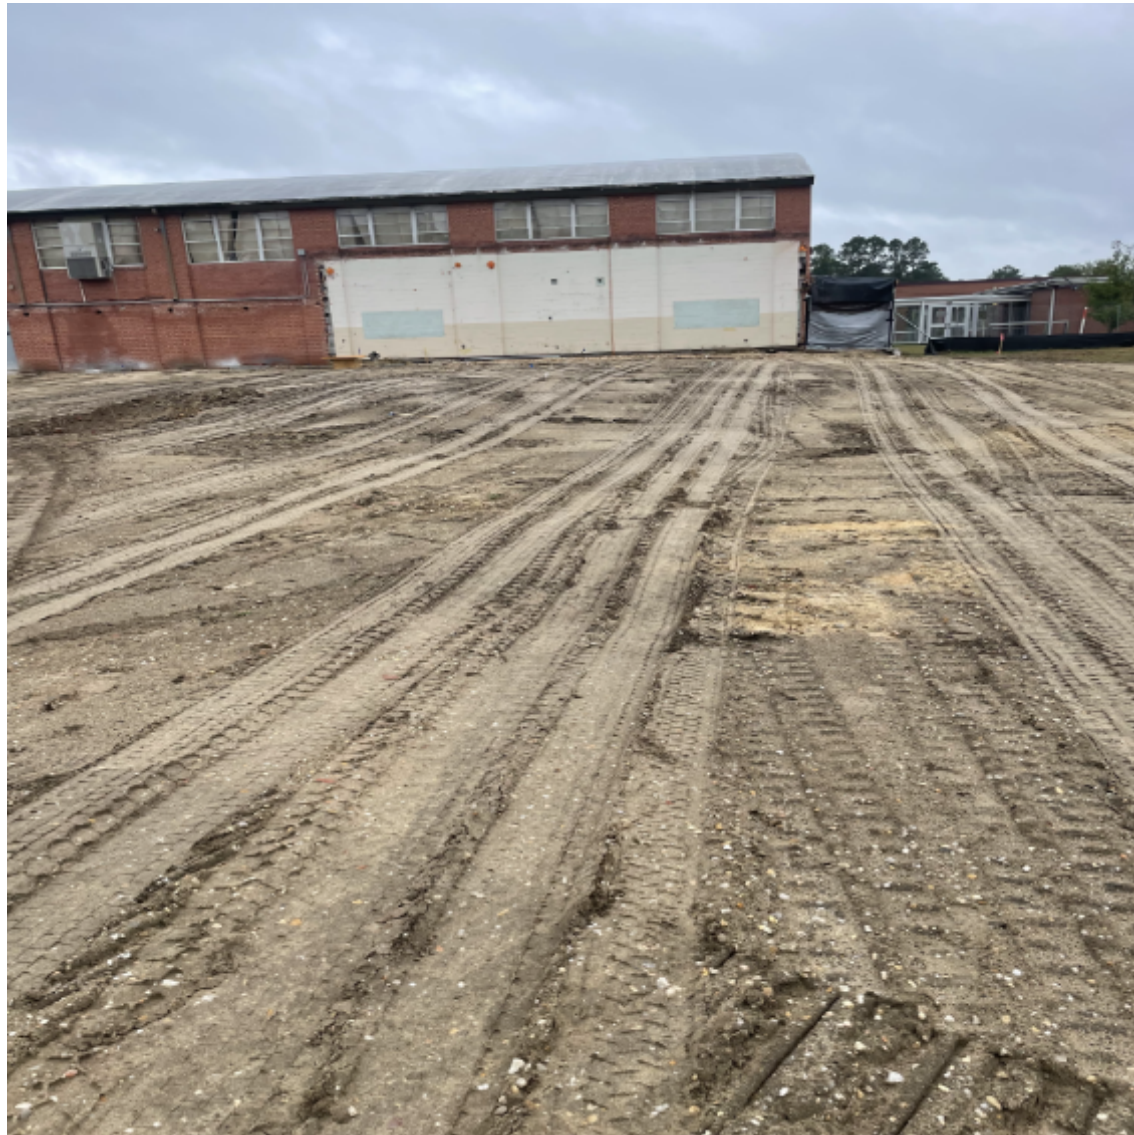
Johnsonville ES Phase 1	Site Plan: Observed Location

Observed Location(s): Building Pad (see attached plan markup)

Subgrade Description: The subgrade was reviewed and consisted of light brown silty sand.

Elevation: Based on the grade stakes the subgrade ranged from 3 to 5 feet below design final soil subgrade elevation.
