Johnsonville classroom addition 11/16/23

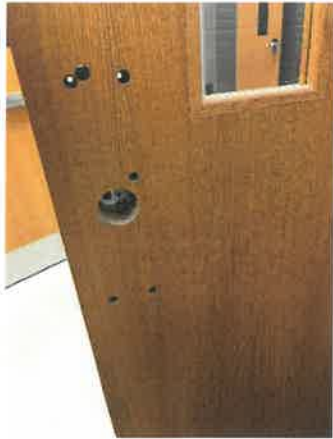
-Continue to install door handles and locks

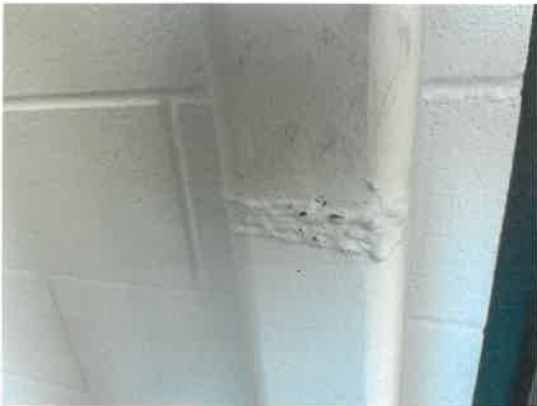
-One metal column has what appears to be a rough weld. Weld should be ground down and made smooth, then painted.

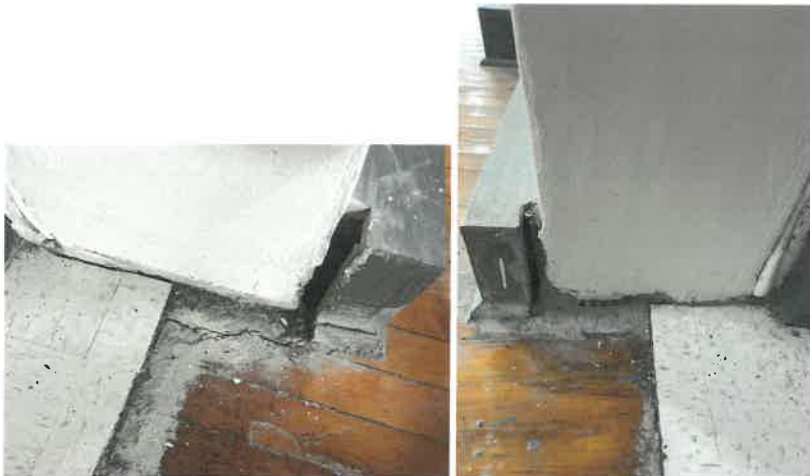
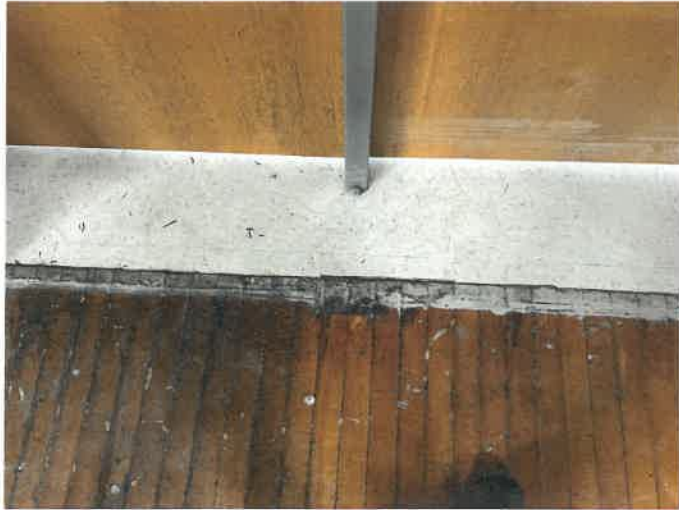
-Area where existing gym meets new construction at doorways has open gap that is filled with soft expansion gasketing that is exposed. Base of walls are unfinished. Open gaps at floor transition, in addition to concrete residue.

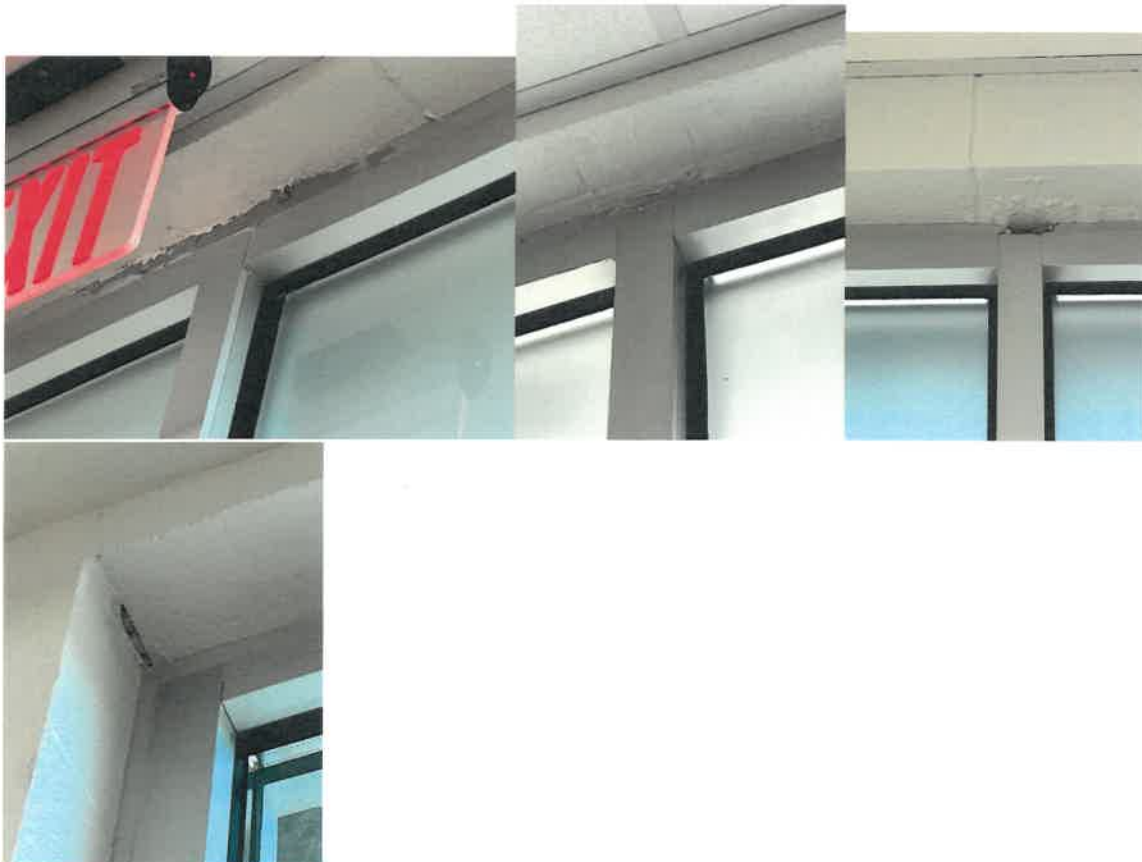
-Areas where mortar or finish is not contiguous and sealed shall be made smooth and easily cleanable. Areas are present above exterior exit doors and in upper casements of classroom windows.

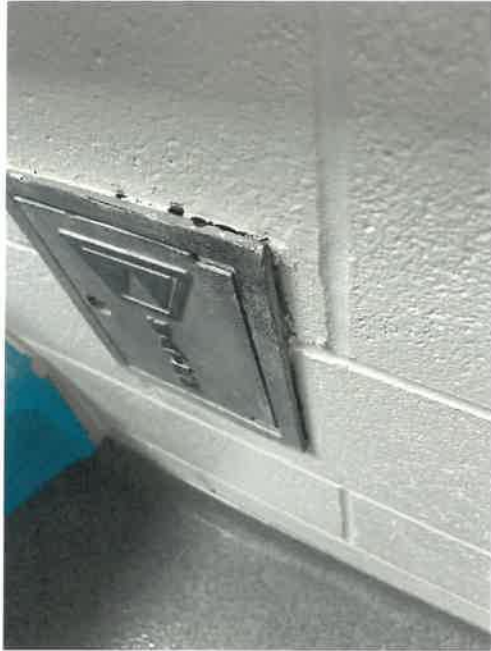
-Small areas to be sealed:
