FOUNDATION OBSERVATIONS REPORT

Report Number:
 70241180.0008

Client Project

3D Community Church Inc
Attn: Mel Manning
658 Graham Road
658 Graham Road
Sanford, NC 27332

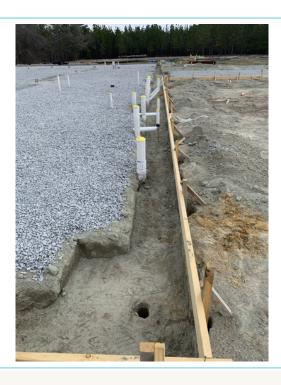
(P1) Foundation observation.

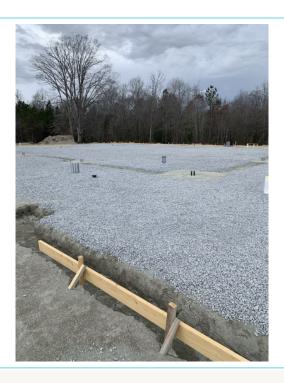
(P2) Foundation observation.

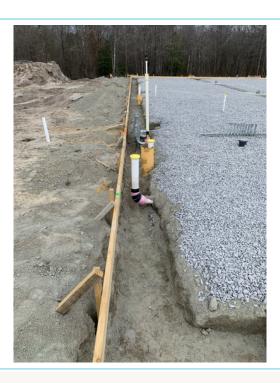
(P3) Foundation observation.

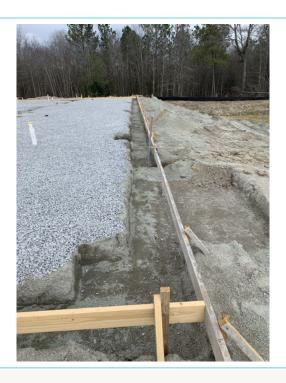
(P4) Foundation observation.
