LOCKLEAR, LOCKLEAR & JACOBS, PLLC

RE: Harnett HS Press Box Replacement (Header and Corner Structural Review)

Client: HCS Project: 21-11110

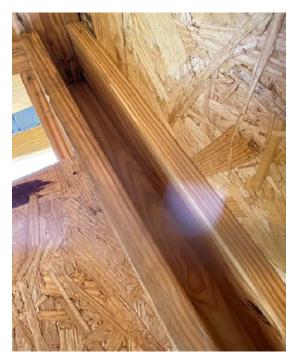
Figure 3: Corner stud that requires blocking.

- Exterior Door Headers A review of the door header on the Western Wall at Harnett Central and the Eastern Wall on Westen Harnett was performed to check the current header as is. Both headers are sufficient. The other exterior doors on the endwalls of the building are framed in solid and have minimum load on them. They are sufficient as well.
- The contractor was advised to block in the corner studs at a minimum of 3rd points and attached these members so they for a typical corner stud situation. This should correct the framing modifications and the corners studs should be sufficient as well.

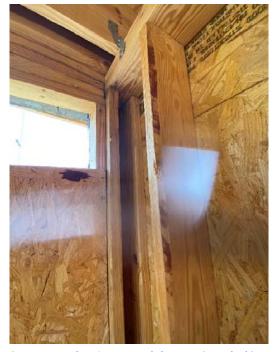
Figure 4: Another Corner stud that requires Blocking.
