RE: Daily Field Report for 01/29/2025
Baucom Business Plaza - Fuquay Varina NC
Building & Earth Project No : RD250053

Field Observations Report

Report of Field Density Testing

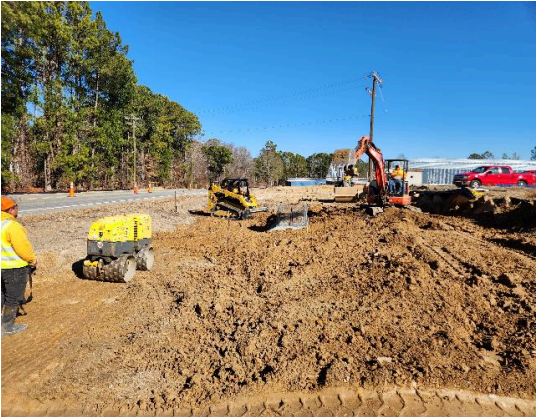
Picture ID	Contractor placing and compacting backfill for turning lane.	Picture ID	Contractor compacting backfill for turning lane.
100296

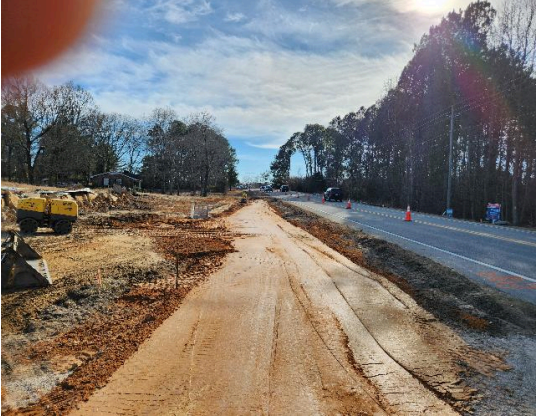
Picture ID	Turning lane.	Picture ID	Contractor compacting fill soils for turning lane.
100319
