# DCP Test Report

**Report #:** SDCP:6423-01309-1      **Issue #:** 2

**Project:** 64B0033  
Fairway Pointe, Spring Lake, NC

**Location:** Building - Footing  
**Location Details:** Building 5 - Wall Footing

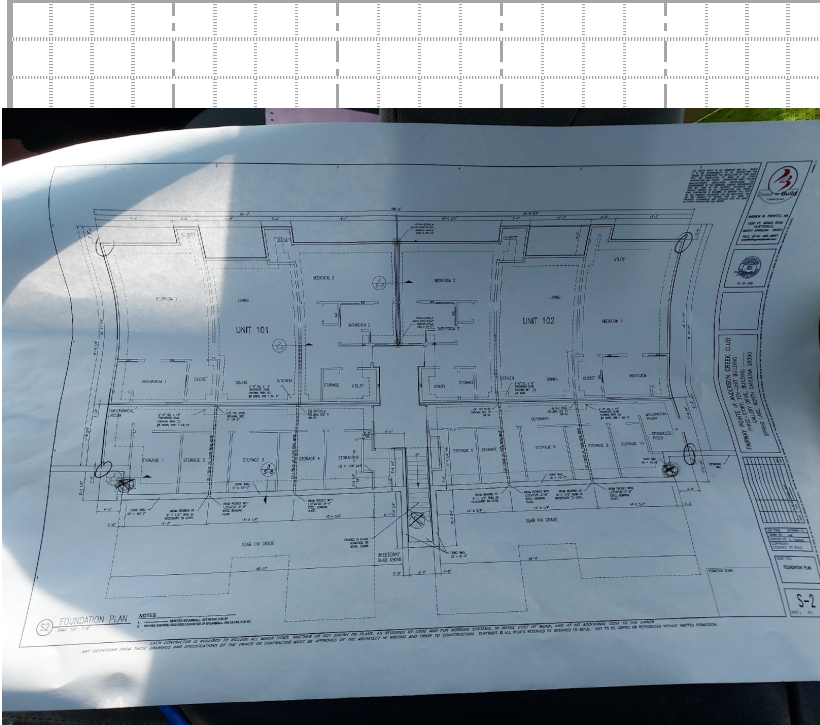
Description: Drawing

Test ID	Test Location	Test Depth <sup>1</sup> Unit: ft.	# of blows per Interval <sup>2</sup> <i>in 1-3/4" increments</i>			Soil Visual Description
			1st	2nd	3rd	
HA-1	Front face of building, stairs	0	5	5	6	Light brown silty SAND
		-1	12	10	10	Brown silty SAND
		-2	15+	---	---	Brown/tan silty SAND
		-3	15+	---	---	Brown/tan clayey SAND
HA-2	Front face of building, right corner	0	10	7	7	Brown silty SAND
		-1	15+	---	---	Brown sandy CLAY
		-2	15+	---	---	Light brown silty SAND
		-3	15+	---	---	Light brown silty SAND
HA-3	Front face of building, left corner	0	7	7	6	Light brown/tan silty SAND
		-1	15+	---	---	Light brown/tan silty SAND
		-2	13	10	10	Light brown/tan silty SAND
		-3	14	15+	---	Light brown/tan silty SAND

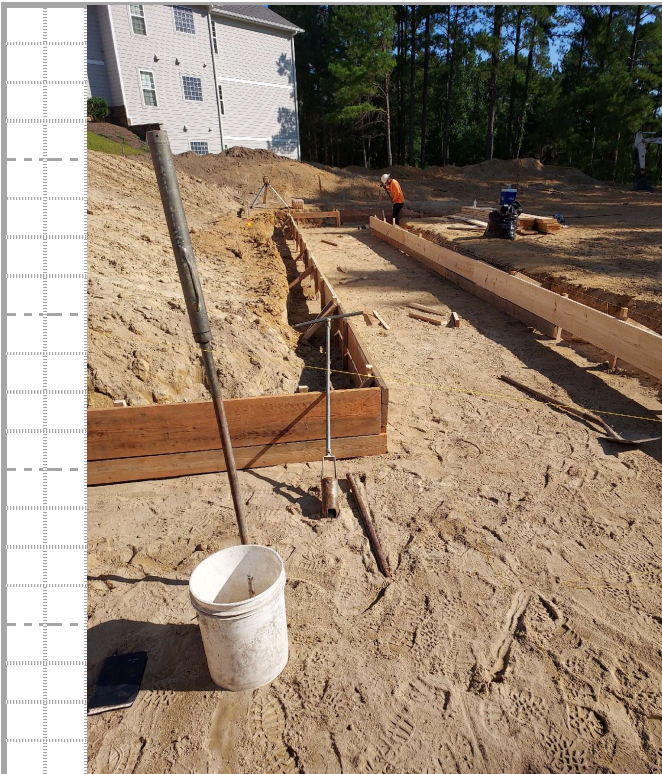
Description: Photo 1

Arrived onsite and contractor HH Multi, LLC had prepared spread/continuous footings along the front face of the Building #5 for the retaining wall. F&R performed three hand auger borings (Hand Auger Borings HA-1 through HA-3) with Dynamic Cone Penetrometer (DCP) bearing testing to depths of approximately 3 feet below the foundation bearing elevation. Loose silty sands were encountered at the footing bottom elevation at all three locations tested. The contractor was informed by F&R to re-compact the footing bottom with either a plate or jumping jack tamper and F&R would return to the site at a later date to re-evaluate the bearing capacity.
