RE: **Coats Comercial Building - 3rd Party
Inspections**

ECS Job # **33:7314**

ENCL: Field Report # 1 4/16/2025

FIELD REPORT

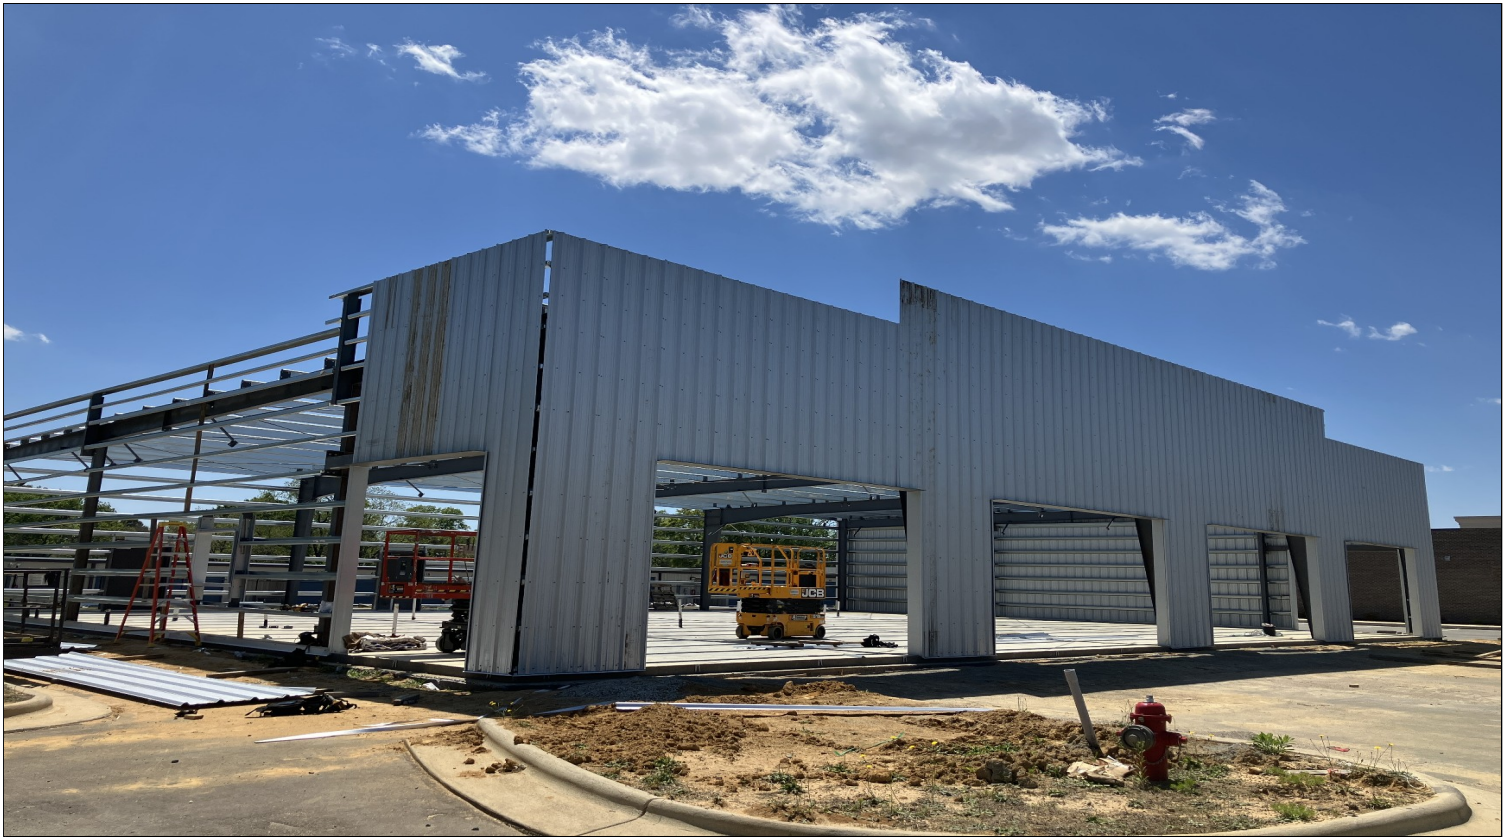
Photo 1 – Project Overview

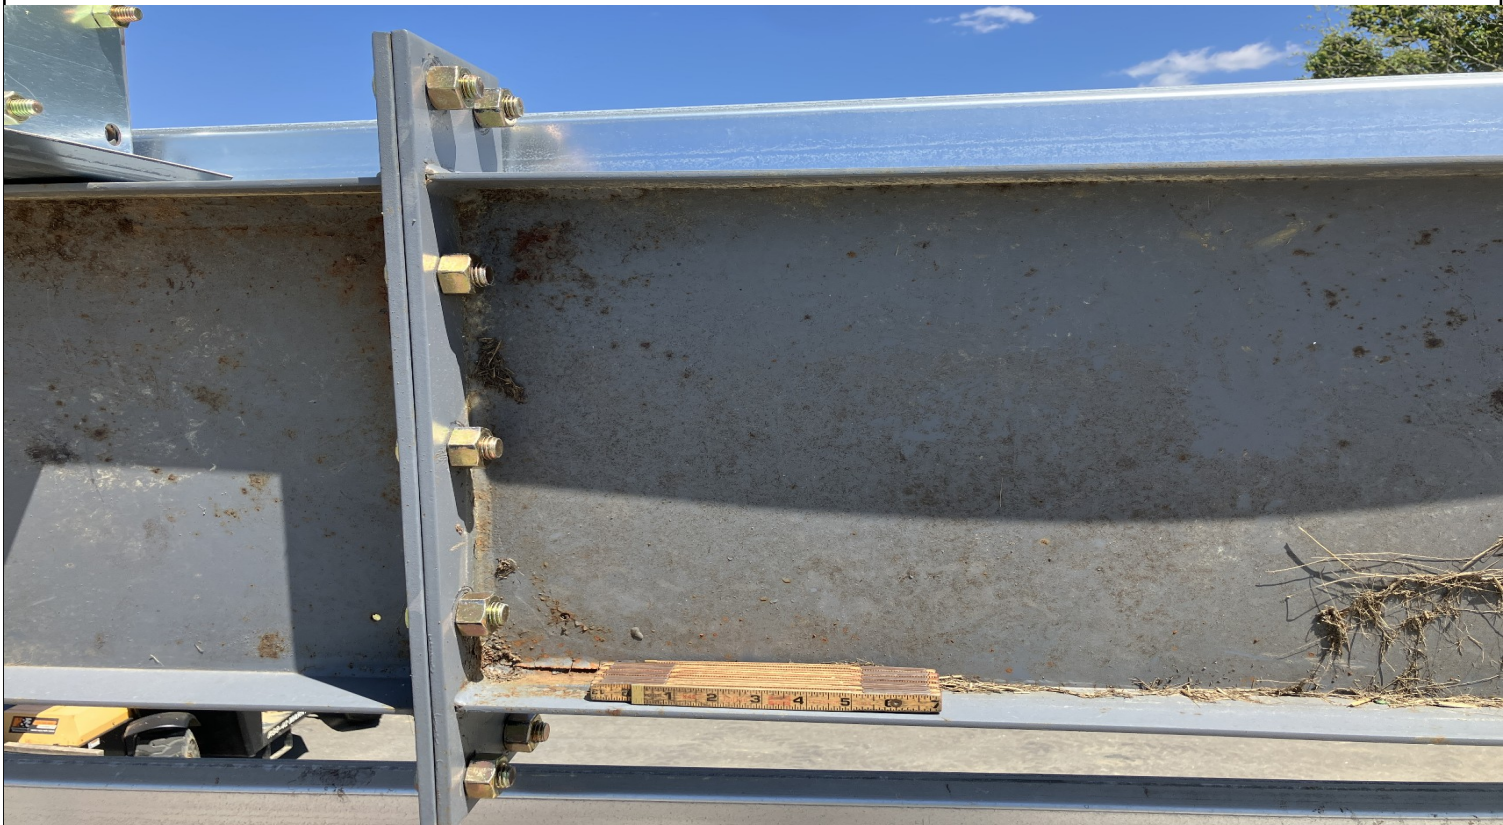
Visual observation of bolted connections was performed in accordance with written procedure ECS NDE VT-001 and RCSC Specification- Section 9. Fastener assemblies checked were installed in accordance with AISC 360 requirements in the following locations:

2a. Roof level framing, between column lines A to D and 1 to 5.

Photo 2 – Checking bolted connections on roof level framing

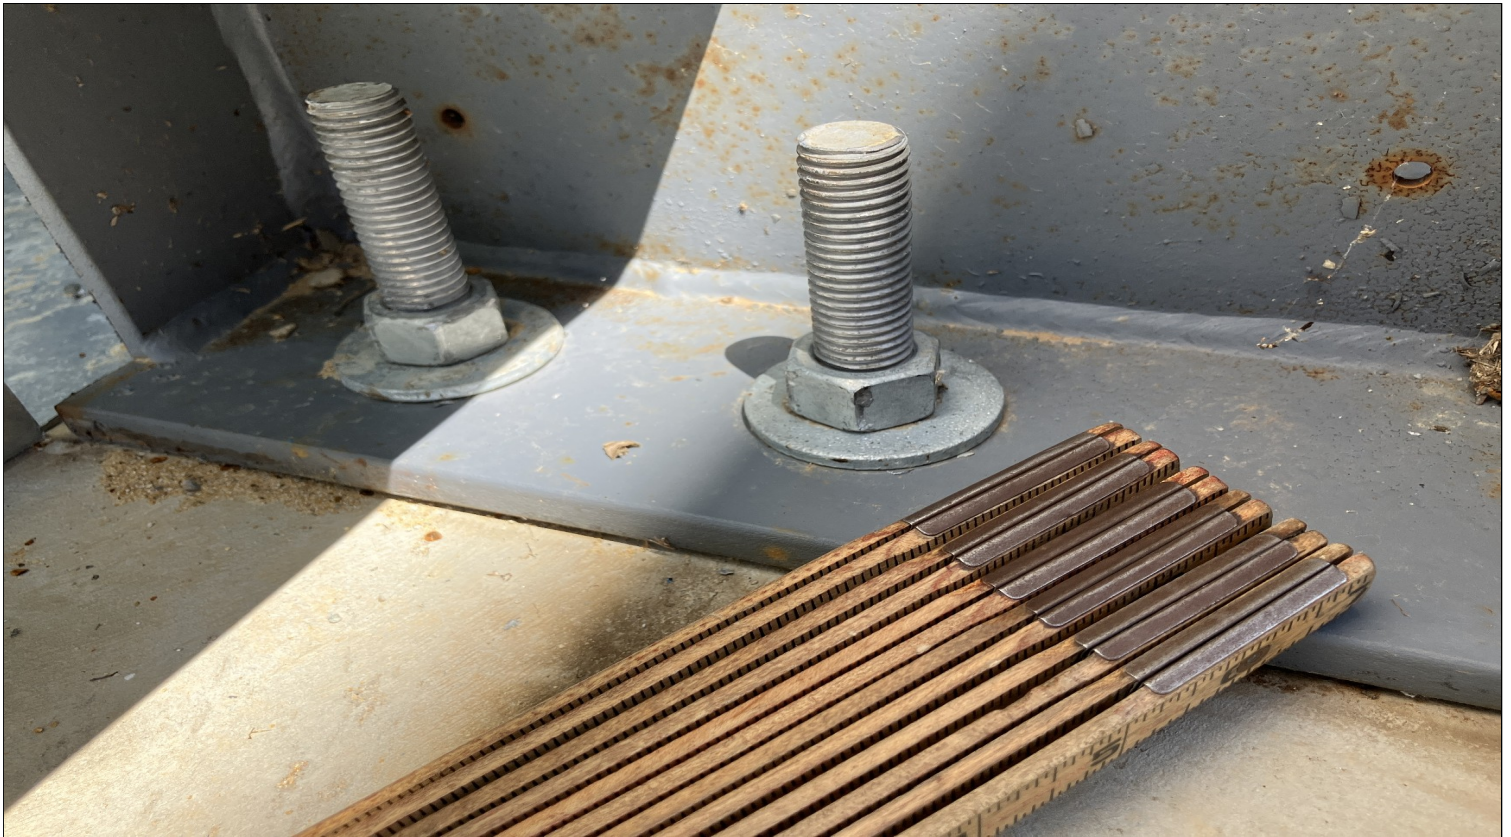
After final positioning and plumbing of the columns by the contractor, anchor rod nuts were checked for snug tight condition. The anchors had sufficient protrusion of the threaded ends to fully engage the nuts. The nuts appeared to be in a snug tight condition. The column base plates appeared to align with the anchor rods without unauthorized modification. Column anchors were checked in the following locations:

1a. Foundation level framing, between column lines A to D and 1 to 5.

Photo 3 – Checking column anchors

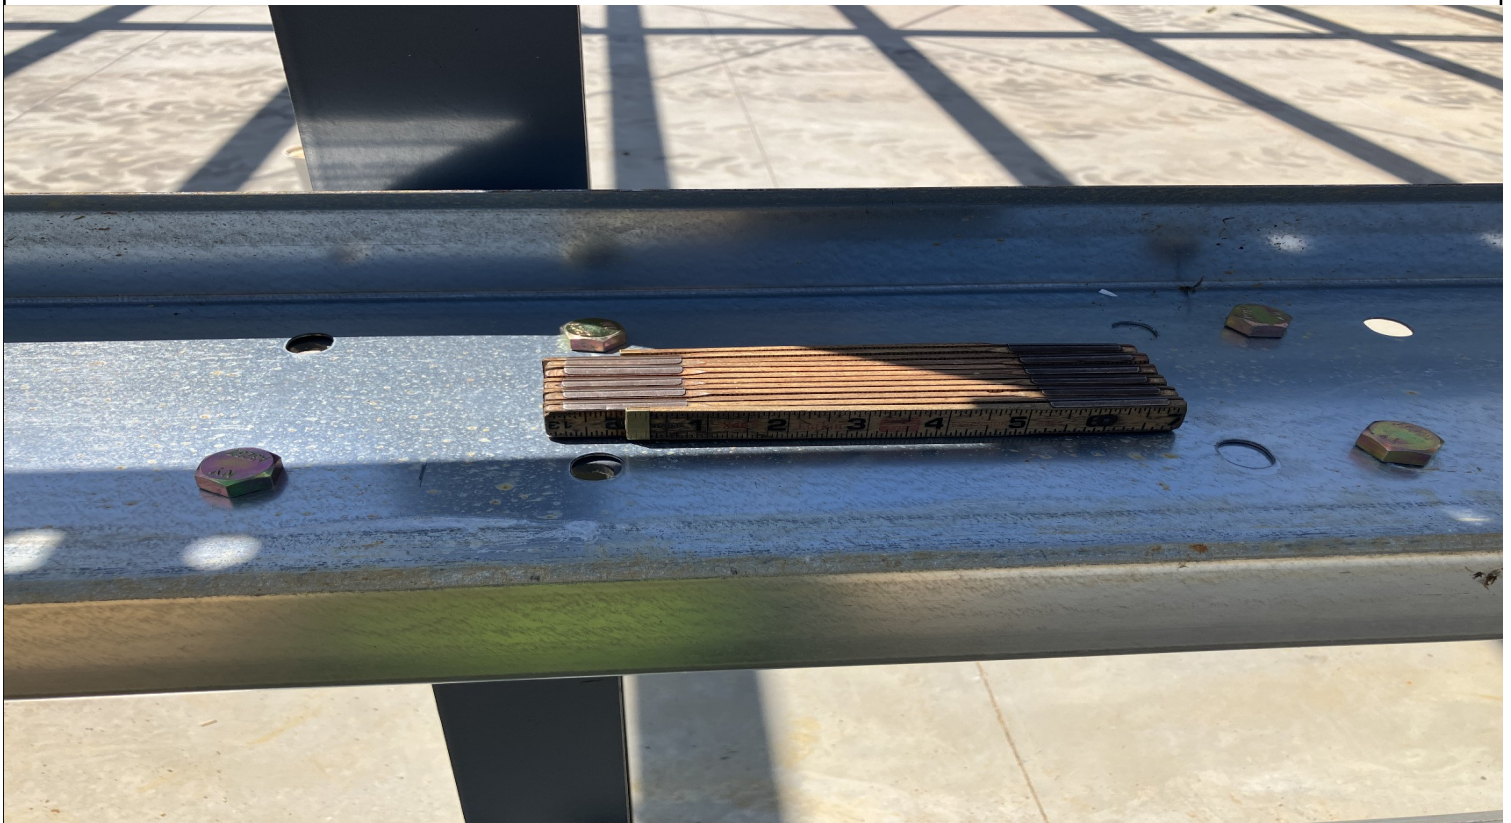
Photo 4 – Checking bolted connections on purlins
