LIMITED STRUCTURAL INSPECTION

6678 River Road
Fuquay-Varina, NC

June 6, 2024

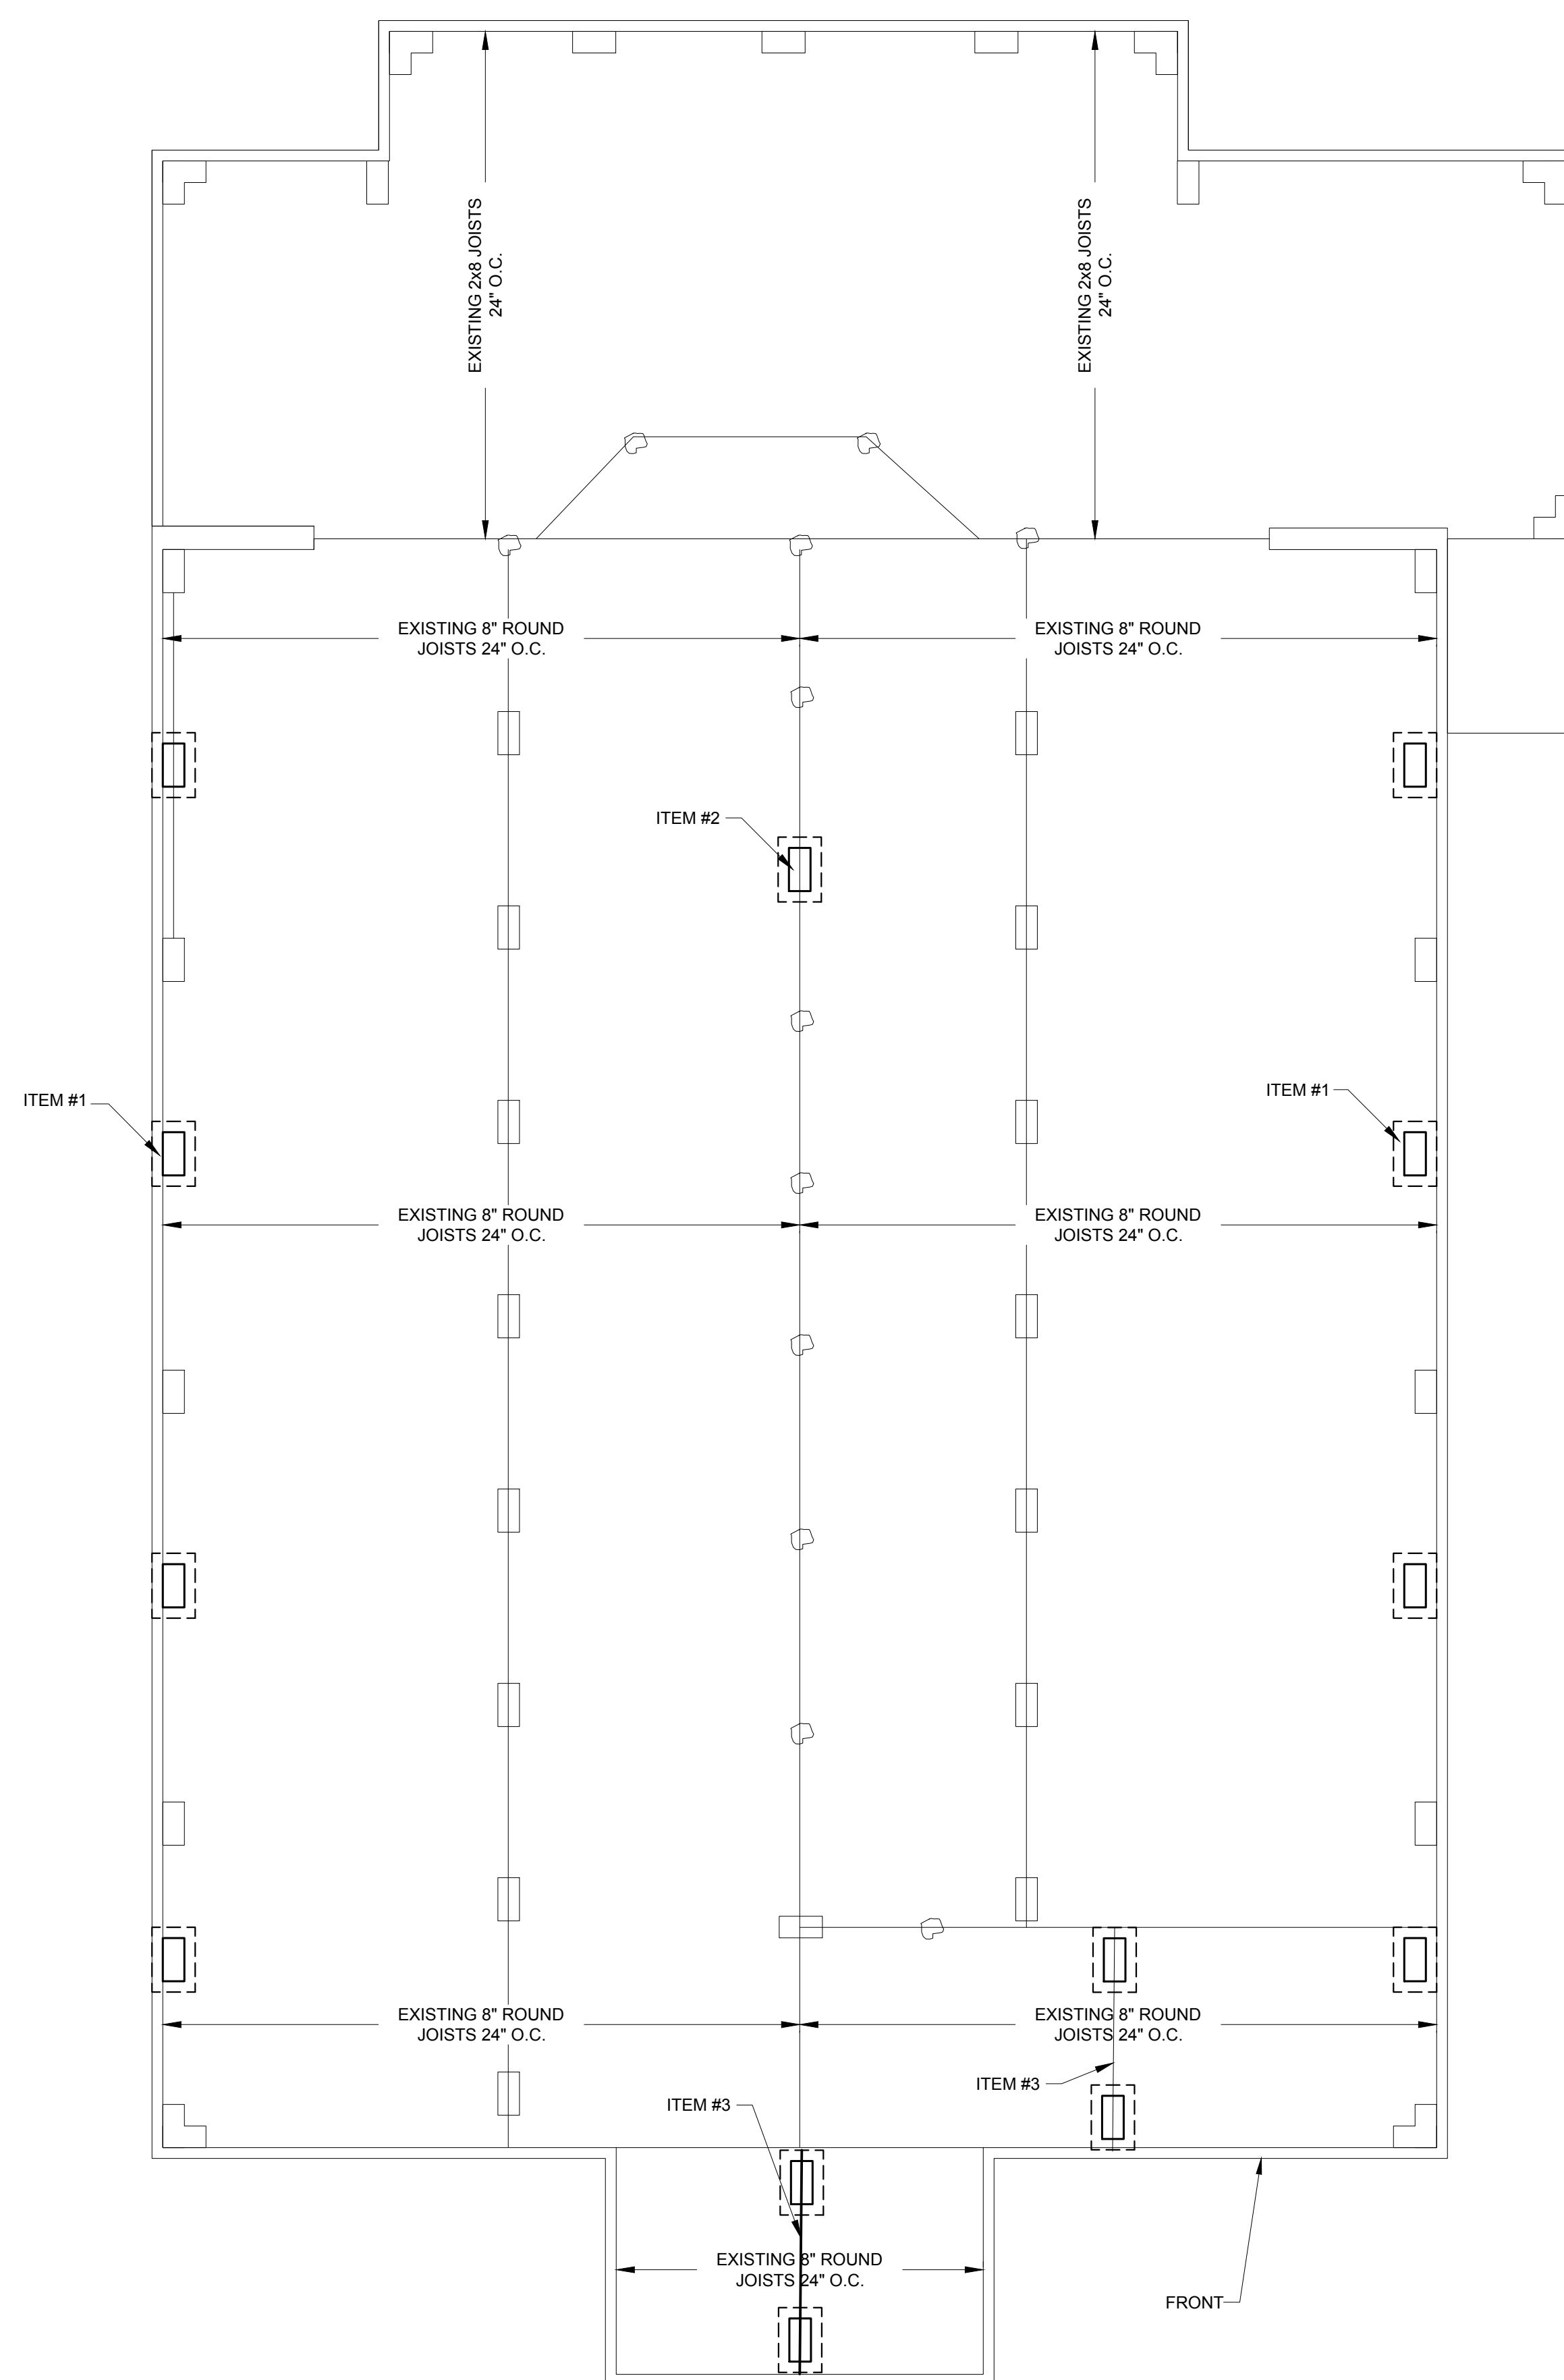
STRUCTURAL SUPPLEMENTAL PLAN - 40 PSF

Per our calculations, in its existing condition, the floor framing appears to be generally adequate for approximately 40 pounds per square foot, which is the design load for most residential applications per current code requirements. Some components of the framing are undersized per our calculations, and these include the drop girders and the perimeter band girders. Note that these components typically are overstressed in bending which per design values includes a safety factor. Further note that due to the significant age of some of the wood components (some greater than 100 years old), reference design values are difficult to quantify, and at best the provided calculations are an estimate. Lumber utilized in wood framing is typically visually graded, and by this process, the design values are estimated based on tabular data, which is based on qualitative testing. For wood of this age, these reference values are likely greater (old-growth wood is typically stronger) which would render the floor system stronger than our calculations show. Nonetheless, for the purposes of calculations and providing a conservative estimate of the floor framing capacity to the ownership, we have assumed values generally based on NDS tabular data.

1. We recommend installing 8x16 solid grouted CMU block piers on 20"x20"x10" thick concrete footings below the midspan of the perimeter girders on the right and left sides. Provide pressure-treated blocking or flashing between non-treated wood members.
2. We recommend installing a 16x16 solid grouted CMU block pier on a 24"x24"x10" thick concrete footing below the 10-foot span of the central girder. Provide pressure-treated blocking or flashing between non-treated wood members.
3. Install a new 3-2x8 drop girder supported on 8x16 solid grouted CMU block piers on 20"x20"x10" thick concrete footings at 7'-0" on-center below the midspan of the joists below the foyer at section at the front-right corner where the existing drop girder terminates. Connect the joists to the girder with Simpson H2.5a hurricane ties at each joist, alternating sides.

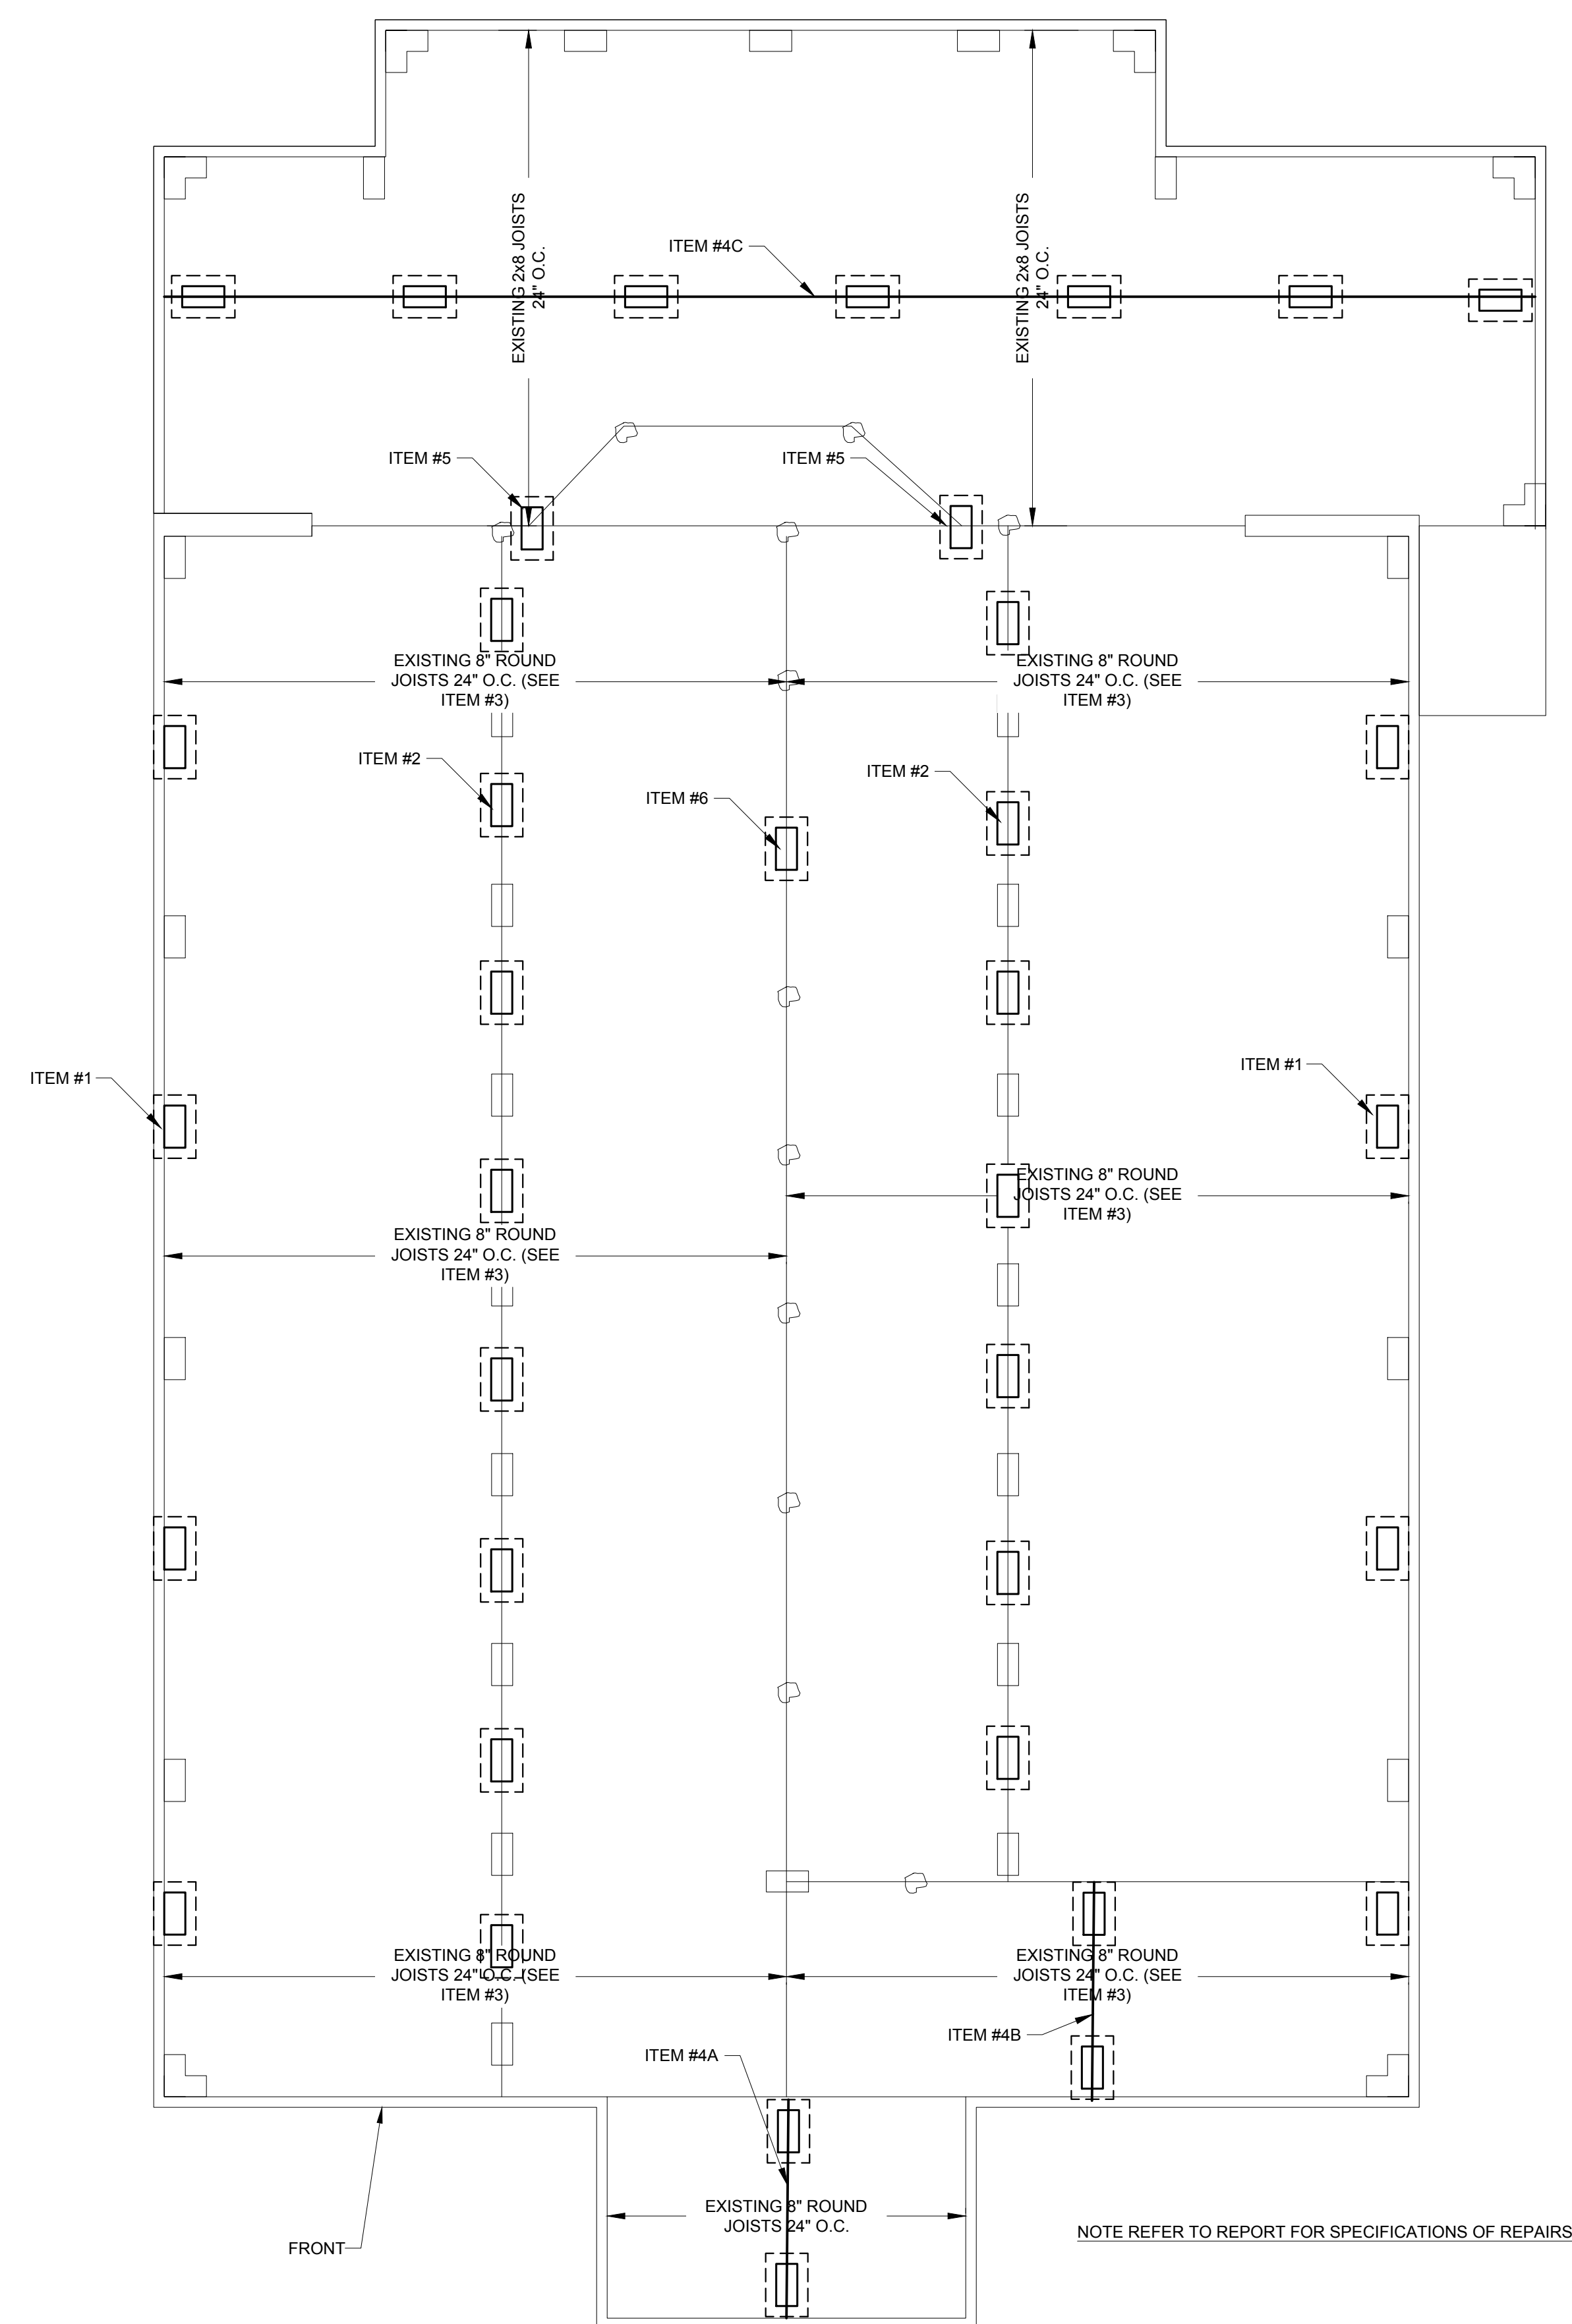
STRUCTURAL SUPPLEMENTAL PLAN -100 PSF

We have provided recommendations to repair the sanctuary floor to a 40 PSF capacity (generally matching original conditions) and also additional recommendations to increase the floor capacity to 100 PSF (per current building codes). Note that increasing the floor capacity would include an extensive amount of additional structural work from below.

1. We recommend installing 8x16 solid grouted CMU block piers on 20"x20"x10" thick concrete footings below the midspans of the perimeter girders on the right and left sides. Provide pressure-treated blocking or flashing between non-treated wood members.

2. We recommend installing 8x16 solid grouted CMU block piers on 20"x20"x10" thick concrete footings below the midspans of the 6x6 drop girders on the right and left sides. Provide pressure-treated blocking or flashing between non-treated wood members.

3. We recommend fully sistering (bearing point to bearing point) **all joists** with 2x8 pressure-treated members on **both** sides. Attach the new joists to the round member with 4" long Simpson SDWS screws at 16" on-center. At the bearing points of the new joists at the girders, provide 2x4 pressure-treated ledgers below the joist with (3) 16d nails below each joist. Note, that the carpet should also be removed, and the subfloor nailed to the top of the joists with 10d nails at 12" on-center.

4. Install a new 3-2x8 drop girder supported on 8x16 solid grouted CMU block piers on 20"x20"x10" thick concrete footings at 7'-0" on-center at the following locations: Connect the joists to the girder with Simpson H2.5a hurricane ties at each joist, alternating sides.

- a) Below the midspan of the joists below the foyer.
 - b) Below the section of joists at the front right corner where the existing drop girder terminates.

- c) At the midspan of the floor framing in the rear classroom areas.
5. Install (2) 8x16 solid grouted CMU block piers on 20"x20"x10" thick concrete footings at the rear of the inset pulpit/stage area (see diagram).

6. We recommend installing a 16x16 solid grouted CMU block pier on a 24"x24"x10" thick concrete footing below the 10-foot span of the central girder. Provide pressure-treated blocking or flashing between non-treated wood members.

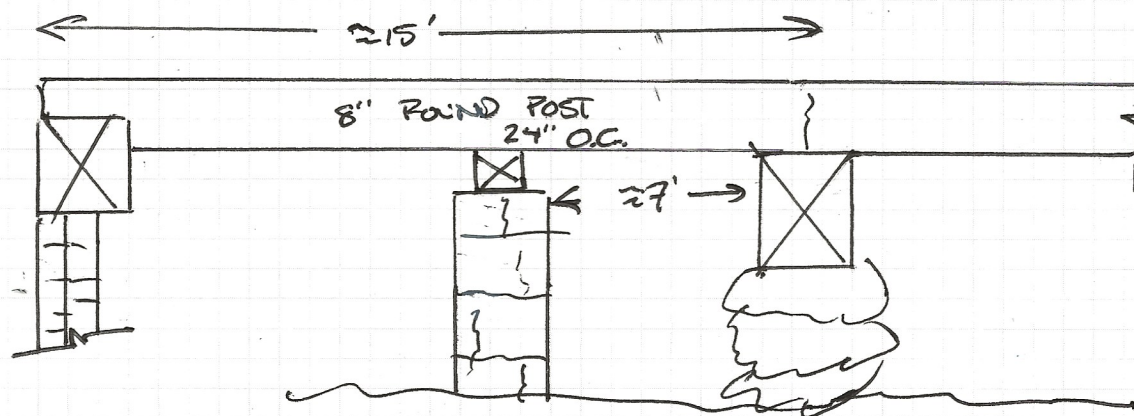
ROUND JOIST CARCS

MAX MOMENT ≈ -1711 FT-LBS (40 PSF) ; -3686 (100 PSF)

496 PSI } 40 PSF
OK

1070 PSI } 100 PSF
NG
