## FIELD REPORT

<b>Project Name:</b> 94 Lunker Lane	<b>Location:</b> Holly Springs, NC
<b>Project No.:</b> 73747	<b>Permit No.:</b>
<b>Client:</b> Triangle Home Pros	<b>Weather:</b> Sunny
<b>Contractor:</b> Triangle Home Pros	<b>Date:</b> 8/27/25
<b>Technician:</b> Sam Kirley	<b>Portal to Portal Time:</b> 2.0

**Summary:** Rebar Check

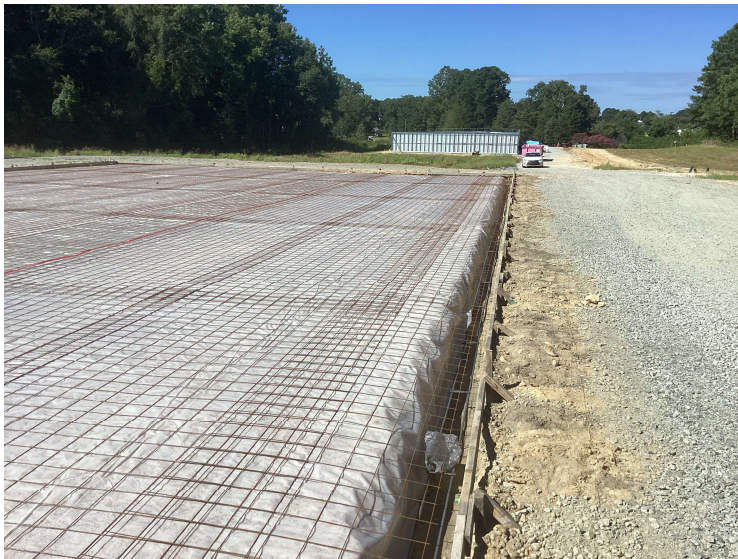
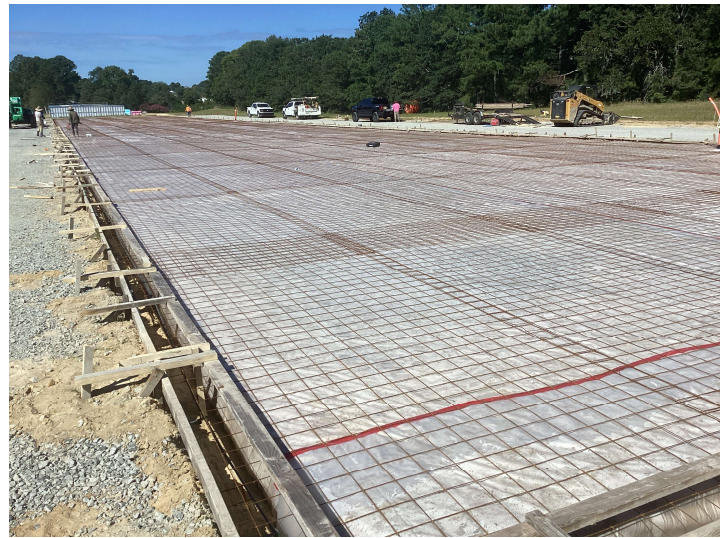
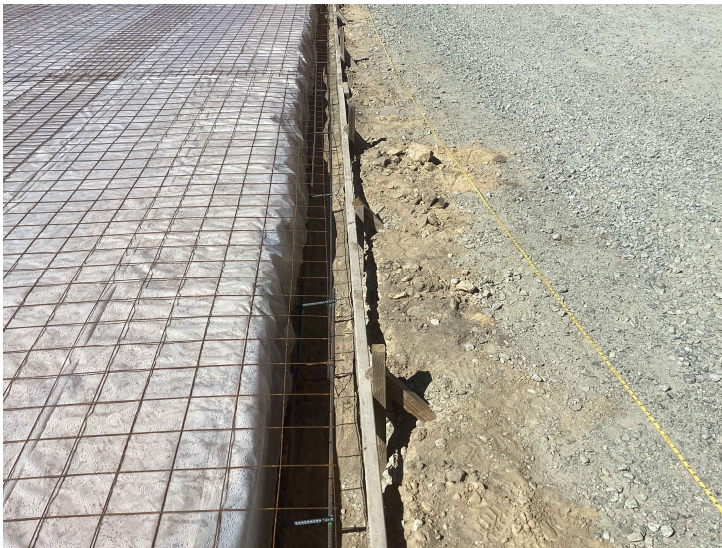
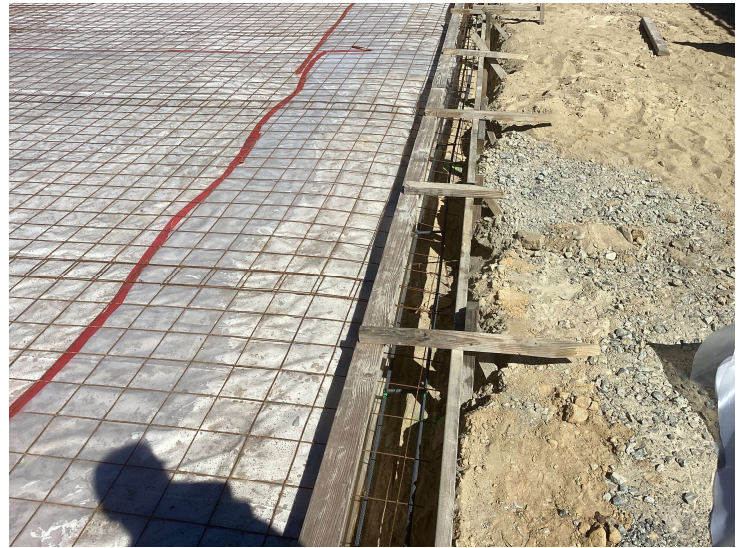
**Notes:** Timmons arrived on site as requested by contractor. Technician conducted rebar inspection and found it meet the specifications in plans on site regarding sizing, spacing, splicing, etc. Technician ensured vapor barrier was in place, properly taped and taped around any existing utilities.
