COUNTY OF HARNETT RESIDENTIAL LAND USE APPLICATION

Re: Damage from Falling Tree
State Farm Claim: #33-5770-G43
Insured: Randall & Kathy Griffen
D.O.L.: 9/14/2018
FAEC File No.: 500-248-NC-18

- Inspect the structure, focusing on the left rear quadrant where a falling tree uplifted the home.
- Determine the extent of structural damage to the home and provide recommendations for repair, addressing the applicable building codes as well.

The insured risk is a 2,610-sf, two-story residential structure built in 1903. The home has wood siding, an asphalt shingle roof, and a brick pier crawlspace foundation. The insured purchased the home in June of 2000. The structure faces south.

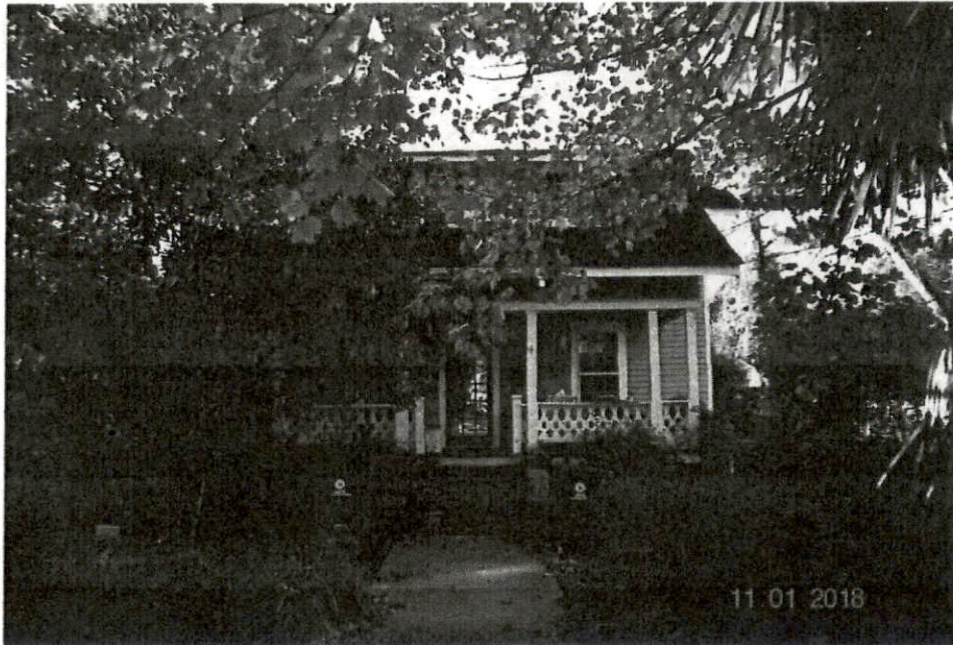
Photograph No. 1 – The insured risk was uplifted at the left rear corner by a large tree that was immediately adjacent to the rear wall and fell away from the house such that the root ball lifted the house framing.

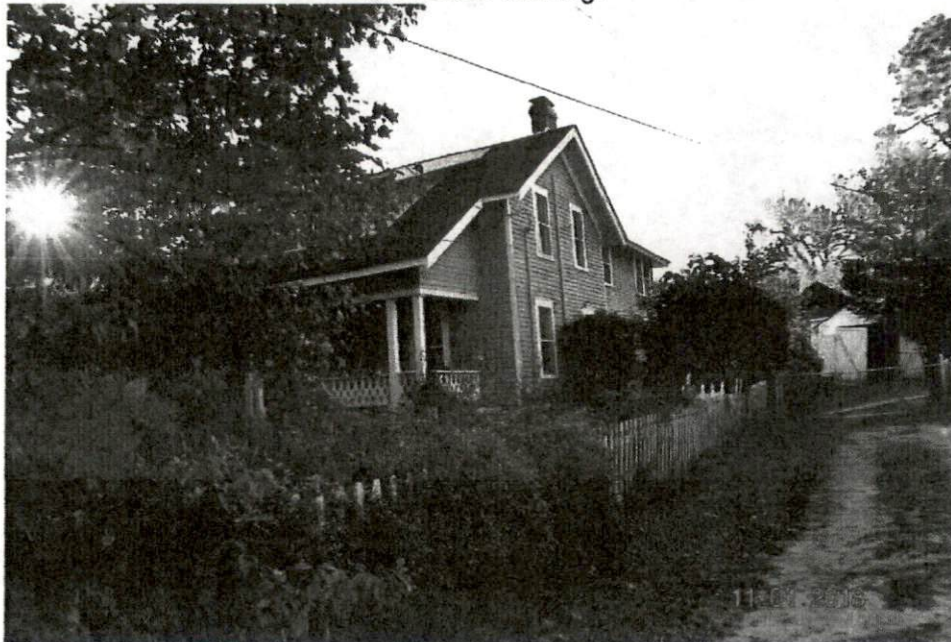
Photograph No. 2 – A view of the home from the right front.

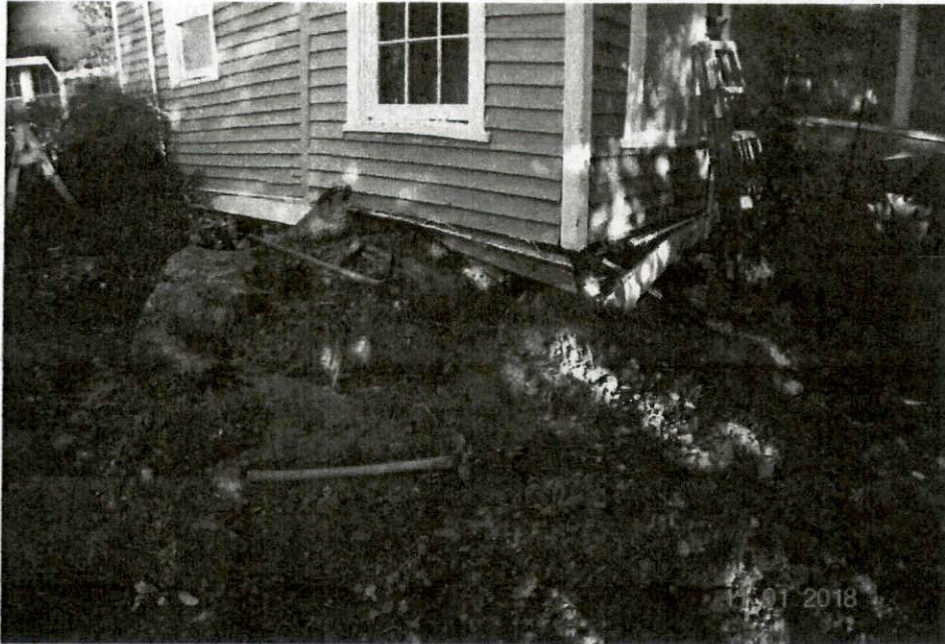
Photograph No. 3 – This is the left rear corner of the home. The tree fell toward the left in this photo, uplifting the left rear corner of the home.

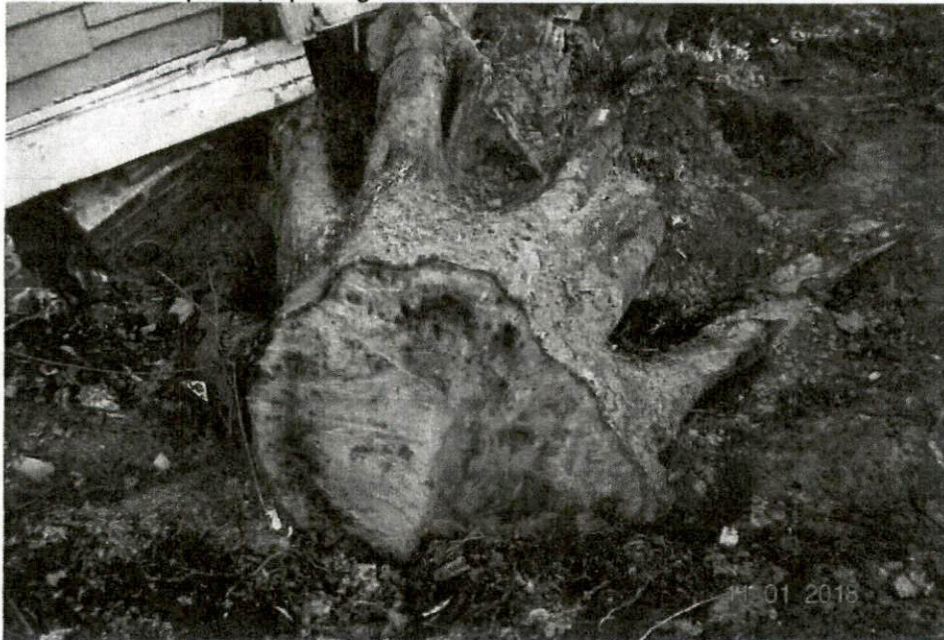
Photograph No. 4 – This is that tree stump. Note the failed brick face wall to the left. There is also a pier in that area that failed.

3. Two brick piers that previously supported the rear wall at the left corner area have been damaged and require replacement or reconstruction. The brick foundation face wall on the left side and along the rear of the main portion of the home require replacement. The face wall is not a structural wall.

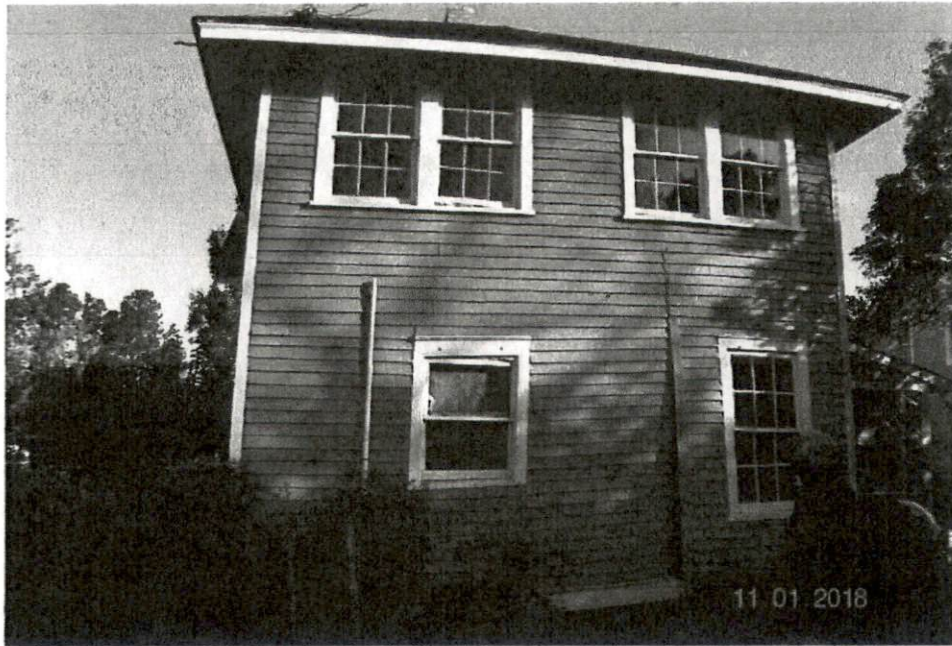
Photograph No. 5 – The rear of the home. The right side in this photo is uplifted and the tree stump is holding it in that elevated position.

The issue is how to support the rear wall while the tree stump is removed. I have suggested to the insured that a specialty foundation contractor inspect the site. It is possible that helical piers can be installed to support the left rear v-corner while the stump is removed, then readjusted to support the home at a normal level or removed in the event that new footings and piers are constructed after the tree is out of the way.

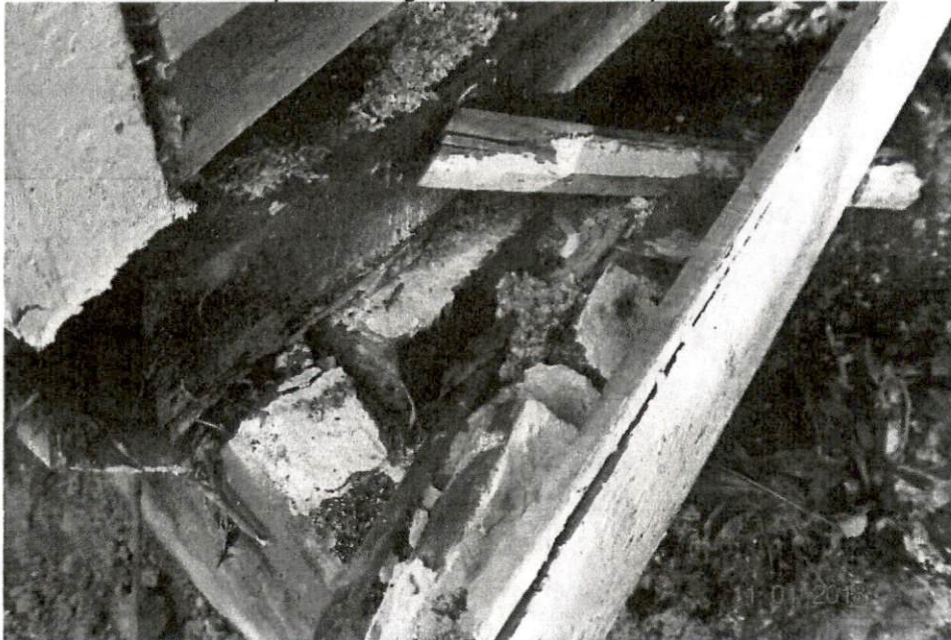
Photograph No. 6 – The left corner pier is damaged. Note the sill beam.

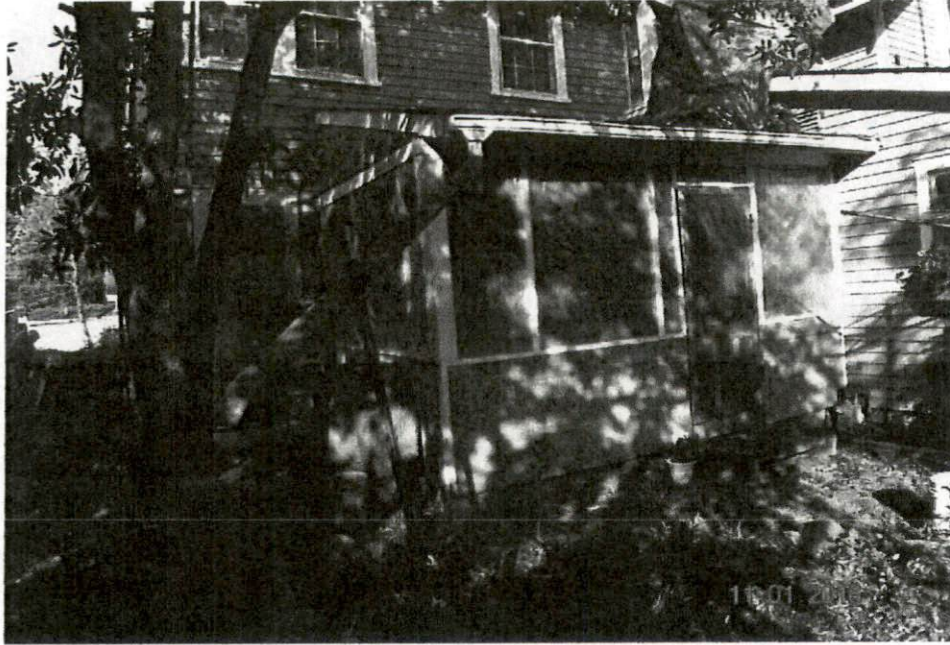
Photograph No. 7 – This is the screened porch along the left side of the home and towards the left rear corner.

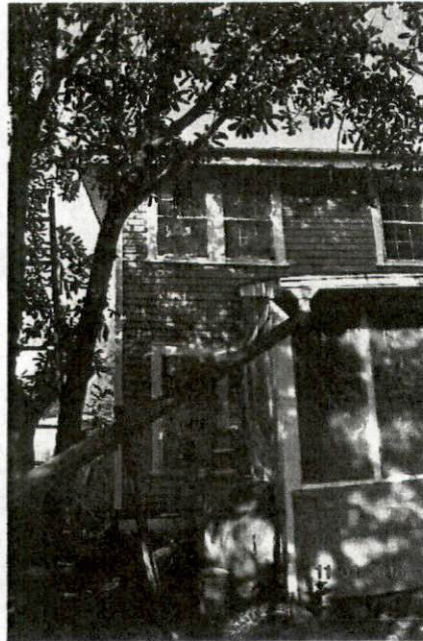
Photograph No. 8 – Another view of the porch and the left rear corner that is uplifted. The rear of the porch also lifted a bit.

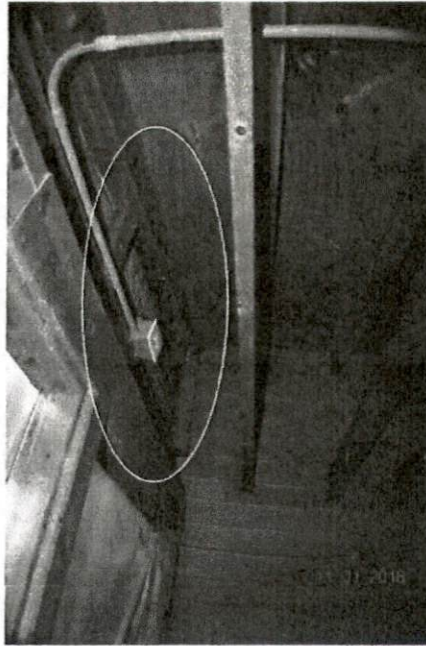
Photograph No. 9 – The interior framing of the porch showing some separation at the house.

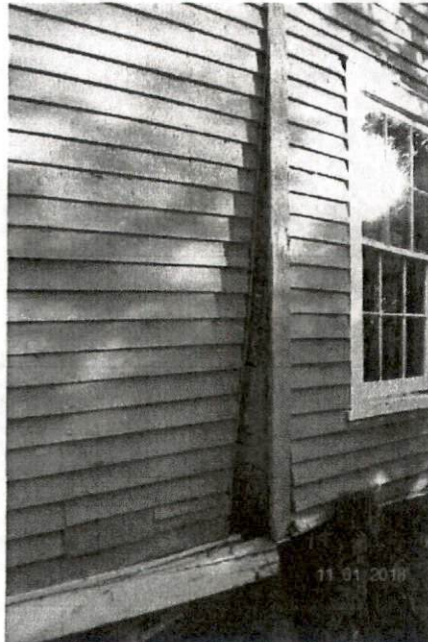
Photograph No. 10 – There is a load bearing wall between the hallway and kitchen. The floor is framed differently on each side of this wall. The hallway side (to the right in this photo) of the rear wall is pushed out a bit.

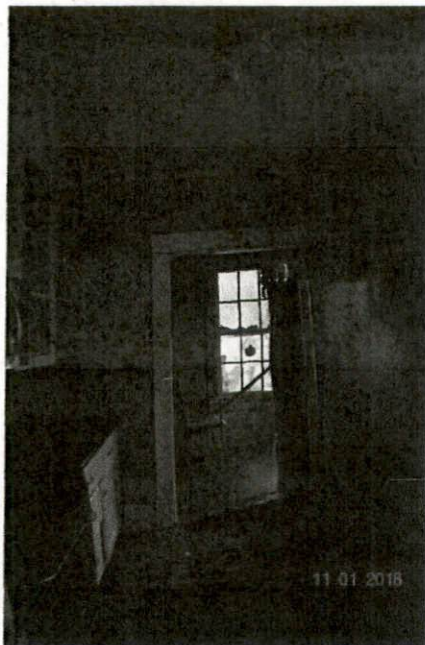
Photograph No. 11 – The kitchen is on the right side of the rear wall, and the hallway is on the left. This photo looks from the kitchen to the hallway. Note the uplift in the hallway floor.

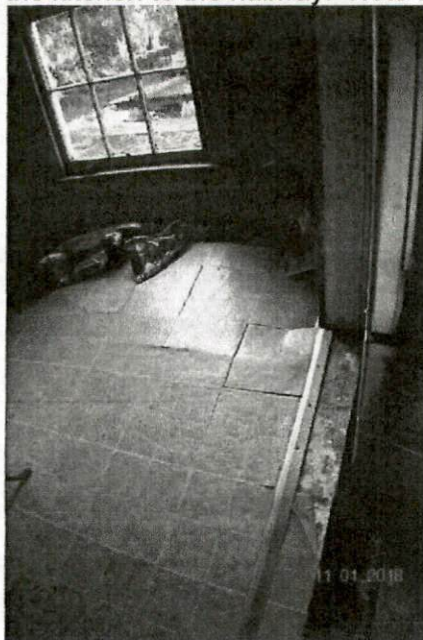
Photograph No. 12 – The stump is right underneath this hallway.

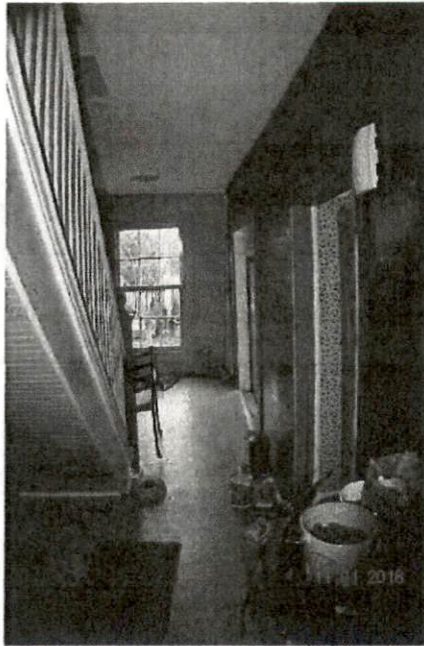
Photograph No. 13 – That hallway as seen from the front of the house.

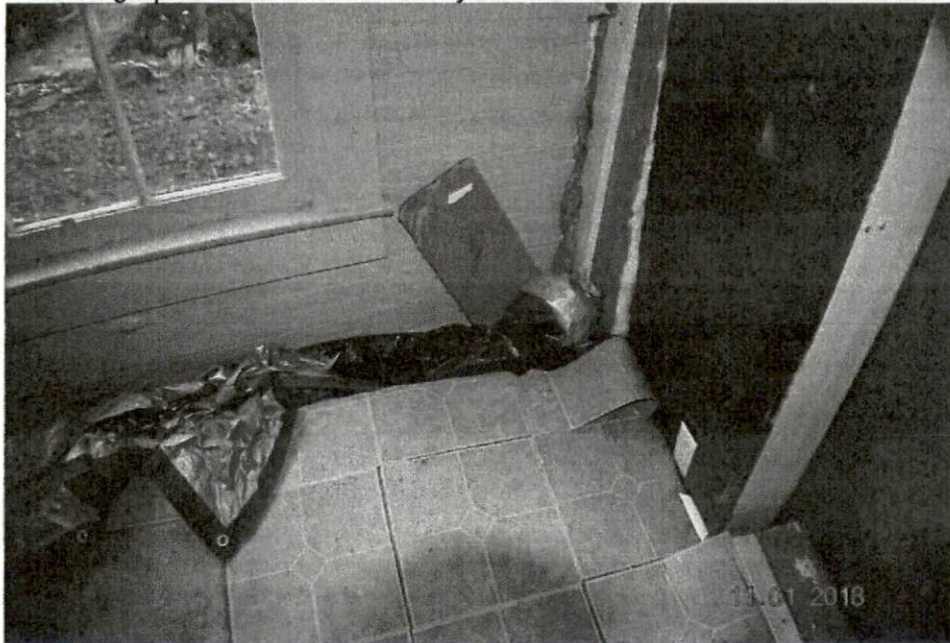
Photograph No. 14 – The rear wall is pushed out a bit.

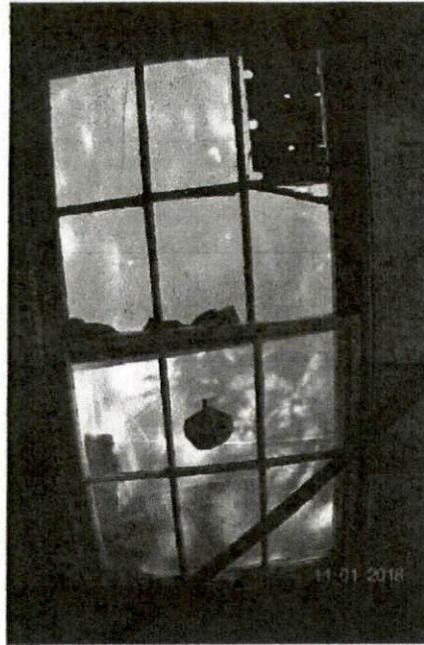
Photograph No. 15 – This window on the left side at the left rear corner is wracked.

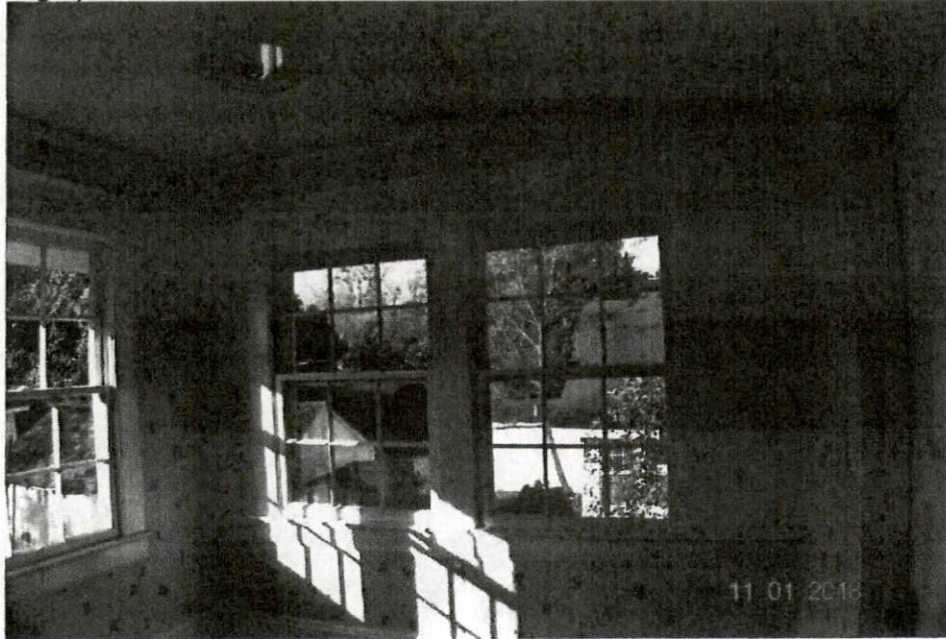
Photograph No. 16 – The room immediately above went along for the ride and shows some distress...

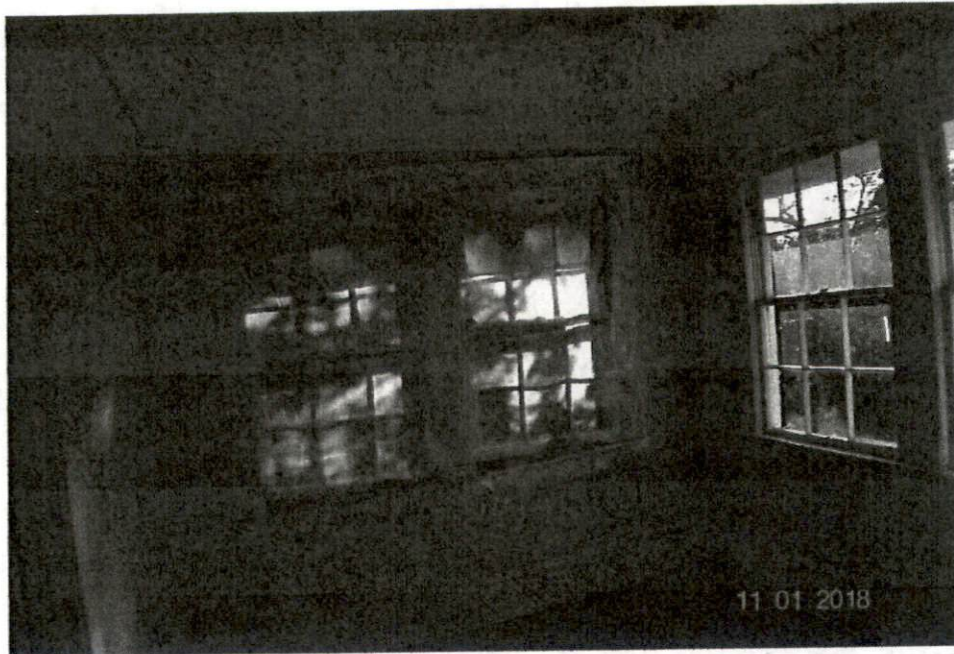
Photograph No. 17 – ...as does the room at the right rear above the kitchen.

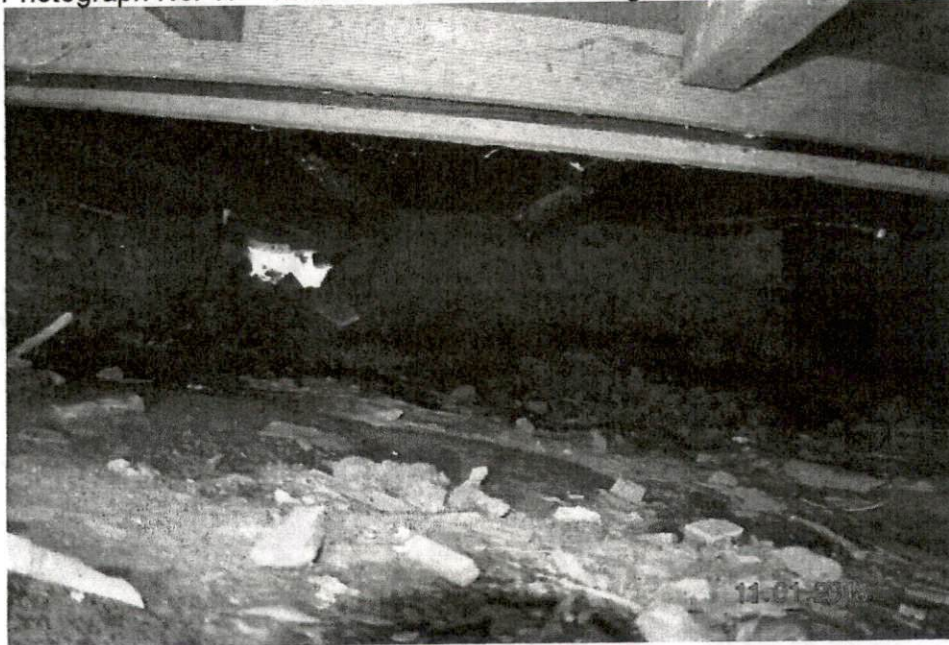
Photograph No. 18 – Looking from the crawlspace under to the rear, showing the root ball.

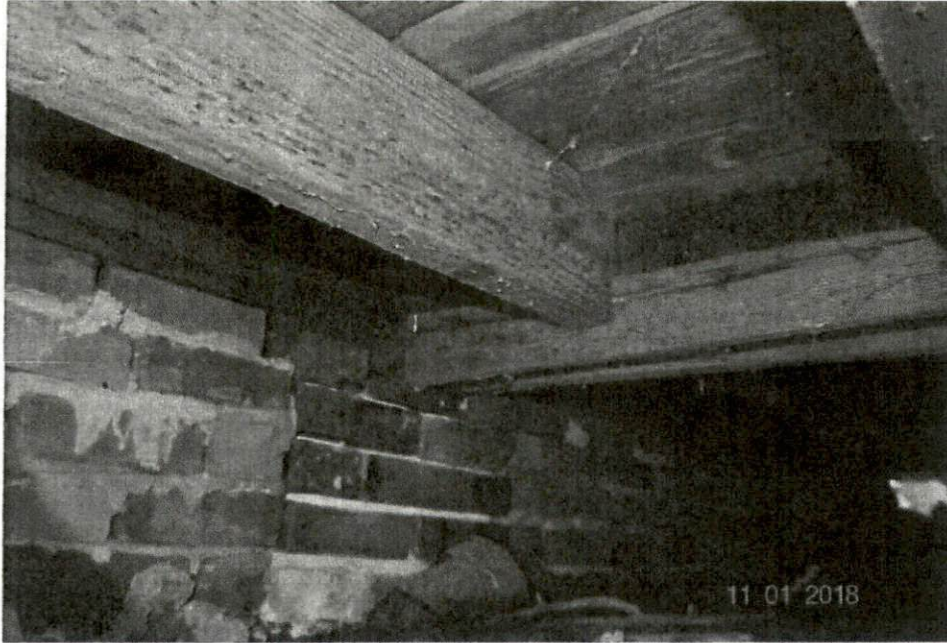
Photograph No. 19 – The pier supporting the left-to-right girder on the left wall is in good shape...

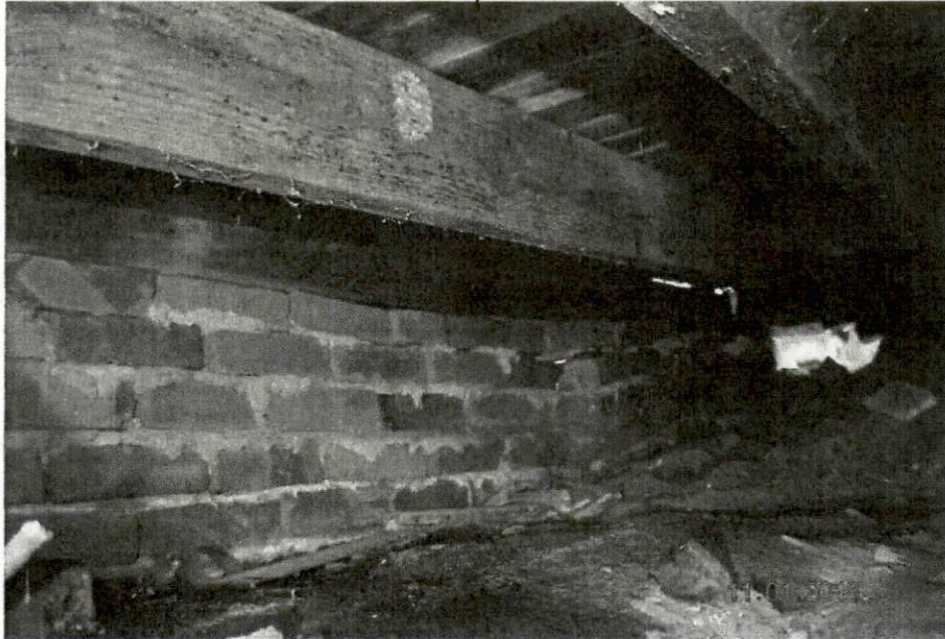
Photograph No. 20 – ... but the face wall is not. The face wall is not a structural component.

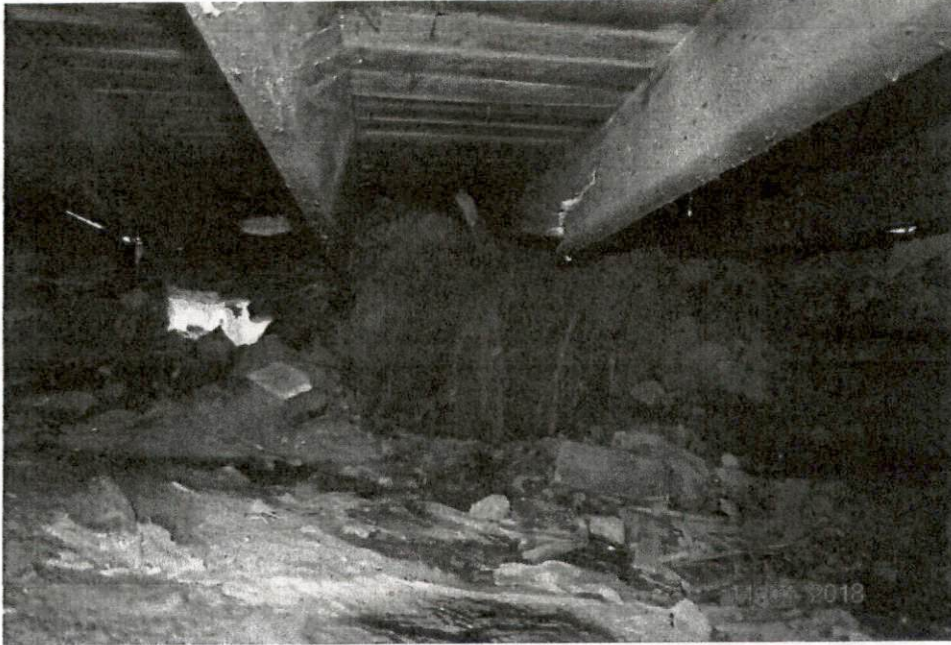
The damage to the framing is more due to displacement caused by the uplift movement of the root ball than by structural failure of the framing members. Only one failed floor joist was observed, although there may be more, including a sill beam that may turn out to be damaged. The two piers to the left side of the rear wall of the home have failed as well.

Photograph No. 21 – The only damaged framing member observed is this floor joists above the tree stump. There may be other framing members damaged but they are not visible at this time. We cannot see the sill beam beyond the stump and this may be damaged.

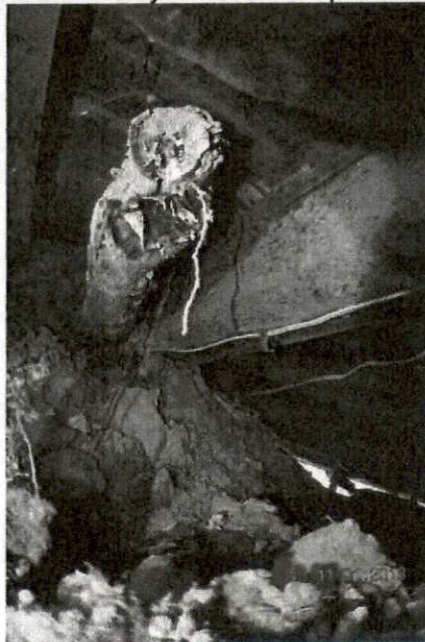
Photograph No. 22 – A root that extended well under the floor framing.

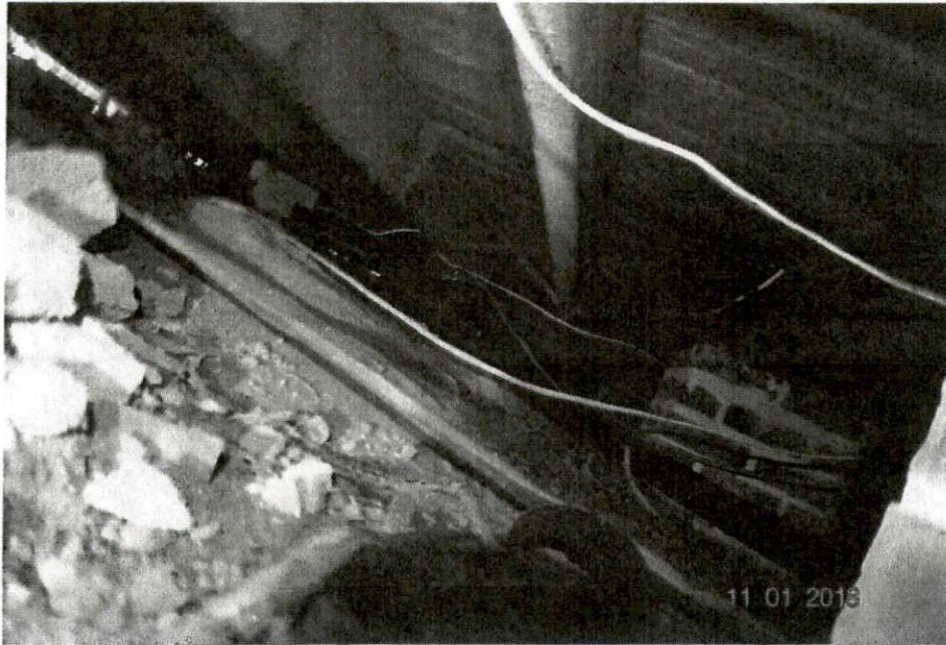
Photograph No. 23 – This photo is taken looking under the kitchen from the left toward the right rear corner. The framing under the kitchen appears undamaged.

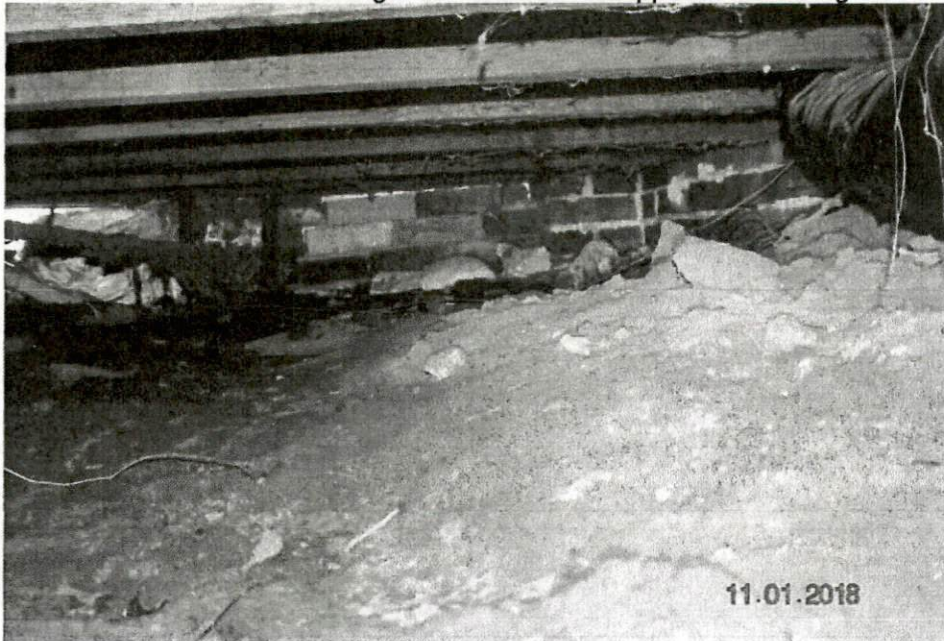
Photograph No. 24 – This photo is taken from the front looking to the right side of the rear wall. The face wall along the rear is damaged.
