November 12, 2018

Re: Damage from Falling Tree
State Farm Claim: #33-5770-G43
Insured: Randall & Kathy Griffen
D.O.L.: 9/14/2018
FAEC File No.: 500-248-NC-18

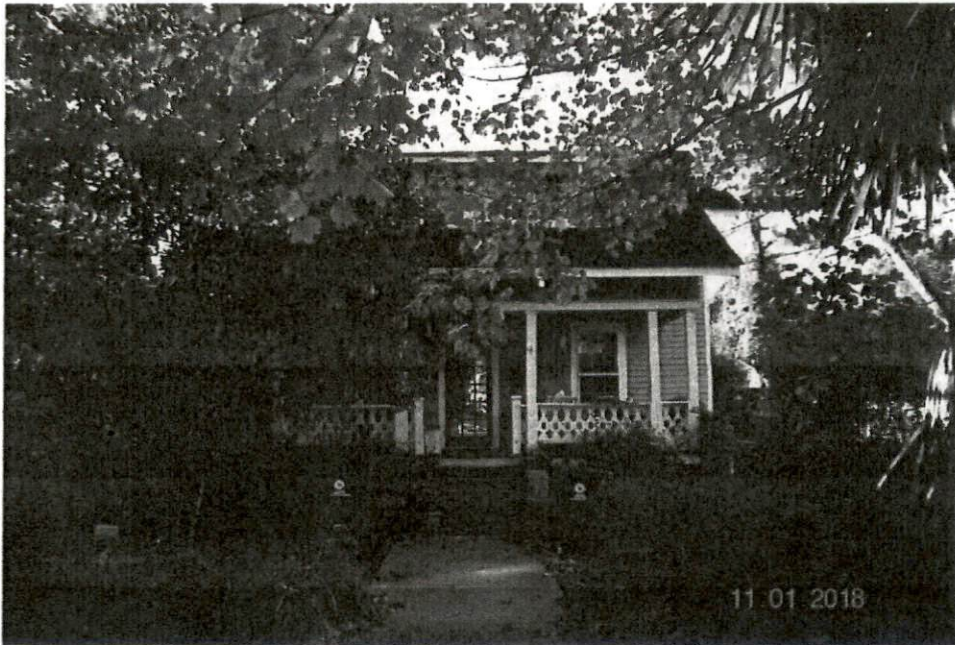
- This home is in an urban neighborhood of similar homes. The tree that fell was located immediately adjacent to the rear exterior wall of the home on the left side with a root structure that extended well under the home. The tree fell to the northeast. The uplifted root ball lifted the left rear corner of the home at least 1-ft vertically.
- Two brick support piers, one on each side of the tree, failed as a result of the tree movement. The leftmost pier that was damaged was the pier at the left rear corner of the home.
- On the interior, there is a hallway over the immediate area of the tree root. The kitchen is along the rear wall to the right of this hallway. The sill beam of the rear

Photograph No. 1 – The insured risk was uplifted at the left rear corner by a large tree that was immediately adjacent to the rear wall and fell away from the house such that the root ball lifted the house framing.

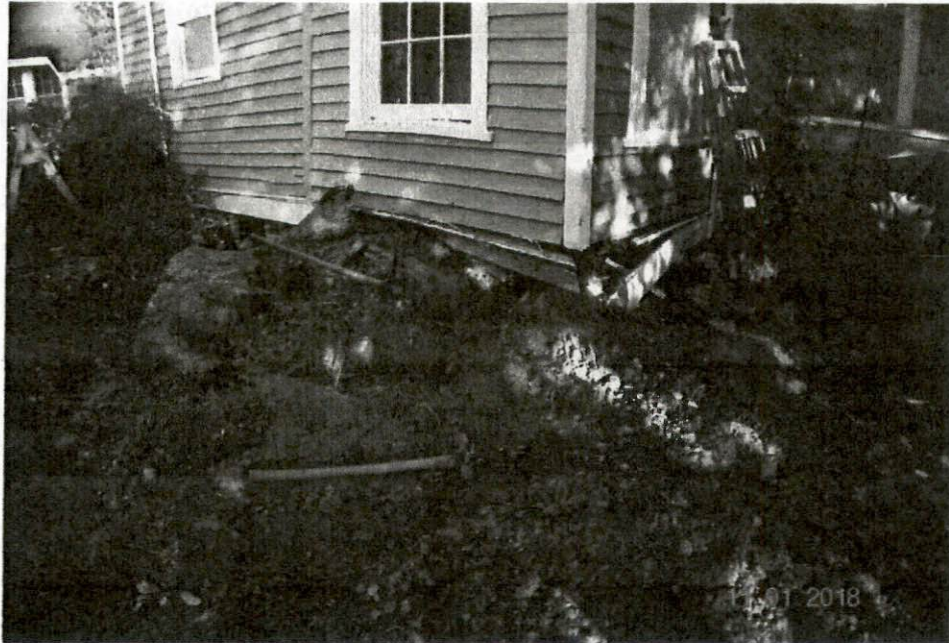
Photograph No. 3 – This is the left rear corner of the home. The tree fell toward the left in this photo, uplifting the left rear corner of the home.

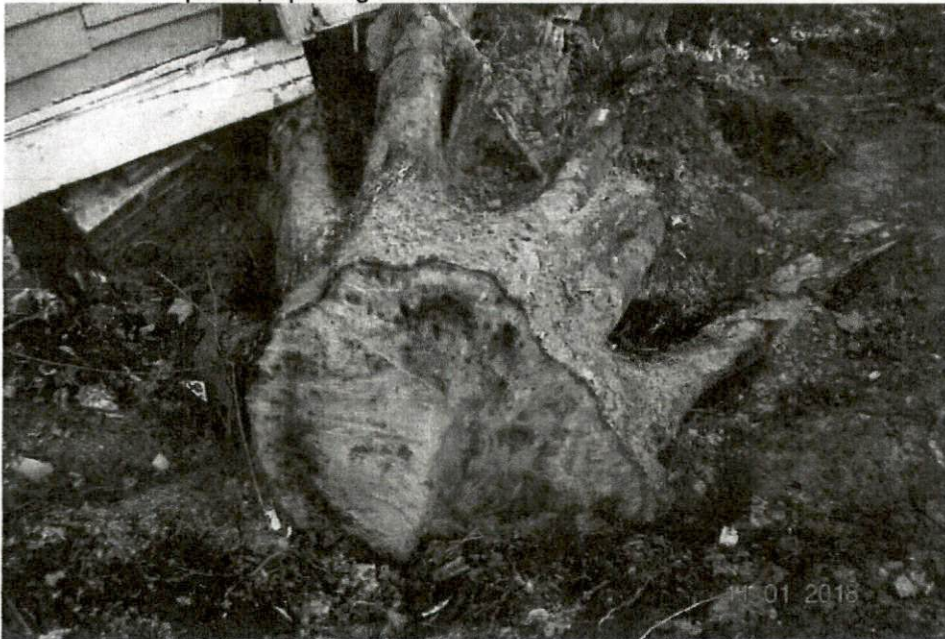
The damage to the framing is more due to displacement caused by the uplift movement of the root ball than by structural failure of the framing members. Only one failed floor joist was observed, although there may be more, including a sill beam that may turn out to be damaged. The two piers to the left side of the rear wall of the home have failed as well.

Photograph No. 4 – This is that tree stump. Note the failed brick face wall to the left. There is also a pier in that area that failed.

3. Two brick piers that previously supported the rear wall at the left corner area have been damaged and require replacement or reconstruction. The brick foundation face wall on the left side and along the rear of the main portion of the home require replacement. The face wall is not a structural wall.

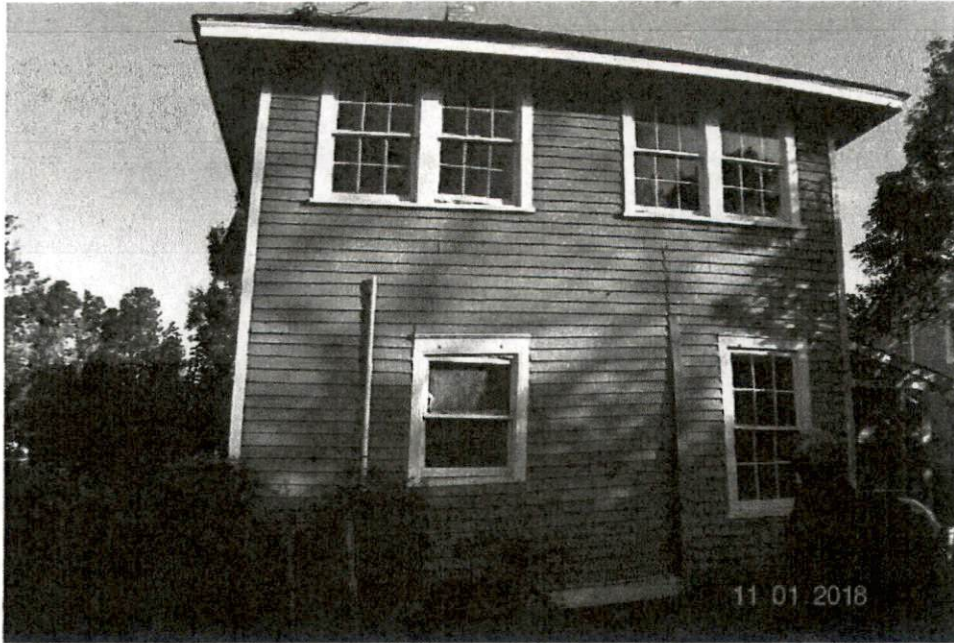
- The body of the stump is supporting the left rear corner of the house in its elevated position.
- The crawlspace under was accessed with difficulty. The floor framing under the hallway runs front-to-back and are ledgered to a left-to-right girder placed an estimated 12-ft- from the rear wall of the home and supported by brick piers at each end. At least one of the floor joists, the one immediately above the tree root ball, is broken.

Photograph No. 5 – The rear of the home. The right side in this photo is uplifted and the tree stump is holding it in that elevated position.

The issue is how to support the rear wall while the tree stump is removed. I have suggested to the insured that a specialty foundation contractor inspect the site. It is possible that helical piers can be installed to support the left rear v-corner while the stump is removed, then readjusted to support the home at a normal level or removed in the event that new footings and piers are constructed after the tree is out of the way.

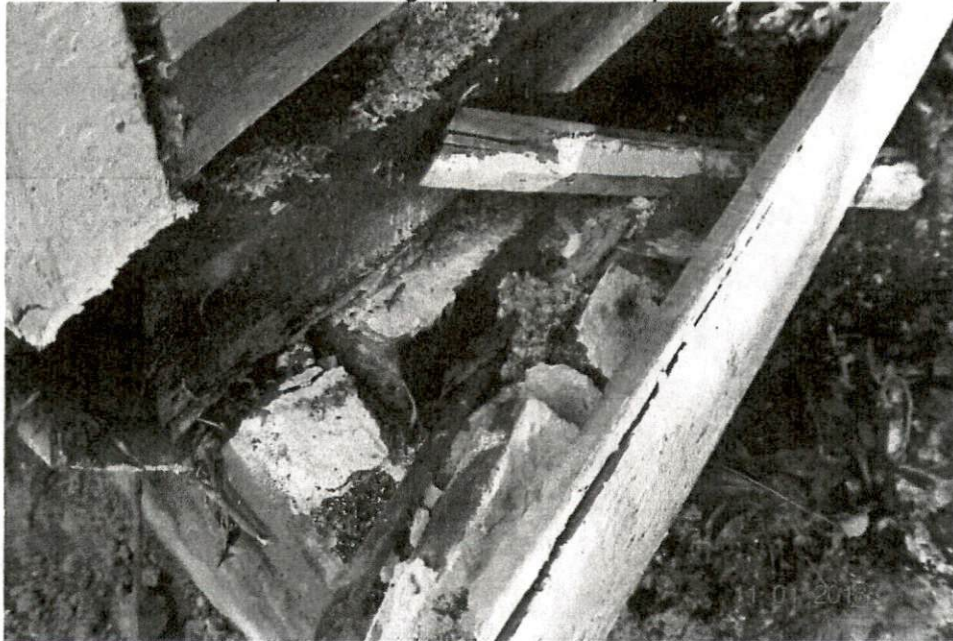
- On the exterior, the sill beam along the rear wall is not completely visible but is uplifted at its left end. The rear wall of the home in the area of the hallway projects out several inches at the bottom from the remaining portions of that wall to the left.

Photograph No. 6 – The left corner pier is damaged. Note the sill beam.

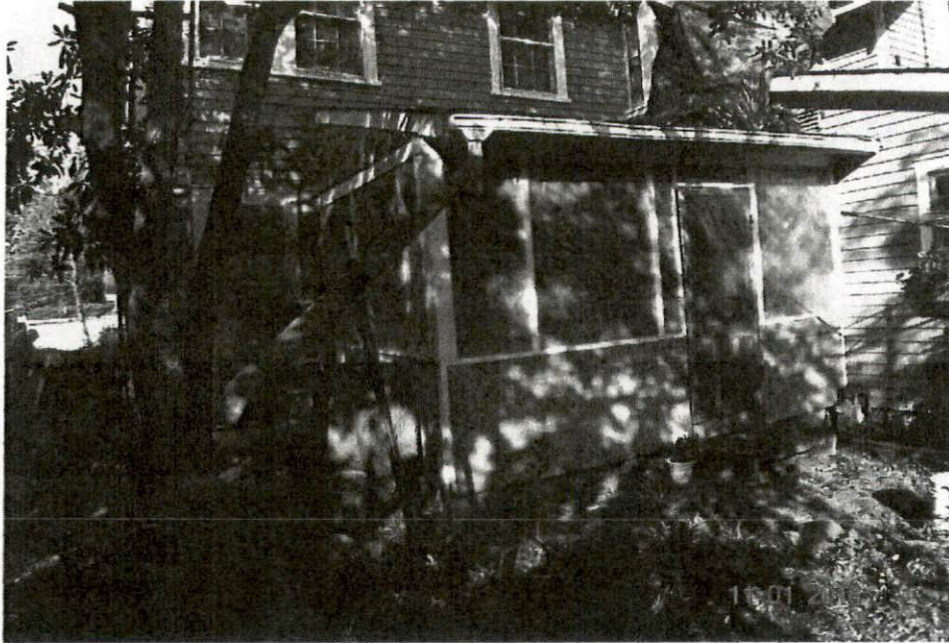
- A screened porch is located on the left side of the house, with the rear wall set forward approximately 5-ft from the rear wall of the main structure. This porch shows distress along its rear wall.

Photograph No. 7 – This is the screened porch along the left side of the home and towards the left rear corner.

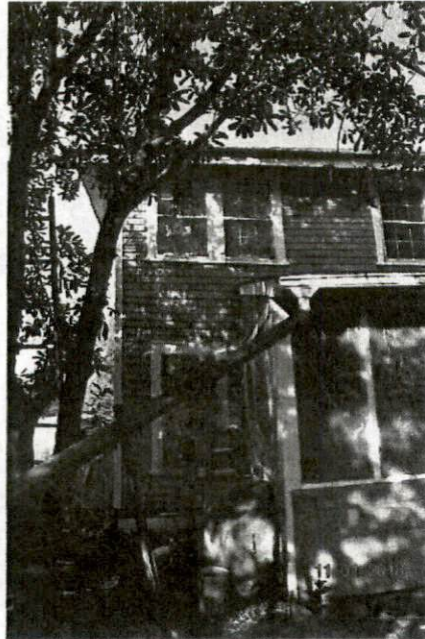
Photograph No. 8 – Another view of the porch and the left rear corner that is uplifted. The rear of the porch also lifted a bit.

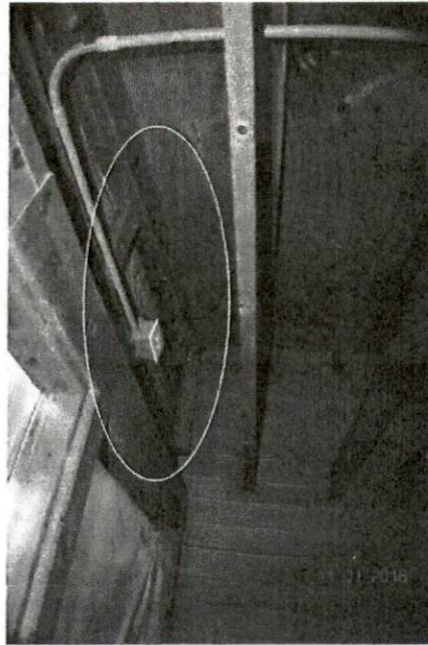
Photograph No. 9 – The interior framing of the porch showing some separation at the house.

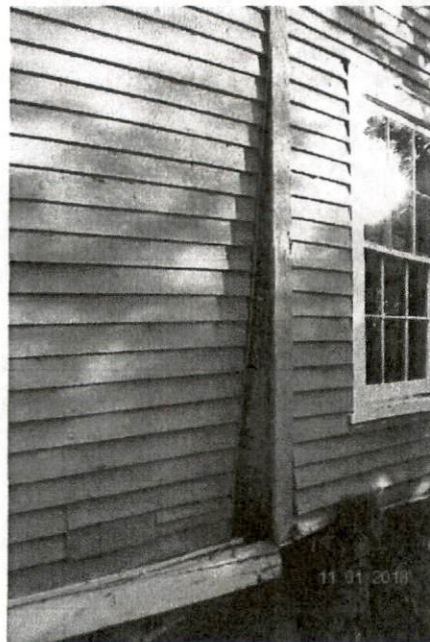
wall under this hallway has been uplifted at least 12-in at the rear wall, with the hall floor following. The common interior wall within the kitchen shows a significant diagonal crack to the front of the door leading from the hallway into the kitchen. The kitchen floor is uplifted and that uplift decreases as one moves to the right away from the tree location.

Photograph No. 10 – There is a load bearing wall between the hallway and kitchen. The floor is framed differently on each side of this wall. The hallway side (to the right in this photo) of the rear wall is pushed out a bit.

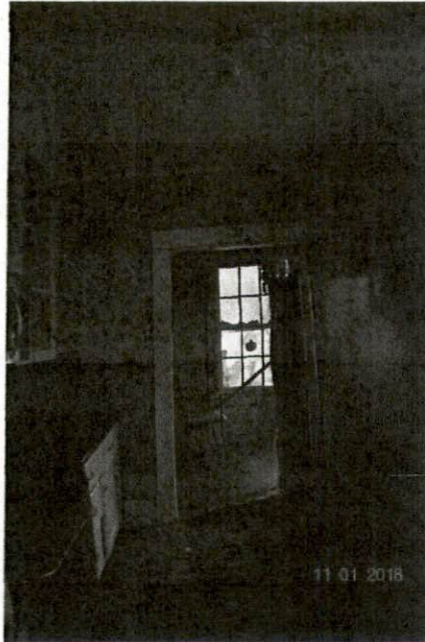
Photograph No. 11 – The kitchen is on the right side of the rear wall, and the hallway is on the left. This photo looks from the kitchen to the hallway. Note the uplift in the hallway floor.

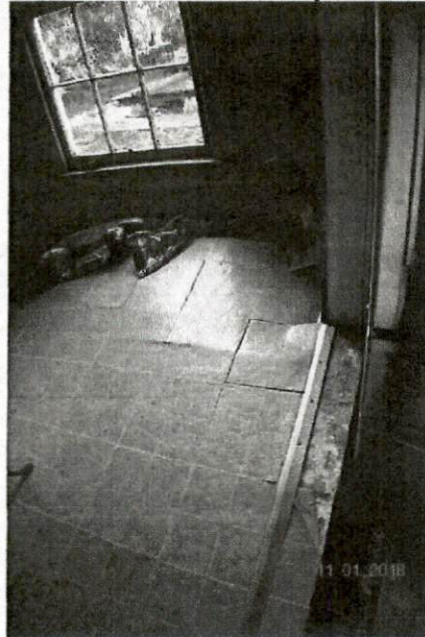
Photograph No. 12 – The stump is right underneath this hallway.

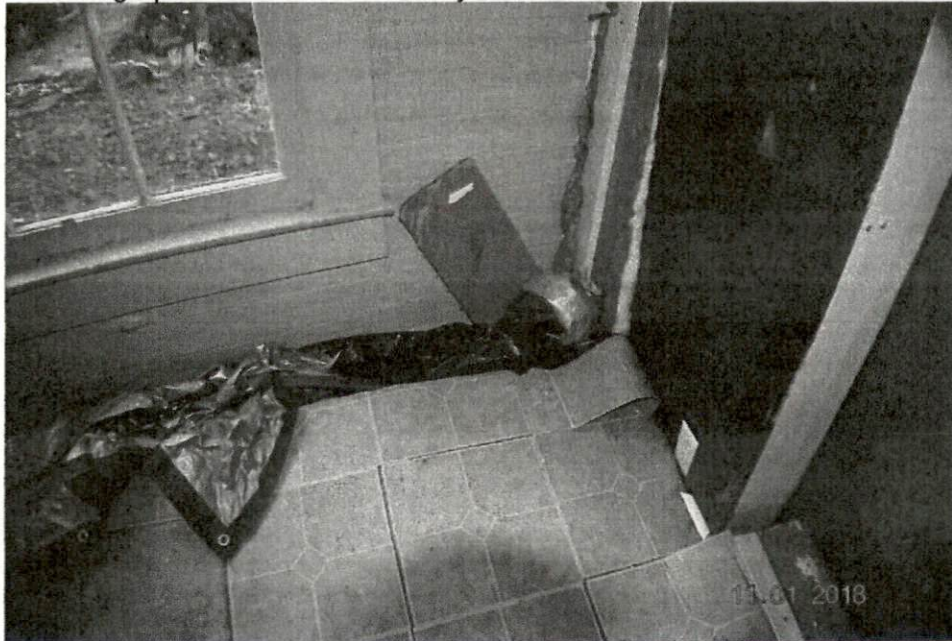
- The finish walls in the hallway are T&G wood plank. These show distress, and the rear wall is pushed out to the rear a few inches at its bottom. The window on the left wall near the left rear corner is wracked significantly. The hallway also contains a stairway that leads to the second floor. The floors on the second floor are also uplifted, following the first-floor lead.

Photograph No. 14 – The rear wall is pushed out a bit.

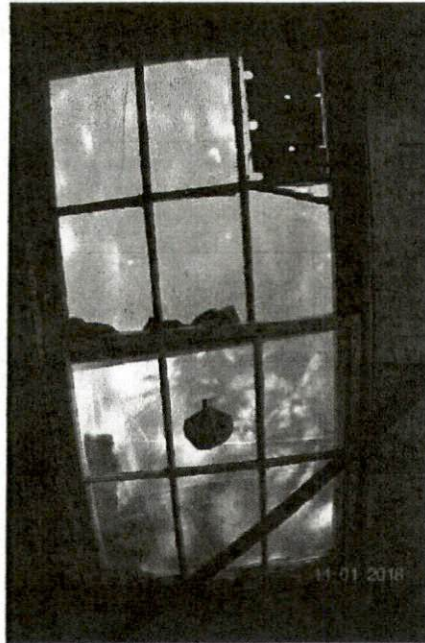
Photograph No. 15 – This window on the left side at the left rear corner is wracked.

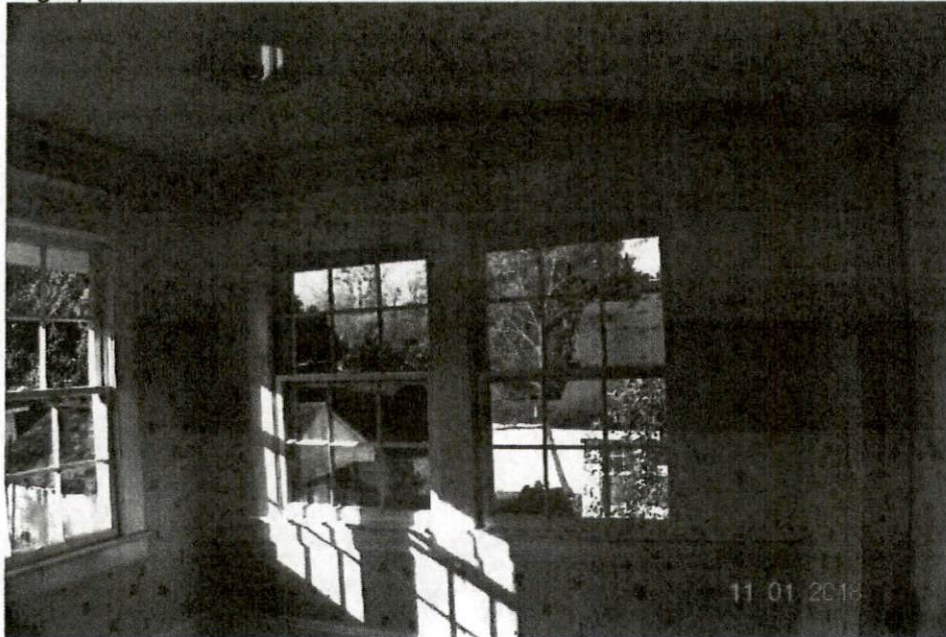
Photograph No. 16 – The room immediately above went along for the ride and shows some distress...

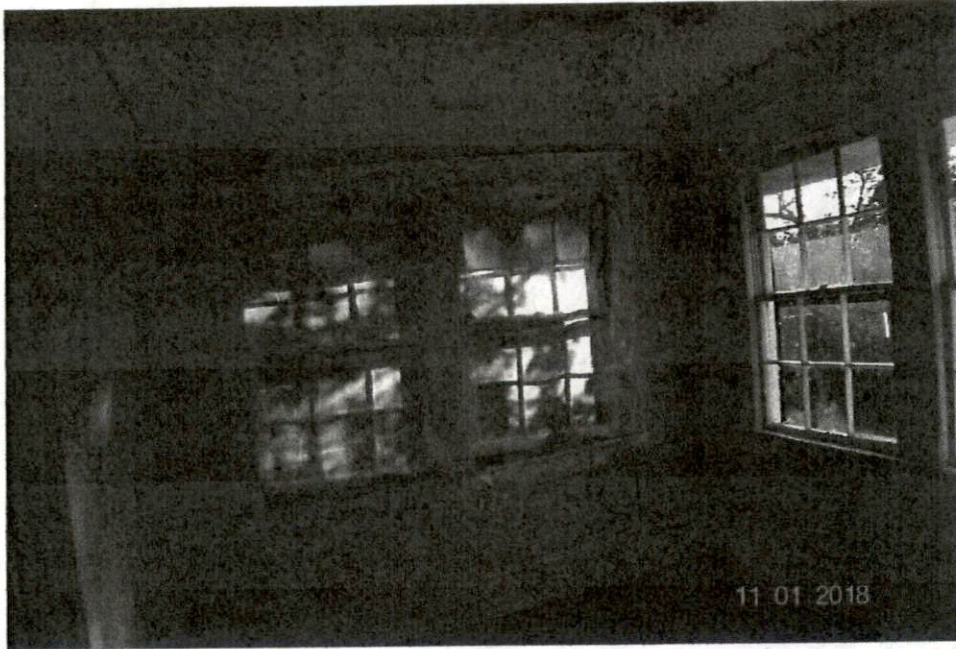
Photograph No. 17 – ...as does the room at the right rear above the kitchen.

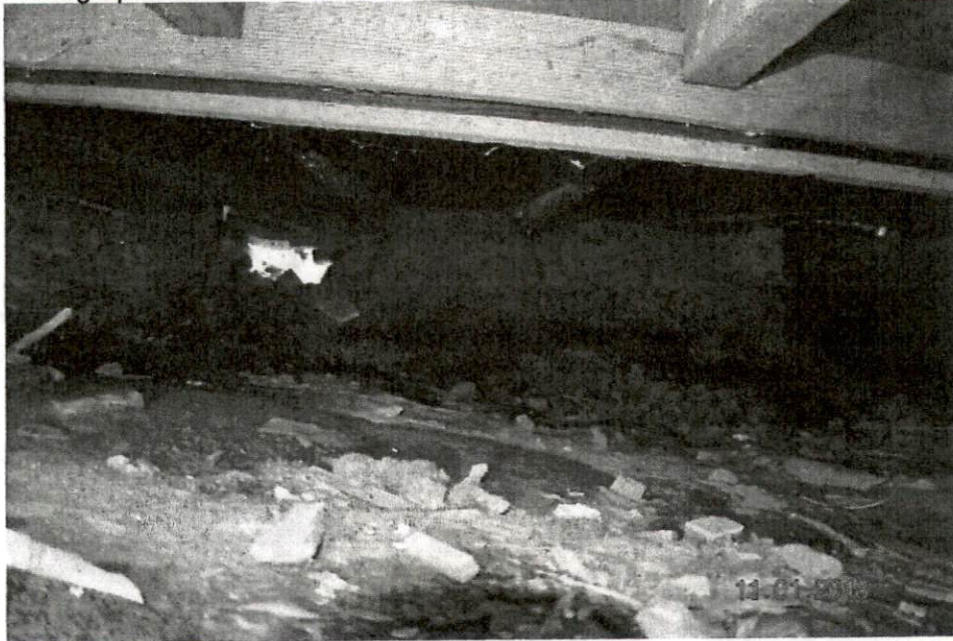
Photograph No. 18 – Looking from the crawlspace under to the rear, showing the root ball.

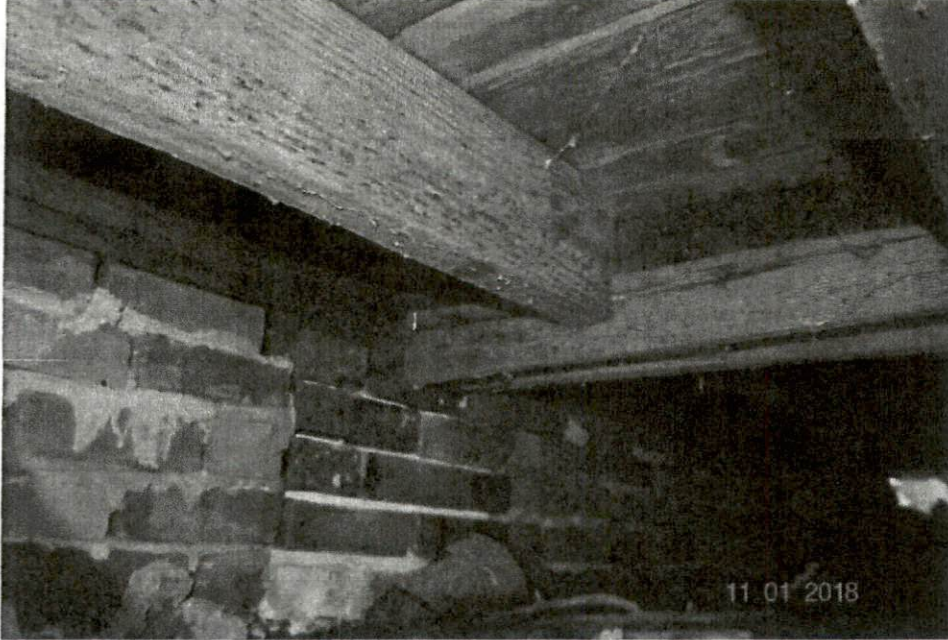
Photograph No. 19 – The pier supporting the left-to-right girder on the left wall is in good shape...

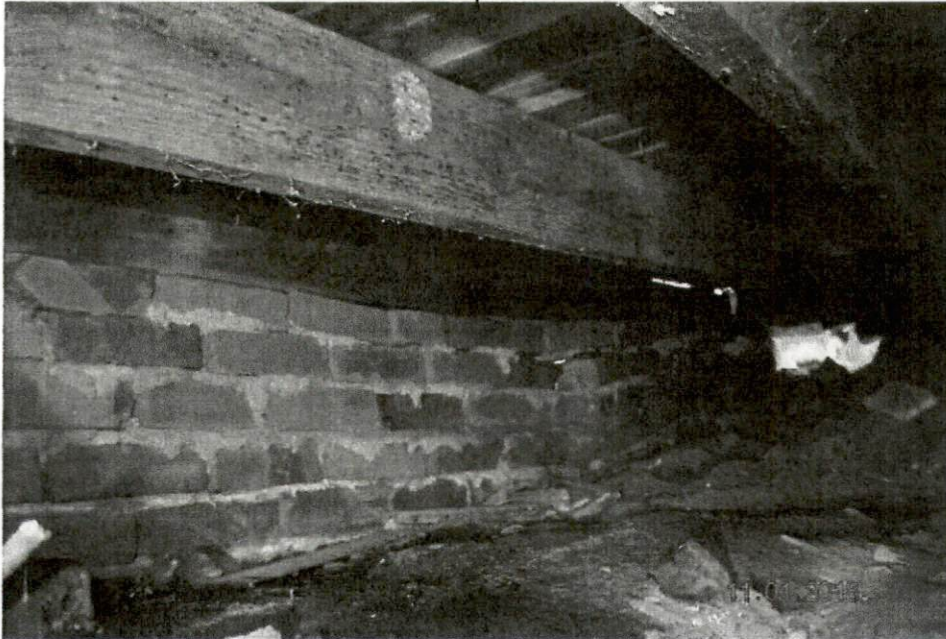
- The girder pier on the left side is intact, although the brick face wall between that pier and left rear corner is leaning inward.
- A significant tree root, at least 4-in in diameter extends up the floor joists bay towards the front of the home. This root has pushed the subfloor up locally.

Photograph No. 20 – ... but the face wall is not. The face wall is not a structural component.

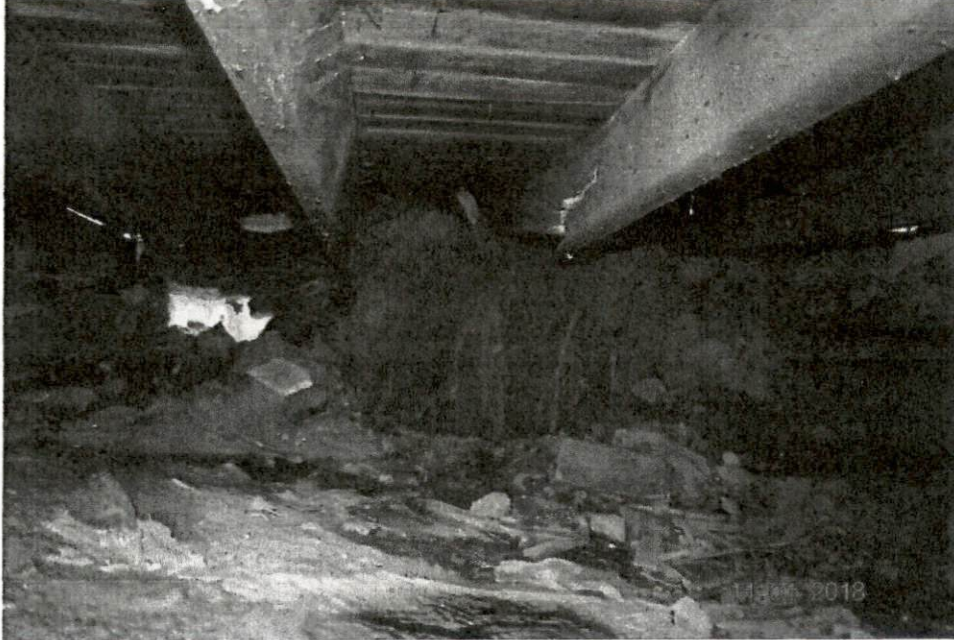
Photograph No. 21 – The only damaged framing member observed is this floor joists above the tree stump. There may be other framing members damaged but they are not visible at this time. We cannot see the sill beam beyond the stump and this may be damaged.

4. The floor and wall surfaces in the affected area of the hallway and leading into the kitchen will be required to be striped to the studs and floor/ceiling framing for repair access and to determine if there is hidden internal damage. Once the structure is stable and reasonably level with replaced piers in place, the framing damage is easily repaired by an NC-licensed general contractor familiar with and highly experienced in repair of aged homes.

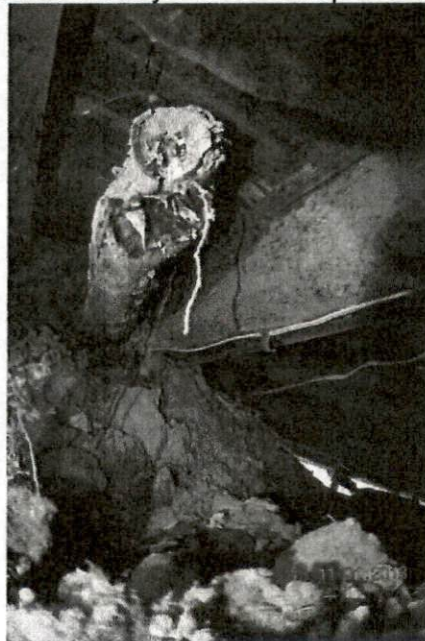
Photograph No. 22 – A root that extended well under the floor framing.

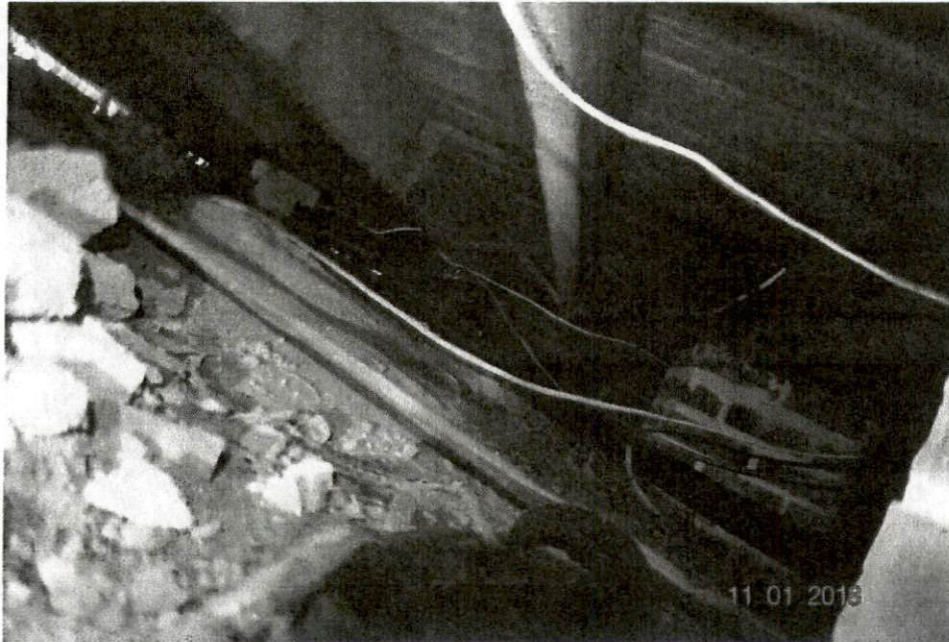
- The floor framing under the wall between the kitchen and the hallway is also a girder, and the joists under the kitchen run left-to-right. These joists appear to be in good condition, but the joists along the rear wall are not fully visible. The right corner pier does not show damage, although the rear face wall is damaged.

Photograph No. 23 – This photo is taken looking under the kitchen from the left toward the right rear corner. The framing under the kitchen appears undamaged.

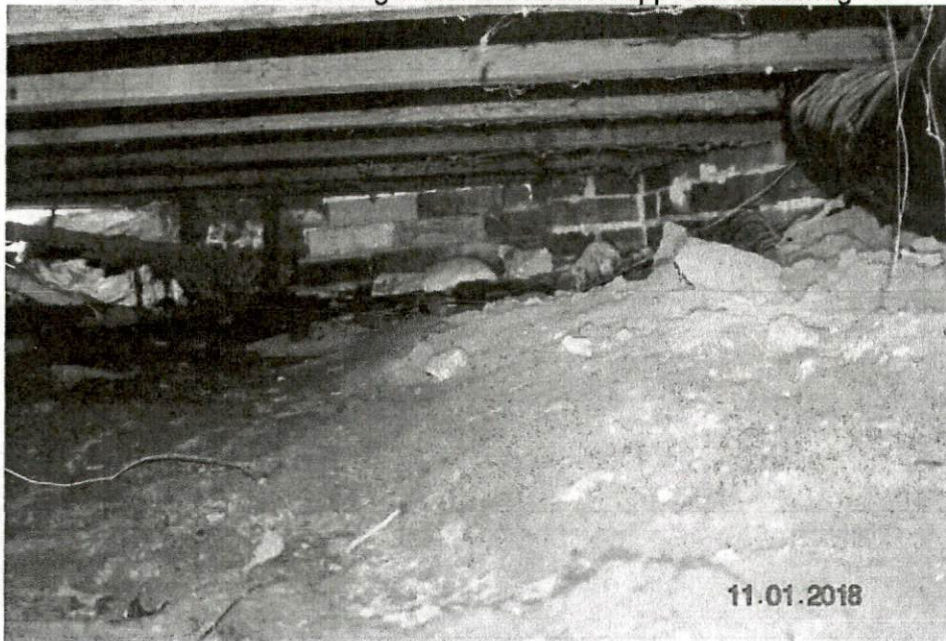
Photograph No. 24 – This photo is taken from the front looking to the right side of the rear wall. The face wall along the rear is damaged.
