4.0 ROOFING SYSTEM

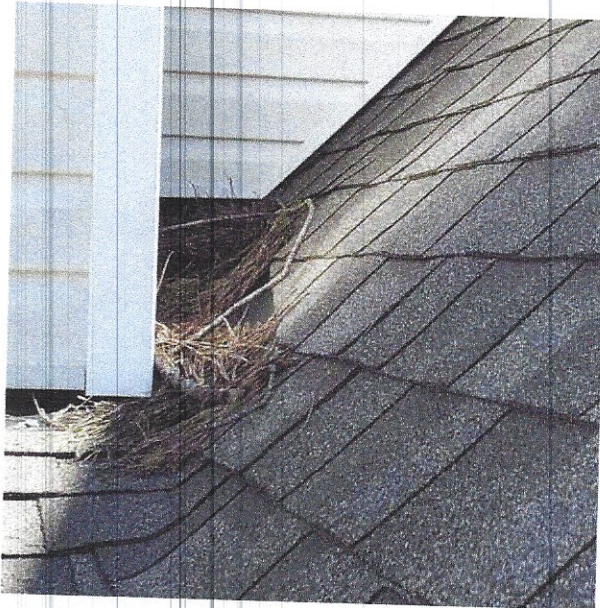
4.1.1 Debris on roof at transition. Debris can hold moisture and cause damage to roof materials and shorten the life cycle of the roof system. Remove debris from the roof as soon as able. **(Exterior Front)**

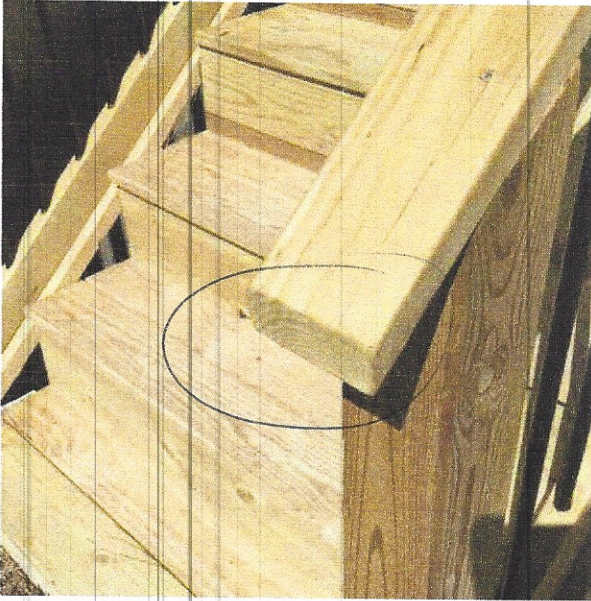
*Railings
Returns*

3.3.1 Deck hand rails don't have returns installed. Sharp edges can cause injury. Railing returns should be installed to increase safety for anyone using the deck.

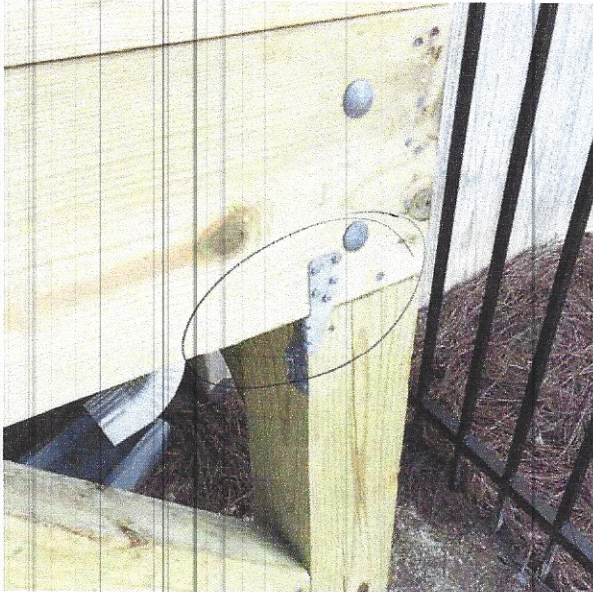
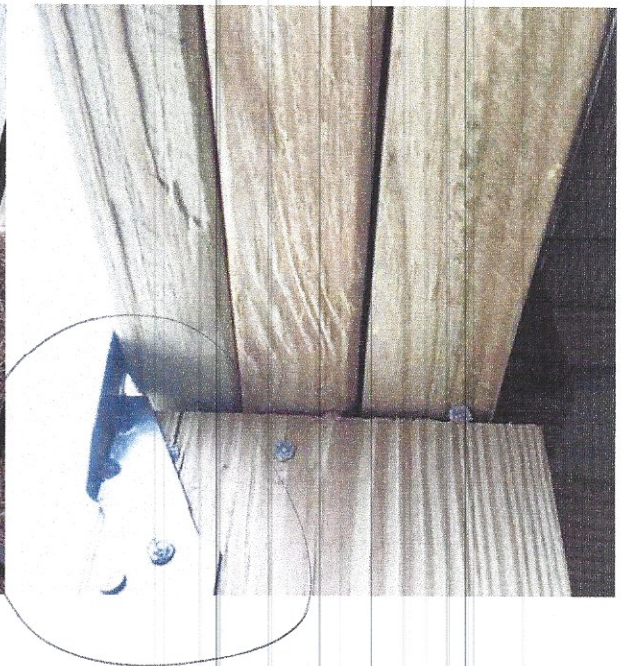
3.3.2 Deck supports were installed using non standard building practices and appear to be inadequate. An improperly supported deck is prone to leaning, tipping, and could slide from its support base causing injury or property damage. Recommend consulting a GC or deck specialist to evaluate the structure and improve support as needed. (Exterior Back)
