Matt Brueshaber, PE
Stonewall Structural Engineering, PLLC
8358 Six Forks Rd, #201
Raleigh, NC 27615
(919)407-8663

Re: Structural Observation — 14 West Landing, Sanford, NC 27332

October 23, 2018

Project No. 18-0716

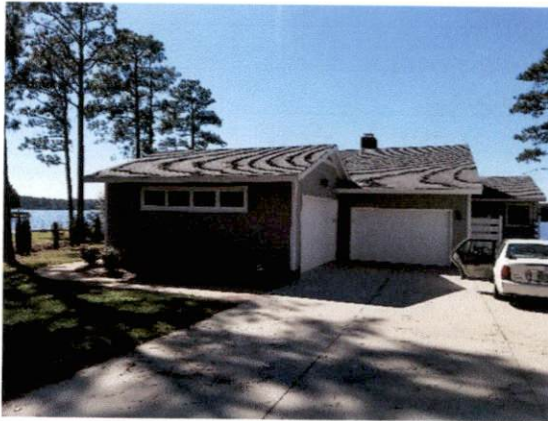
*Picture 1 – 24 West Landing,
Sanford, NC*

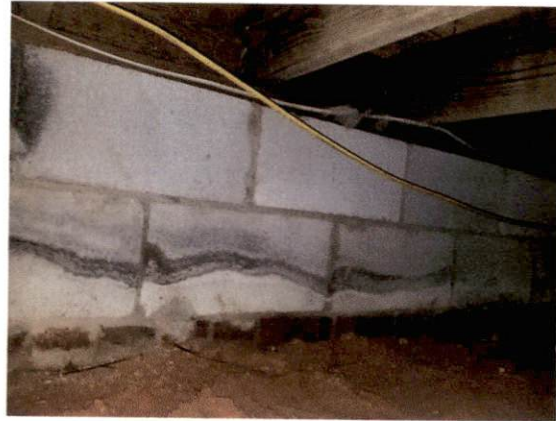
- Signs of water intrusion were noted around the perimeter of the crawlspace (*see picture 2 for example*).
 - The structure was noted to lack roof gutters along the low perimeter edges of the roof system (*see picture 3 for example*).
 - The exterior grade was inadequately sloped away from the perimeter of the home (*see picture 4 for example*).
 - Vents at various locations at the perimeter of the home were noted to have less than 4" of clearance from the bottom of the opening to the top of the exterior grade (*see picture 5 for example*).
- The bottom of the wood joists were water stained (*see picture 6 for example*).
 - Thorough probing revealed the joists were not deteriorated at this time.

- The above-noted water intrusion has not caused any major structural concerns at this time. However, the water-stained joists and signs of water intrusion indicated high

*Picture 2 – Example of evidence of water
intrusion into crawlspace*

- Due to the infeasibility of achieving adequate cross-ventilation of the crawlspace, we recommend installation of a Code-approved closed crawlspace system with adequate vapor barrier and mechanical drying measures to help avoid future occasions of advanced framing deterioration due to wood rot.

- We recommend installing a perforated interior perimeter crawlspace drain system with discharge through the low point of the perimeter foundation system at least 5' from the perimeter of the home onto soils adequately graded away from the structure. Transition to non-perforated pipe outside the footprint of the structure.

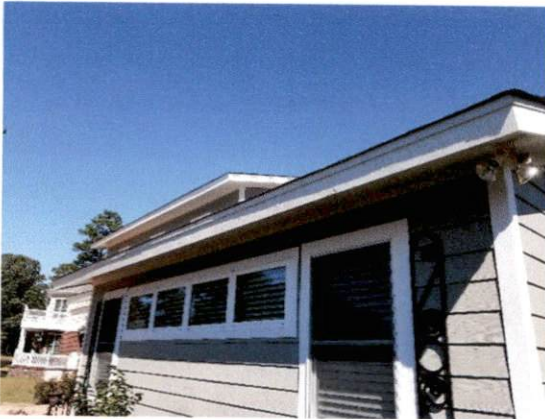
Picture 3 – Example of missing roof gutters

- Install a system of roof gutters and downspouts around the low edges of the roof system on the perimeter of the structure. Extend gutter downspouts for discharge at least 5' away from the structure onto soils inadequately sloped away from the home.

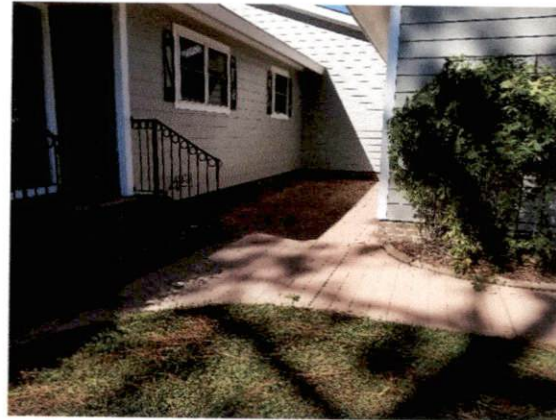
*Picture 4 – Example of inadequately sloped
exterior grade*

- All out of contact structural members should be shimmed into contact with the masonry elements below.
- Provide drainage improvements around the perimeter of the structure such that rainwater runoff is adequately diverted from the perimeter of the home. Drainage improvements are intended to help avoid the need for extensive foundation repair/stabilization work in the future.

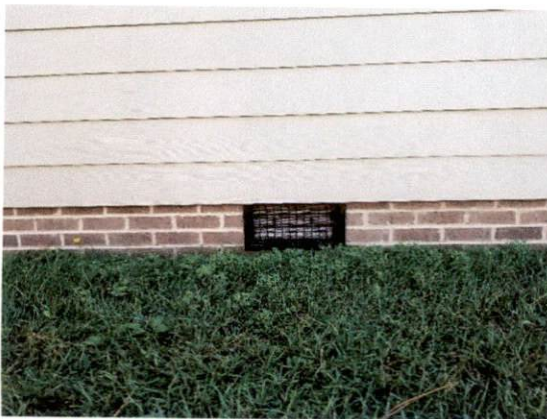
*Picture 5 – Example of vent with less than 4" to
top of exterior grade*

- Install half-moon vent wells as needed such that all vent openings have at least 4" of clearance from the bottom of the opening to the top of the exterior grade.

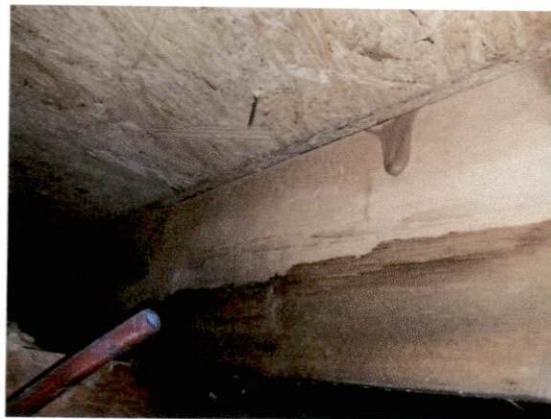
moisture in the crawlspace. This can lead to deterioration of wood elements throughout the home.

*Picture 6 – Example of water-stained floor
joists*

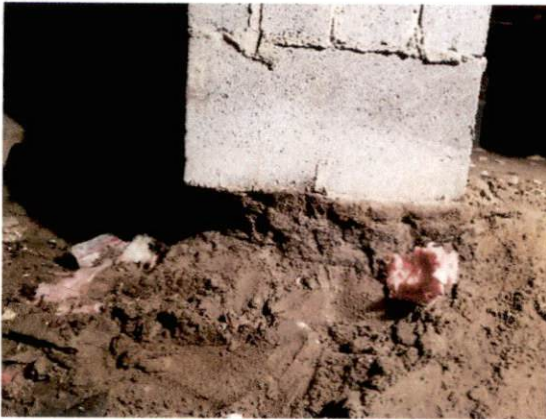
- The piers that supported the girder beneath the back living room wall were not set over adequately sized footers. Additionally, two of the piers were undermined by an apparent excavation for HVAC (*see picture 7 for example*).
- The perimeter sill was found to support floor joists over openings that were added in the perimeter foundation wall at the front of the master bathroom and at the back-left of the original crawlspace (*see pictures 8-9*).
- Various framing members were out of contact with the masonry elements that were intended to support them (*see pictures 10-11 for examples*).

Picture 7 – Example of undermined and inadequately sized piers

- Remove the masonry piers over the inadequately sized footings noted above and replace using new 16"x16" hollow CMU piers with solid 8" caps, centered over 30"x30"x12" thick poured concrete footings set at least 12" into suitable bearing soils.

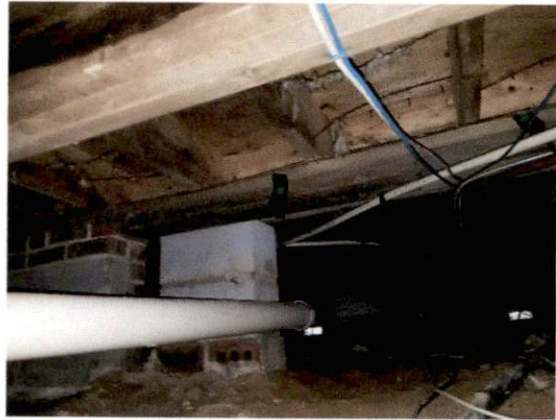
Picture 8 – Inadequately supported joists over foundation wall penetration

- Fasten all joists that currently bear on flat 2x sill plates over openings in the foundation wall to the perimeter rim beam using Simpson face hangers.

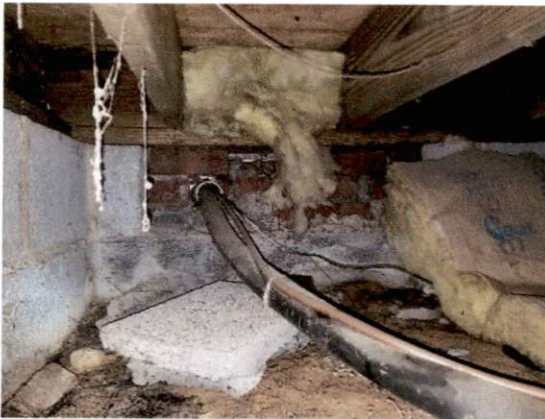
Picture 9 – Inadequately supported joists over foundation wall penetration

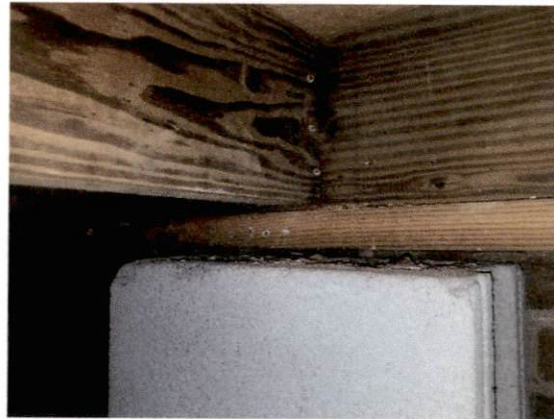
Picture 10 – Example of out-of-contact masonry support

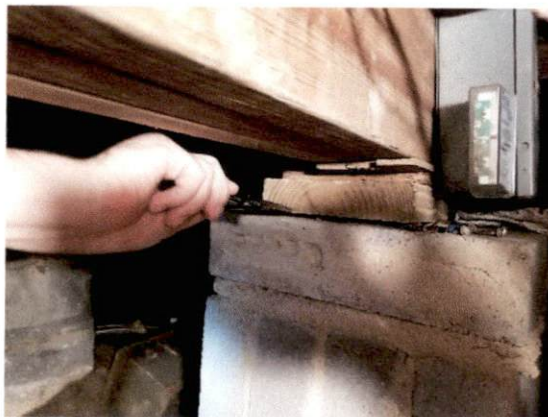
Picture 11 – Example of out-of-contact masonry support
