Jenkins Restoration
Residence 33 Colonist Place
Cameron NC 28326
Wednesday, January 30, 2019

DAMAGE ASSESSMENT FIELD REPORT:

Date of visit: Saturday, January 26, 2019

RESIDENCE

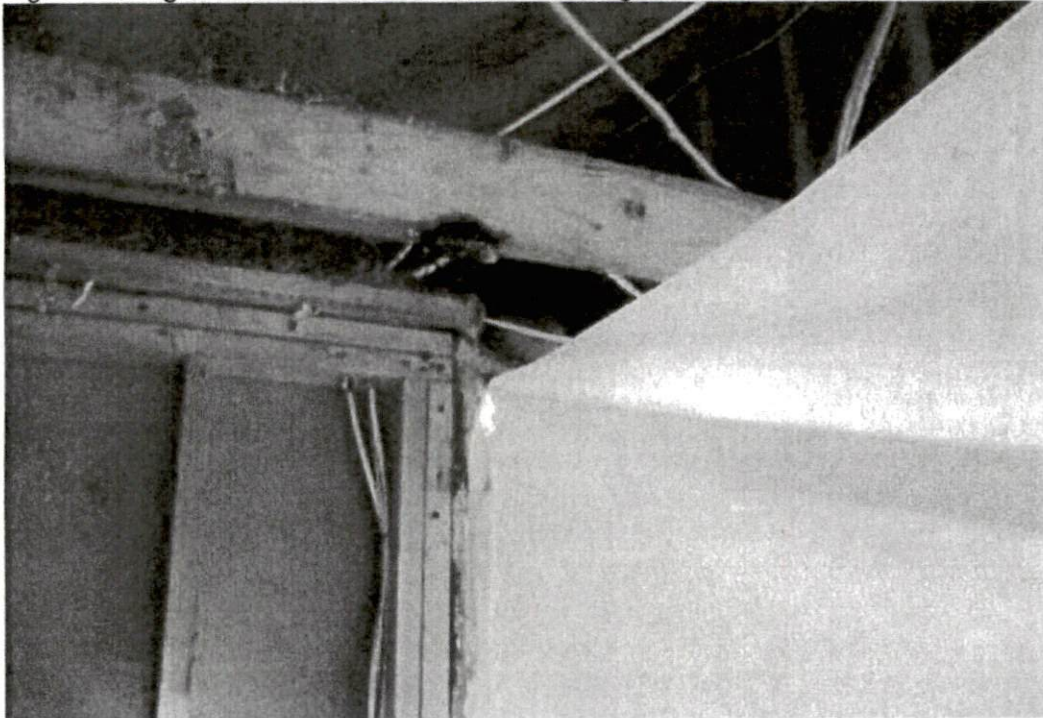
Light charring to outboard most of the five damaged trusses

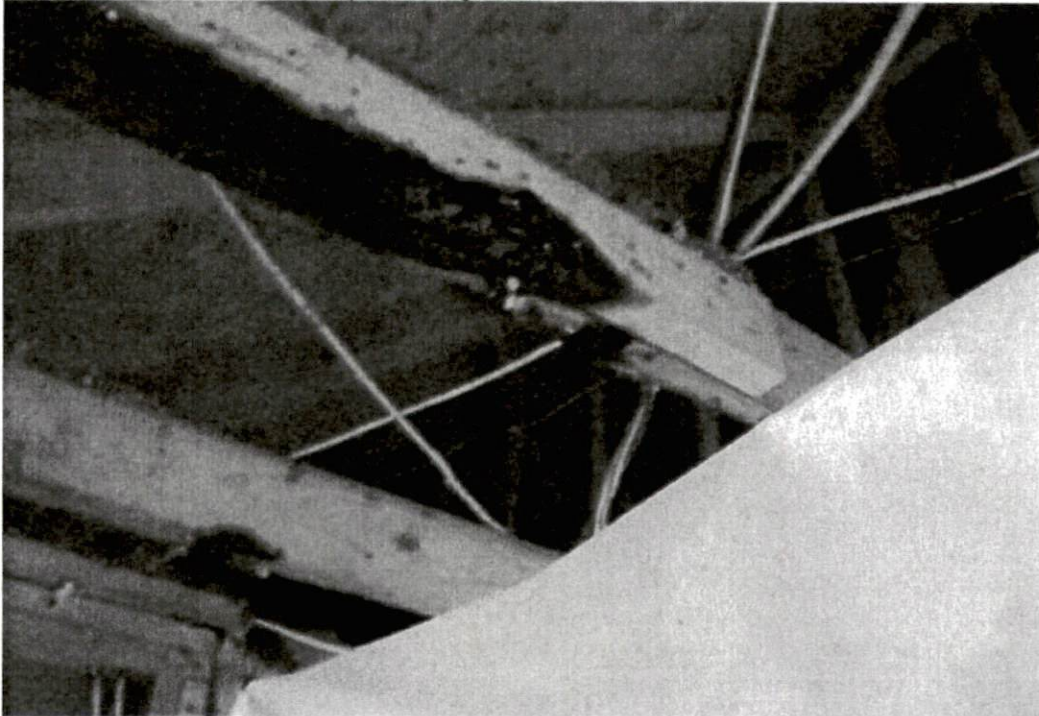
Damage to truss closes to point of ignition

There is some light burning of the bottom chord of 5 successive roof trusses. The truss over the center of ignition point showed the most damage - perhaps 1/2 " to 3/4" deep on one side of the bottom chord, but it can easily be repaired by sistering a length of 2x6 to the side of the bottom chord of the truss as per the attached detail. The two adjacent trusses on each side of the middle truss show less damage, but I would still recommend application of a sistered piece of 2x6 to these trusses. The outboard trusses on each side show very light charring of the surface fibers of the wood and in my opinion result in no loss of structural integrity and can be allowed to remain without repair.

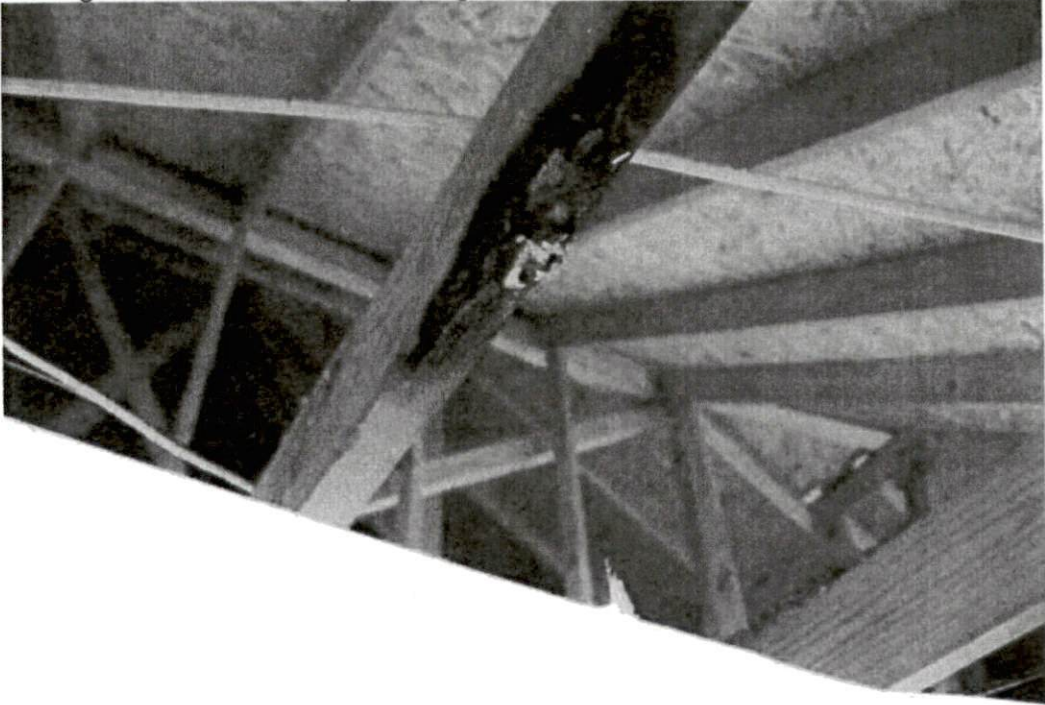
Damage to truss closes to point of ignition

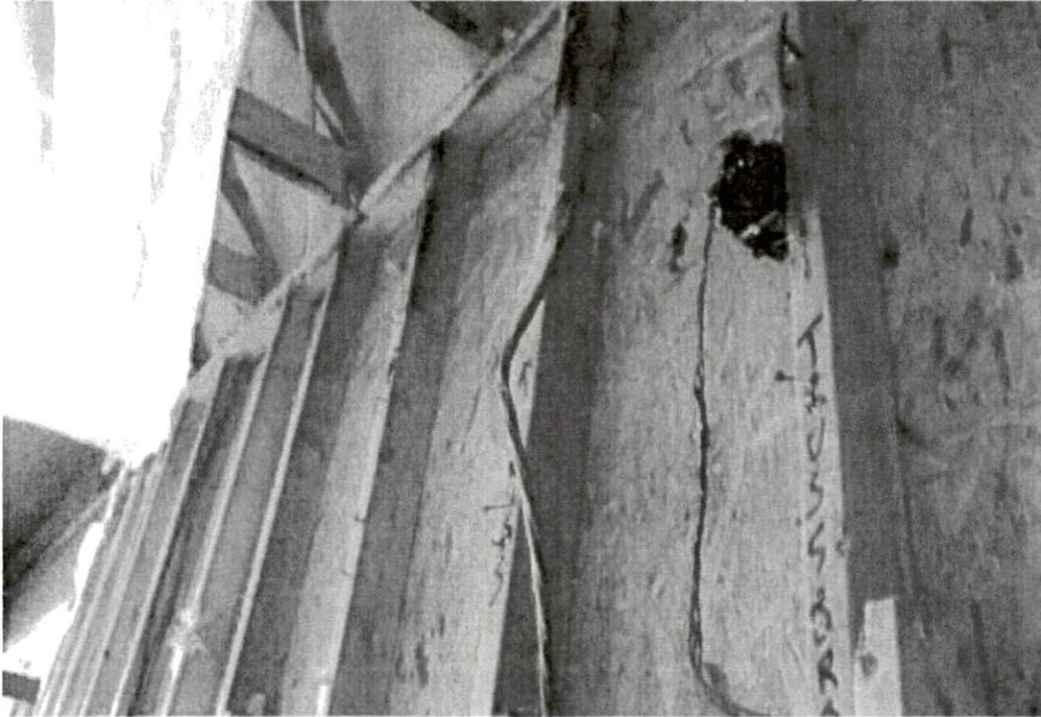
I observed only light fire damage to the wall studs in the area of initial ignition and in my opinion not compromising of structural integrity.

Light charring of the surface fibers of the wall studs at the point of ignition

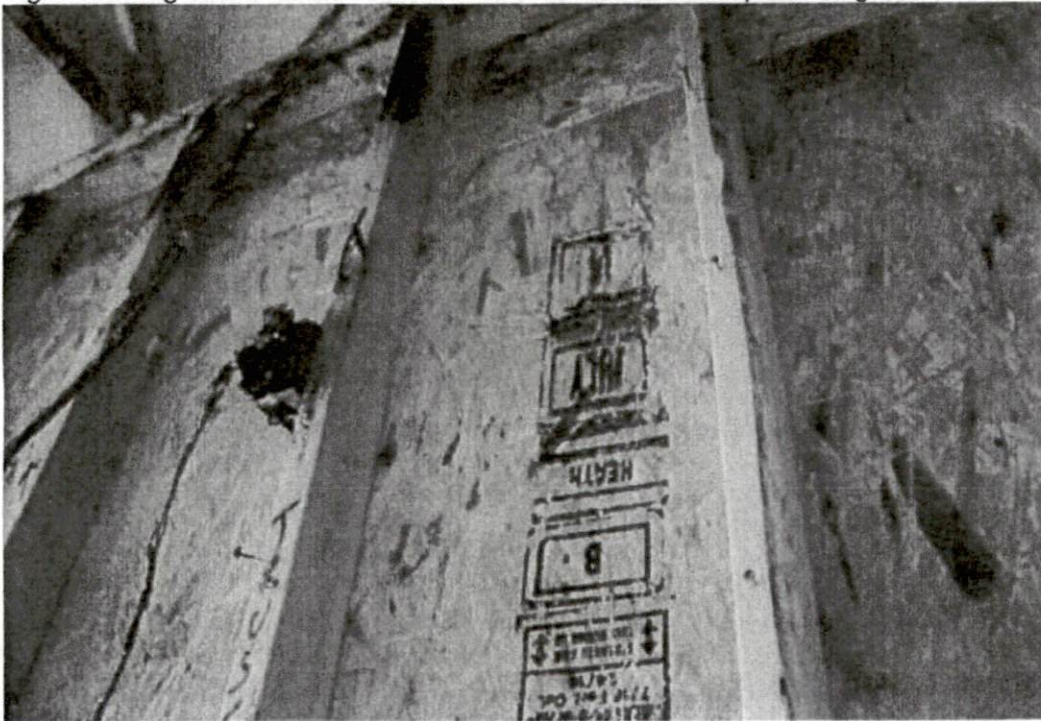
Light charring of the surface fibers of the wall studs at the point of ignition

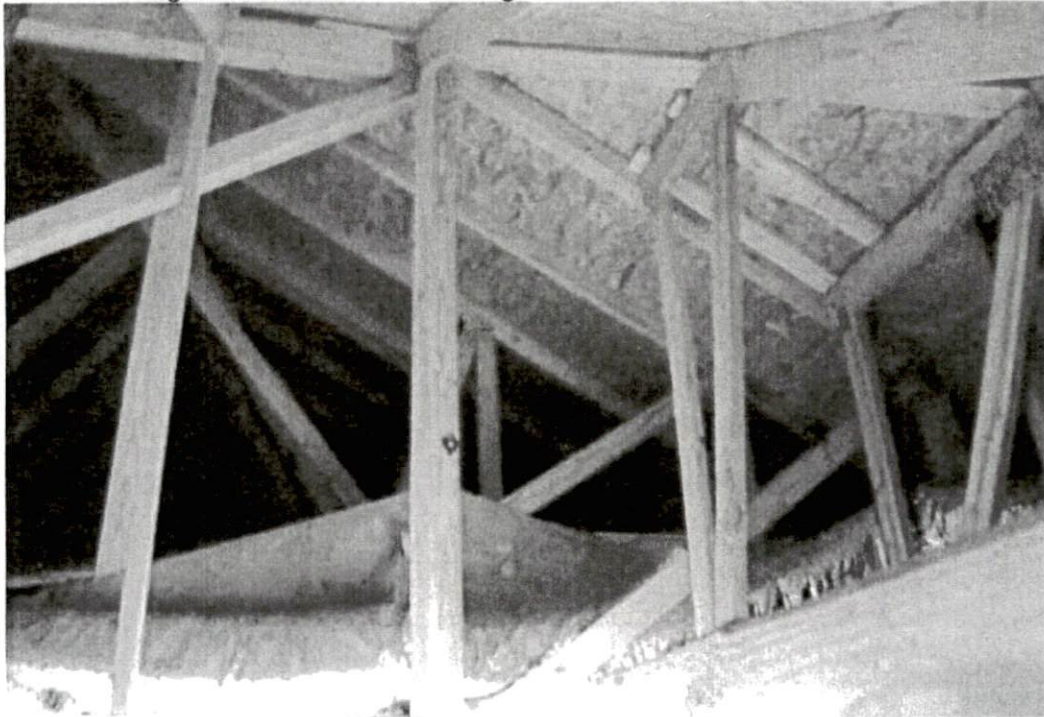
View of the bottom chords of the damaged trusses near point of damage. You can see a slight amount of smoke damage on the truss to the left

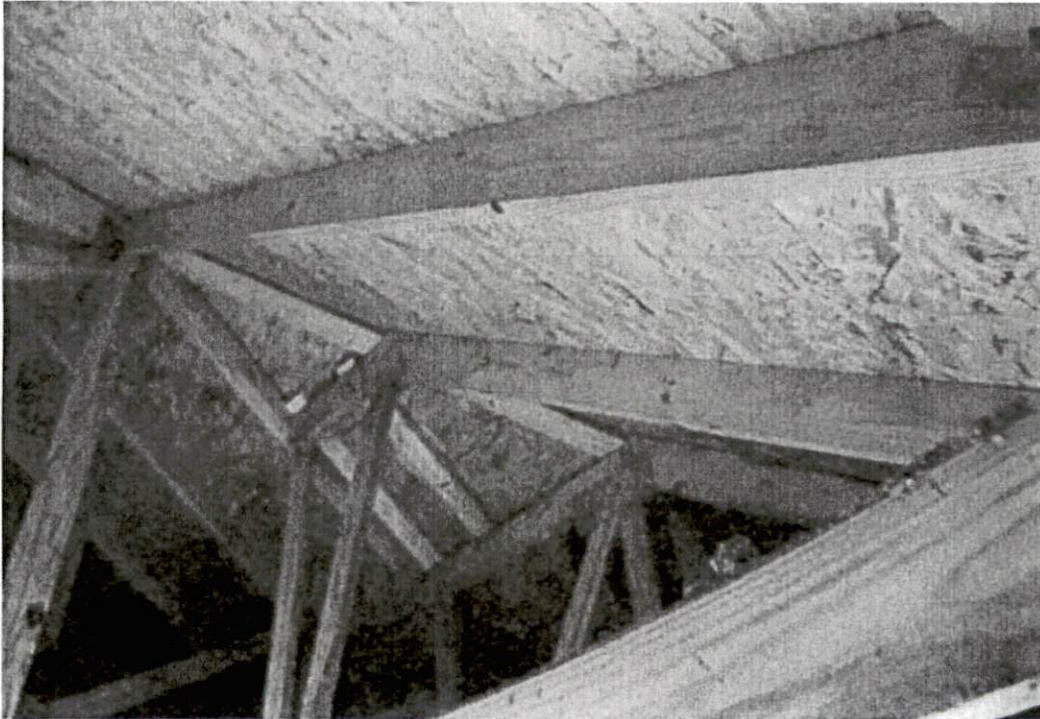
I saw no other fire damage to any other part of the wood trusses or the underside of the roof sheathing and no visible smoke damage at all.

View of the underside of roof sheathing directly over point of ignition shows no fire or smoke damage

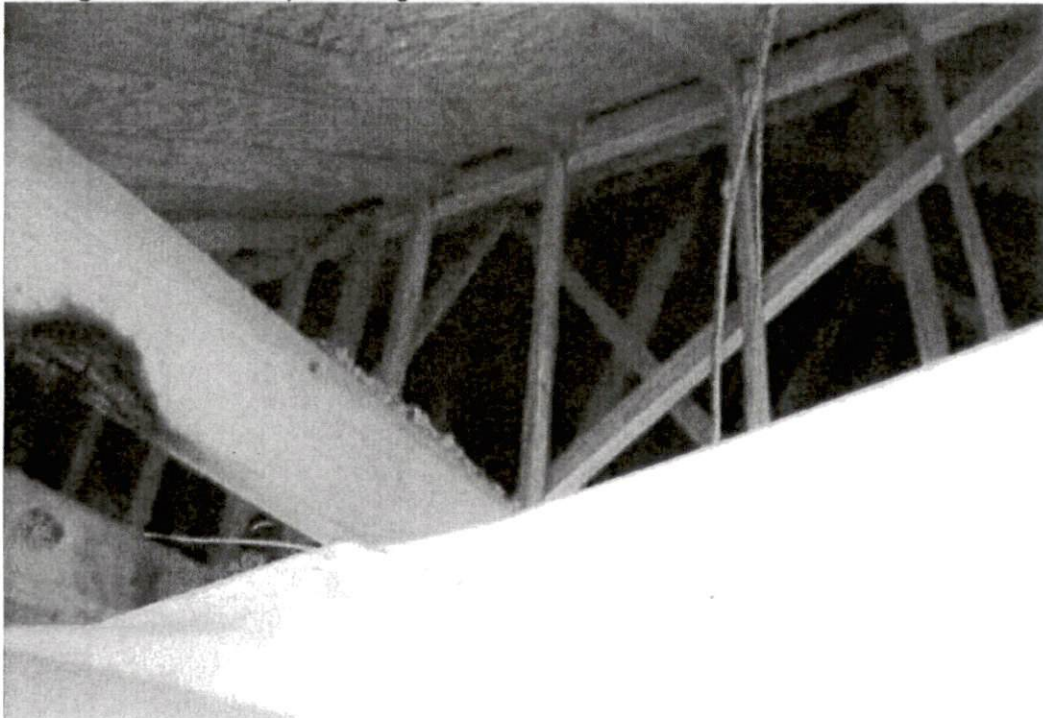
View of one of the two lightly damaged trusses on either side of the more damaged truss at the point of ignition
