Matt Brueshaber, PE  
 Stonewall Structural Engineering, PLLC  
 4800 Falls of Neuse Rd. #120  
 Raleigh, NC 27609  
 (919)407-8663

Re: Structural Observation — 2755 Brick Mill Road, Lillington, NC 27546

At your request, on February 11<sup>th</sup>, 2019 we performed a visual structural observation of damaged floor framing, and signs of structural movement at the chimney at the Lillington residence noted above. The structure is a conventionally framed, detached, single family residence with raised first floor framing over a pier/girder foundation system with perimeter masonry foundation walls (*see picture 1*).

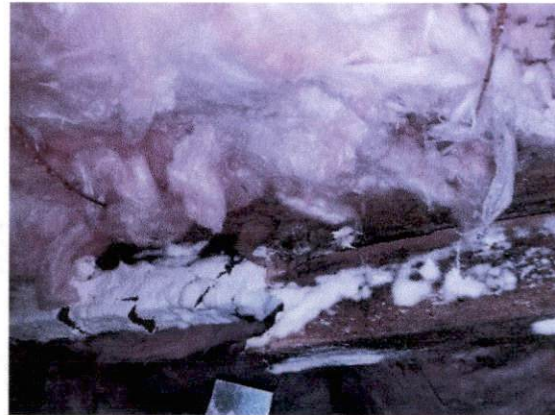
- Thorough probing revealed the following floor-framing members were deteriorated beyond salvageable limits (*see pictures 2-4 for examples*):
  - A section of floor joists in the back joist bay, starting approximately 19'-10" from the right wall and extending to the right toward the girder with front-to-back orientation,

- A section of floor joists in the 2<sup>nd</sup> joist bay from the back wall, starting approximately 25'-8" from the right wall and extending to the right toward the girder with front-to-back orientation,

- The 5<sup>th</sup> through 9<sup>th</sup> joists from the right wall, in the 3<sup>rd</sup> joist bay from the back wall,
  - The floor joist ledger support strips along the girders located approximately 8' and 18' from the back wall

- The above-noted deteriorated floor framing has been the result of a combination of potential wood destroying insect (WDI) activity and rot due to prolonged exposure to moisture in the crawlspace.
  - Stringing fiberglass insulation and organic growth are further indications of excessive moisture levels and improper ventilation in the crawlspace.
- Our calculations show that the moderately deteriorated girder spans are currently able to still support structural loads.
  - Further deterioration of the girders may require removal and replacement of the affected girder spans.
- Due to the lack of excessive cracking around the chimney, its plumb state, and the above-noted signs of extended exposure to rainwater runoff from the edge of the roof, we believe the above-noted brick crack was due to long-term exposure to rainwater runoff and the un-laced construction of the veneer.

*Picture 2 – Example of deteriorated and broken  
floor joist*

- Reinforce each of the deteriorated joists noted above with an additional full depth ply of 2x #2 Southern Yellow Pine (SYP), fastened to the side of the deteriorated joists using (3)10d common nails at each end and at 12" on center staggered top and bottom along the lengths of the joists. Sistered material should span continuously between end supports.

- If the deteriorated joist has less than 3" of non-deteriorated material remaining at the top of the joist, install tight-fit 2x blocking in the joist bays on both sides of the sistered members at 32" o.c. to prevent rotation of the members.

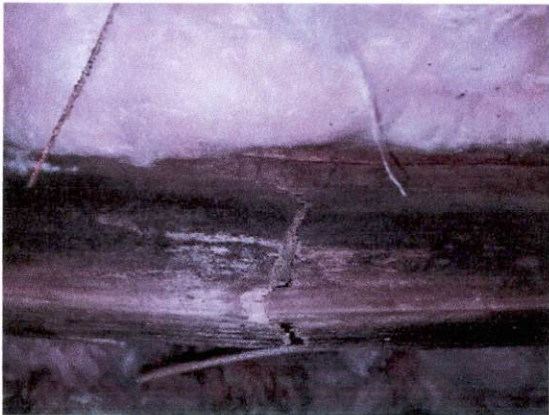
*Picture 3 – Example of deteriorated and broken  
floor joist*

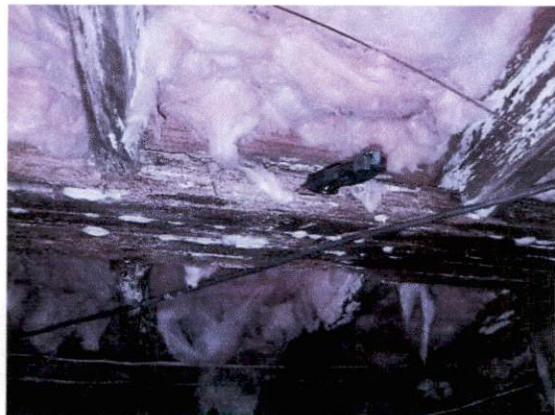
*Picture 4 – Example of deteriorated and failed  
ledger strip*

- Remove the above-noted deteriorated sections of the ledger strips and replace with Simpson face hangers to the end of each joist and fastened to the side of the existing girders.

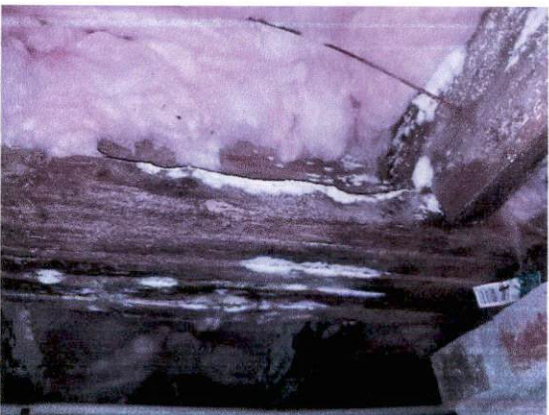
- Various girder spans were noted to be moderately deteriorated (*see pictures 5-6 for example*).
- Areas of organic growth were noted on the floor framing throughout the central portion of the crawlspace. The worst of the organic growth was found between the HVAC ducts and the floor framing members (*see pictures 7-8 for examples*).

*Picture 5 – Example of moderately deteriorated  
girder span*

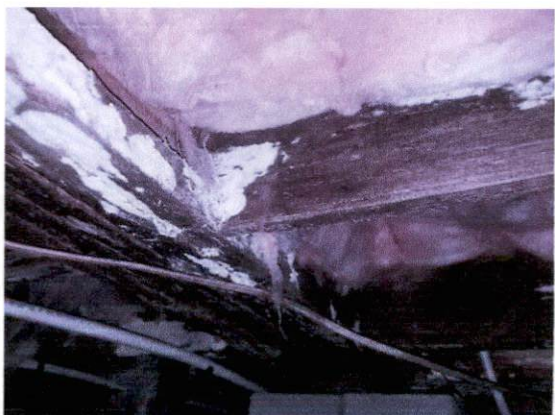
*Picture 6 – Example of moderately deteriorated  
girder span*

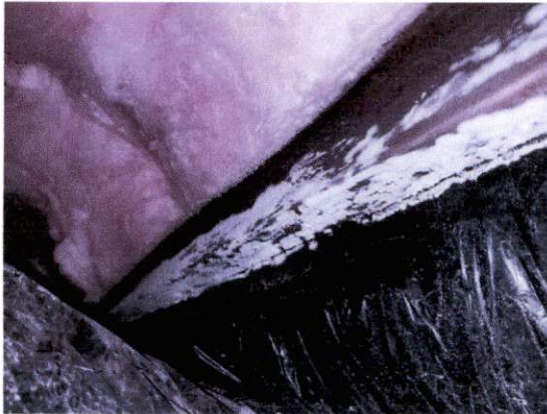
*Picture 7 – Example of area of organic growth*

- At the owner's discretion, any floor joists harboring organic growth may be removed and replaced with full depth 2x members. However, this would require access from within the finished living space in order to fasten the existing floor sheathing to the new members.

- We recommend consulting with a qualified fungal remediation specialist to test and treat the above-noted organic growth as deemed necessary.
- We recommend consulting with a qualified WDI specialist to determine the level and distribution of possible WDI activity, especially in the back-middle portion of the floor framing system.

- Due to the infeasibility of achieving adequate cross-ventilation of the crawlspace, we recommend installation of a Code-approved closed crawlspace system with adequate

vapor barrier and mechanical drying measures to help avoid future occasions of advanced framing deterioration due to wood rot.

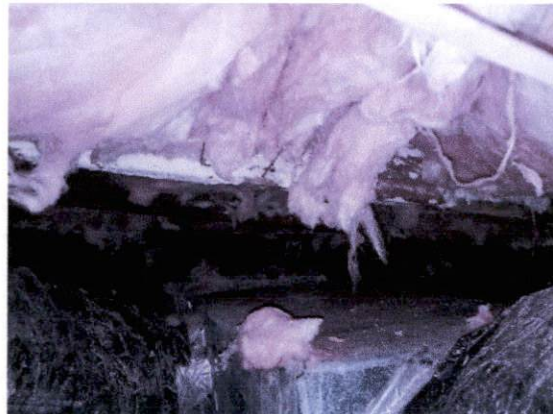
*Picture 8 – Example of area of organic growth*

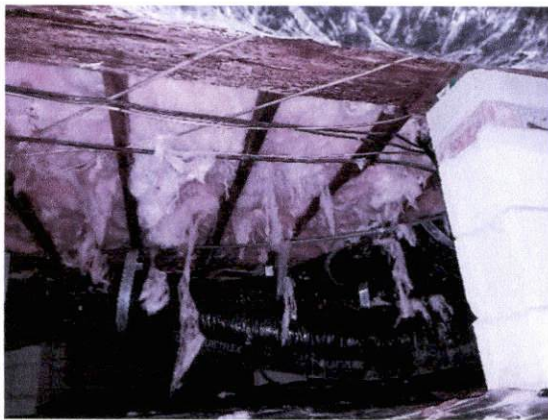
- Fiberglass insulation was noted to be stringing in the central portion of the crawlspace (*see picture 9 for example*).

*Picture 9 – Example of strapping fiberglass insulation*

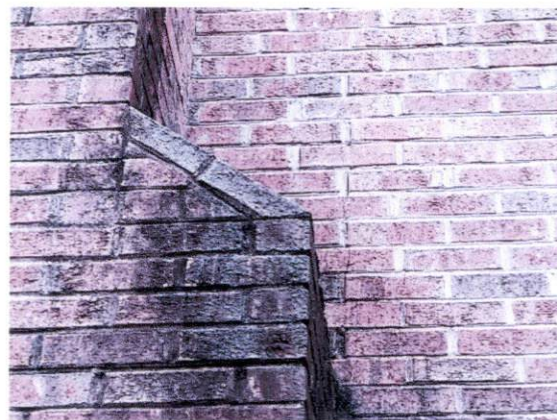
- A brick crack as wide as approximately 1/8" was noted along the back side of the chimney, where the chimney met the right wall of the home. A gap was also noted between the fly-rafter and the back face of the chimney where the chimney penetrated the roof line (*see pictures 10-11 for examples*).

- Measurement by spirit plumb indicated the chimney was plumb in both orientations to within approximately 1/16" over 4'.
- Water staining was noted on the back face of the chimney.
- The bricks in the adjacent veneer of the wall did not appear to be laced with the chimney.
- No other brick cracks were noted where the front face of the chimney met the right wall of the home (*see picture 12 for example*).

*Picture 10 – Example of brick crack along back face of chimney at right wall of home, and water staining on brick face*

- Any cracks in the brick veneer near the chimney should be closed with a clear or color-matching sealant, and monitored for signs of further movement.

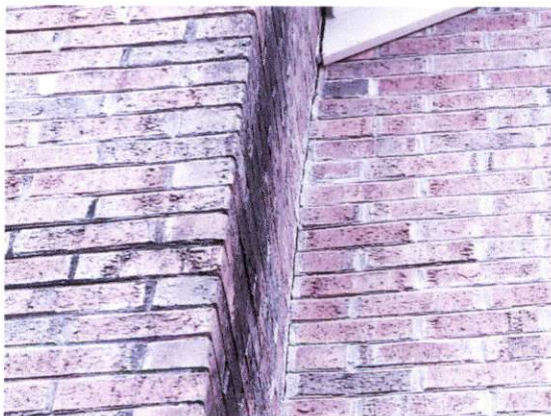
*Picture 11 – Example of gap between chimney and end of fly rafter, and brick veneer crack*

- Additionally, we recommend the roof framing in the gable soffit along the back face of the chimney be observed to determine the cause of the apparently fallen fly-rafter, and possibly compromised waterproofing detail.

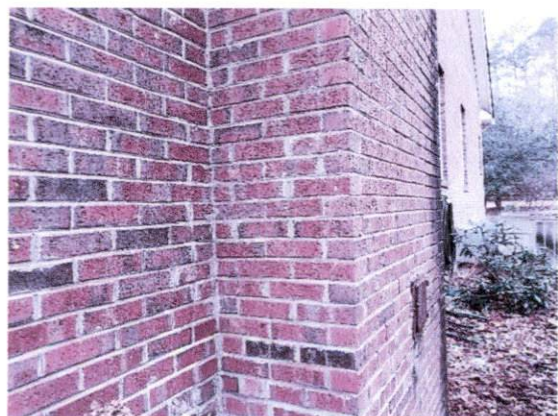
*Picture 12 – Example of front face of chimney and right wall of home with no cracks*
