Project No. 19-1514

Re: Structural Observation — 45 Orchard Falls Drive, Spring Lake, NC 28390

PICTURE ADDENDUM

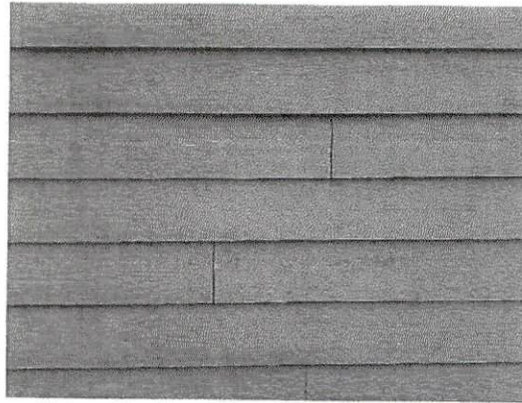
- Gaps were noted in the siding along the right wall of the garage and beneath the right garage wall sill plate. Cracks were noted in the foundation wall along the right side of the house and along the back wall of the garage (*see pictures 2-4 for examples*).

Picture 2 – Example of gaps in siding along
garage

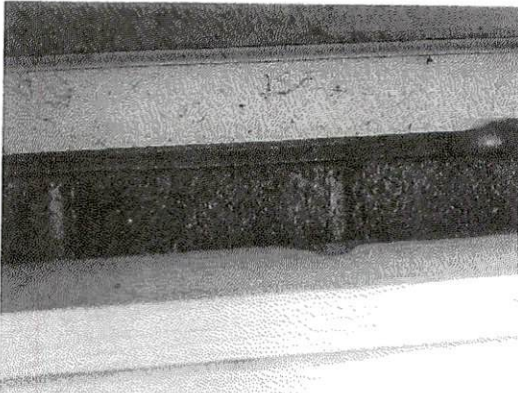
Picture 3 – Example of gap between sill plate
and foundation wall

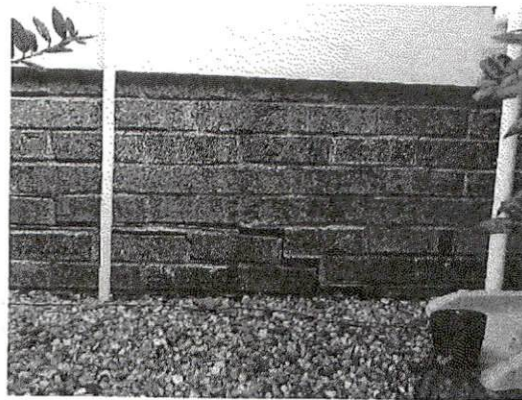
- The above-noted gaps in the siding and cracks in the perimeter foundation and garage slab have been the result of differential settlement of the perimeter foundation and the slab which can be accelerated by inadequate management of rainwater runoff around the perimeter of a home.
 - Soils in this area tend to expand when wetted and contract when dried. These cyclical movements can cause short term cosmetic damage and long term structural damage at areas around the structure with poor exterior drainage which can cause differential settlement to occur as parts of the structure settle at faster rates than at other locations.
 - The void beneath the foundation wall may be the result of decomposing organic material, exacerbated by drainage issues.

Picture 4 – Example of crack in foundation wall

- Install a series of (8) galvanized steel push piers under the back wall of the garage and along the right foundation wall to stabilize the structure against additional differential settlement.

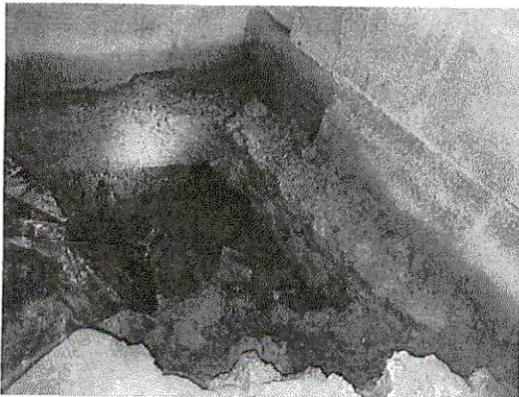
- Investigation in the crawlspace revealed a large void near the back-right corner of the garage (*see pictures 5-6 for examples*).
 - Measurement by laser level indicated that the right end of the back wall of the garage was down as much as approximately 7/8" relative to the crack adjacent to the rightmost pilaster (*see picture 7 for example*).

Picture 5 – Example of void under foundation
wall footings

- And (2) along the back wall of the garage, with (1) at the crack next to the rightmost pilaster.
 - After push piers have been installed, fill the void beneath the foundation wall footings using adequately tamped clean gravel.

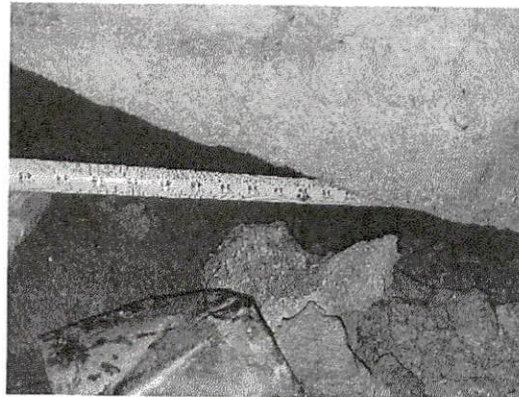
Picture 6 – Example of void under foundation
wall footings

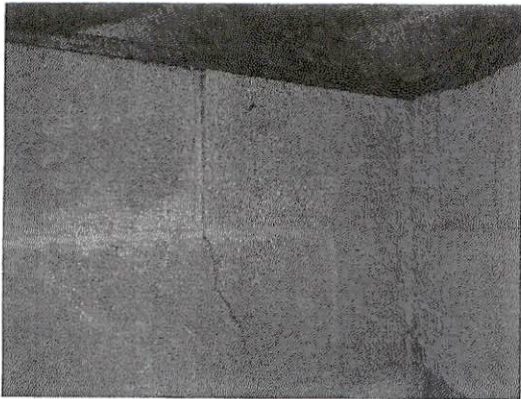
Picture 7 – Example of crack next to rightmost pilaster along back of garage

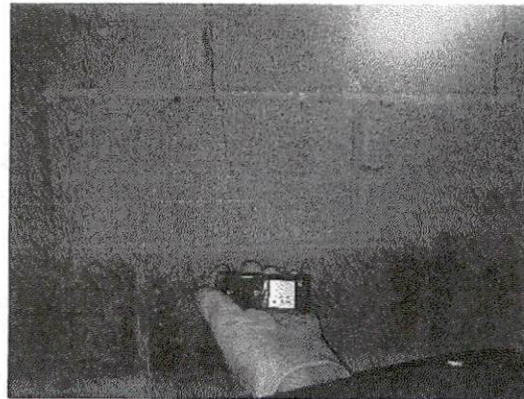
- Measurement by laser level also indicated that the front end of the right foundation wall in the crawlspace was down as much as approximately ½" relative to the crack located approximately 6' from the front end of the wall (*see picture 8 for example*).

Picture 8 – Example of crack in the right foundation wall behind area with void

- (6) along the right wall of the garage and right foundation wall, with (1) at the crack located approximately 6' behind the back wall of the garage, and (1) at the intersection of the back and right garage walls,

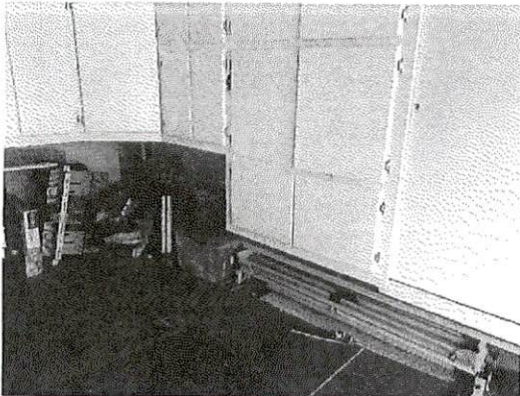
- Personal property and cabinetry along the right wall of the garage prevented measurement of the foundation wall in this area at the time of our observation (*see picture 9 for example*).

Picture 9 – Example of personal property and cabinetry in garage

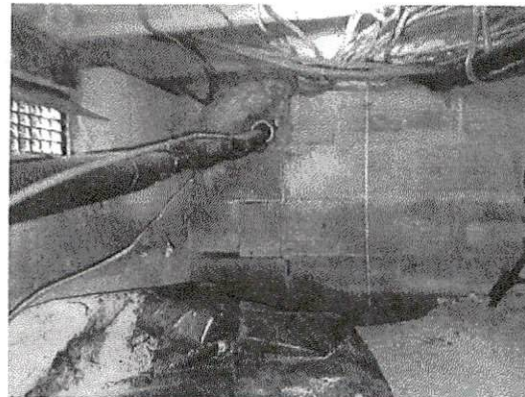
- Various signs of water intrusion were noted along most of the walls of the crawlspace (*see pictures 10-11 for examples*).
 - Roof gutter downspouts were installed for discharge at the foundation onto soils that were inadequately sloped away from the home (*see pictures 12-13 for examples*).

Picture 10 – Example of signs of water intrusion

- We recommend installing a perforated interior perimeter crawlspace drain system with discharge through the low point of the perimeter foundation system at least 5' from the perimeter of the home onto soils adequately graded away from the structure. Transition to non-perforated pipe outside the footprint of the structure.

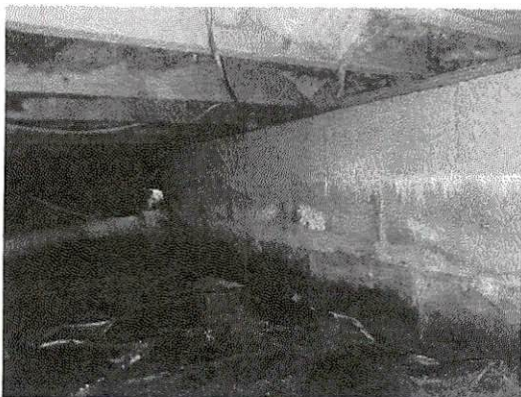
Picture 11 – Example of signs of water intrusion

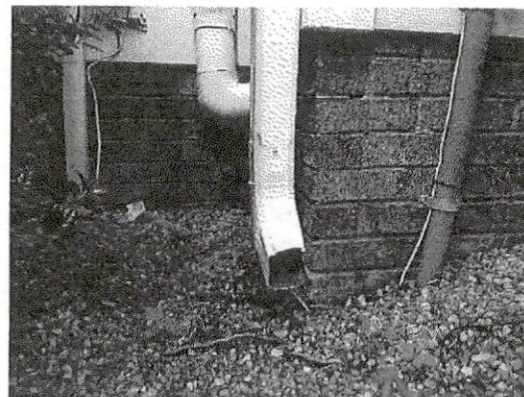
Picture 12 – Example of roof gutter downspout installed for discharge at the foundation

- Extend roof gutter downspouts and any HVAC condensation drains for discharge at least 5' from the perimeter of the structure onto soils adequately graded away from the home.

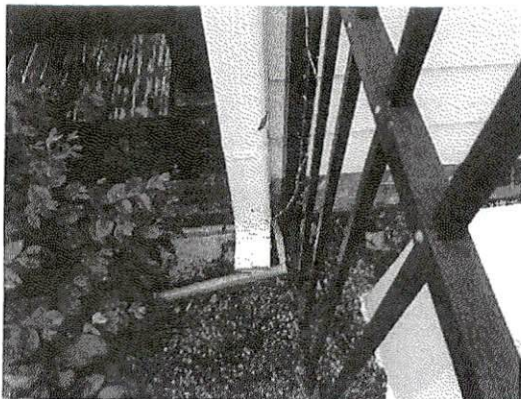
Picture 13 – Example of roof gutter downspout installed for discharge at the foundation

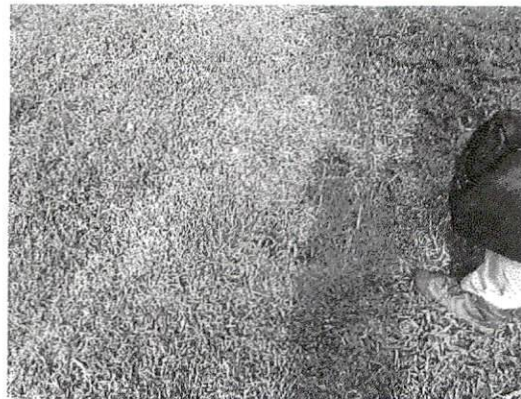
- Various holes as deep as approximately 2' were noted in the crawlspace soils and in the backyard, which is consistent with a previously wooded lot (*see pictures 14-15 for examples*).

Picture 14 – Example of hole in back yard, possibly from organic void

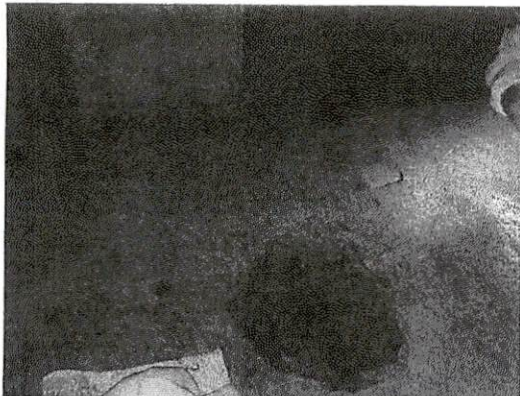
Picture 15 – Example of hole in crawlspace soils, possibly from organic void

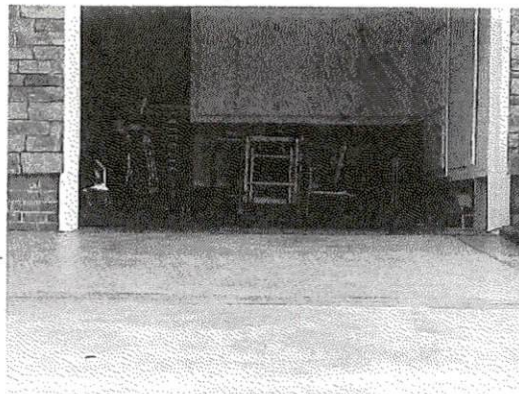
- Various cracks were noted in the garage slab (*see picture 16 for example*).
 - Measurement by laser level indicated that the front-right corner of the garage slab was down as much as approximately 2¾" relative to the back-middle portion of the slab.
- The bottom of various floor joists were noted to be discolored, and had signs of organic growth (*see pictures 17 for example*).
 - Various foundation vents were noted to be closed at the time of our observation (*see picture 18 for example*).

Picture 16 – Example of cracked and settled garage slab

- Settled portions of the garage slab may be raised to the desired level by pressure grouting or structural polyurethane foam injection. Any remaining slab edges should be ground smooth and closed with flexible epoxy as needed.

- Alternatively, the slab may be removed and replaced with a 4" thick reinforced concrete slab over properly compacted base material and 4" clean gravel.

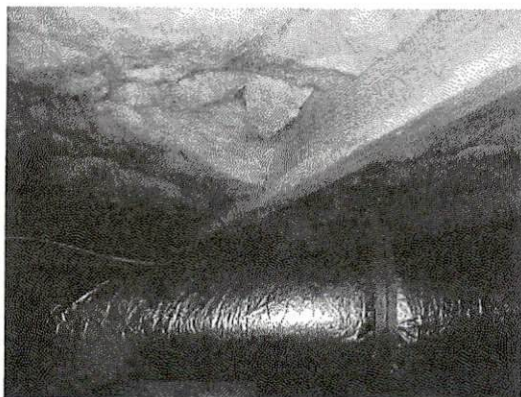
Picture 17 – Example of discolored floor joists

- Due to the infeasibility of achieving adequate cross-ventilation of the crawlspace, we recommend installation of a Code-approved closed crawlspace system with adequate vapor barrier and mechanical drying measures to help avoid future occasions of advanced framing deterioration due to wood rot.

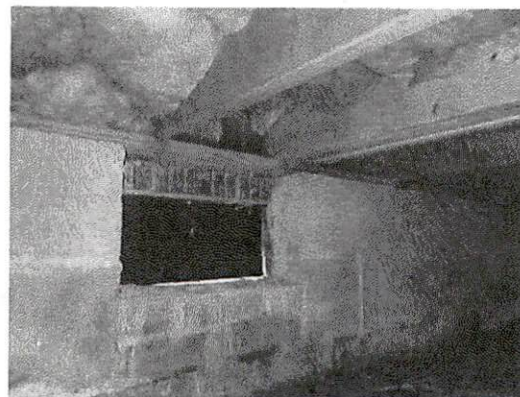
Picture 18 – Example of closed foundation vent
