REGIONAL

Job location:
204 E F St,
Erwin, NC 28339

GILES FLYTHE
ENGINEERS

Re: Limited Structural Inspection
204 East F Street
Erwin, NC

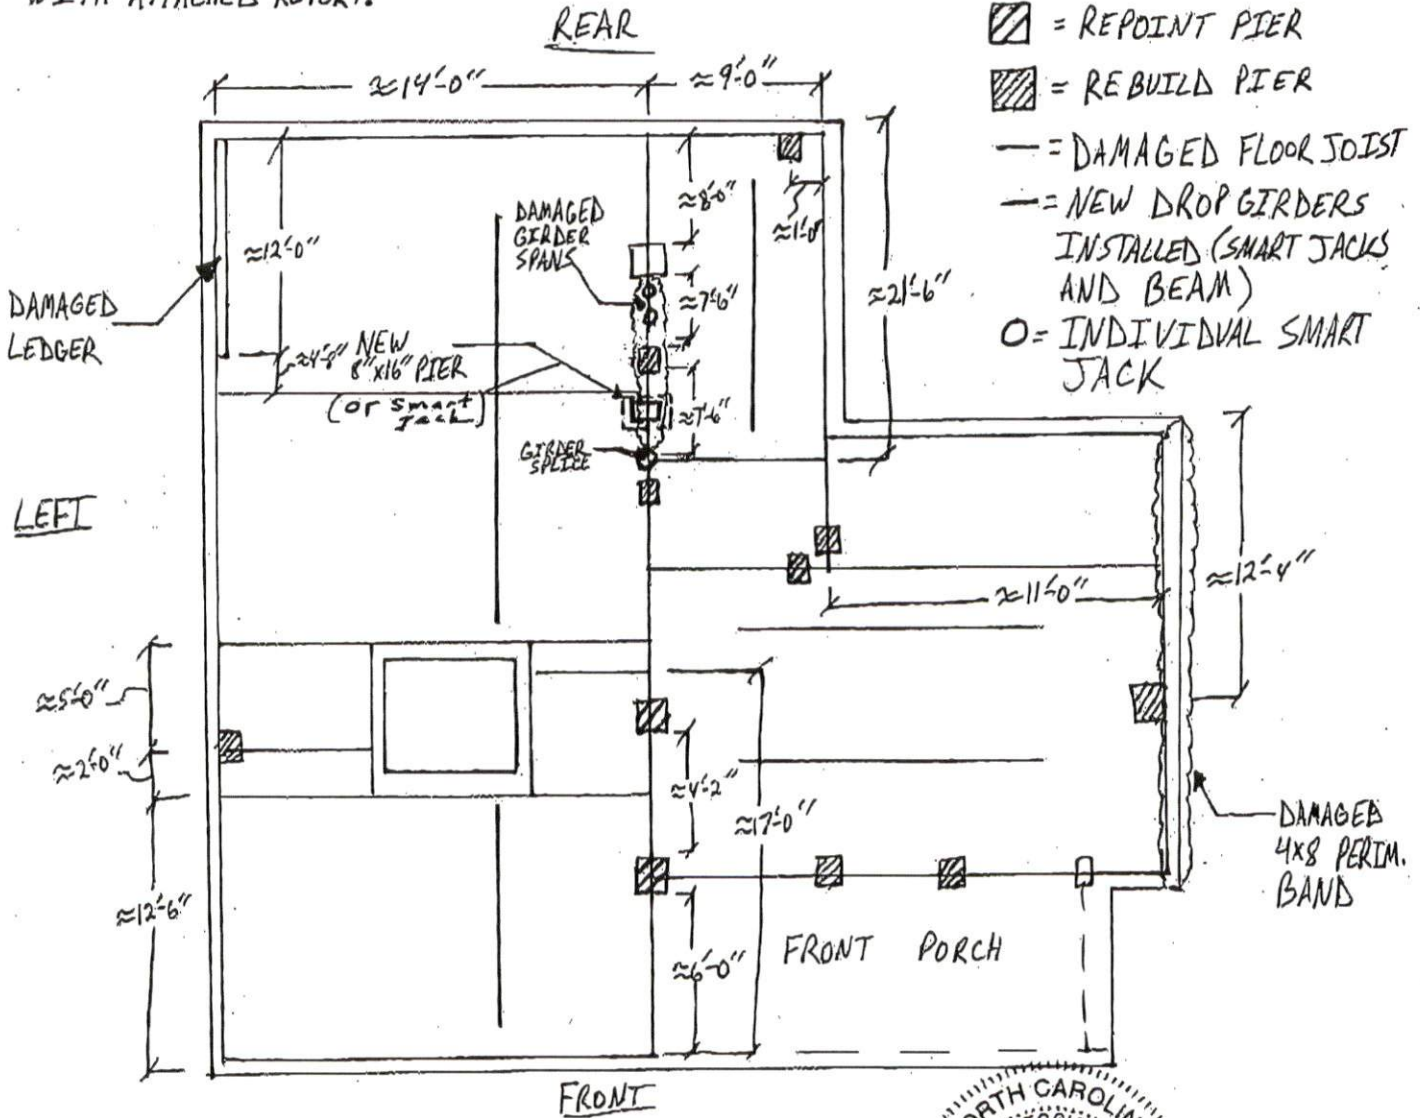
204 EAST F STREET, ERWIN (REPAIR PLAN)
SCALE: NTS

3. Multiple additional observations were noted in the crawlspace. Refer to the attached sketch for locations of damages observed.
 - a. Multiple partially sistered and damaged floor joists were observed throughout the crawlspace.

- b. A damaged ledger board was observed at the rear left of the crawlspace. Note, a wooden auxiliary girder was installed adjacent to the damaged ledger. No physical damage to the perimeter band or floor joists was observed.

- c. The central girder contained significant damage and was cut to accommodate plumbing piping near the rear of the crawlspace and was sistered on one side. Note, a cut floor joist was also observed at this location.

- d. The central girder was damaged for an approximate 6'-0" span at the front of the crawlspace.
 - e. The perimeter band along the right perimeter wall was previously sistered to the rear of the re-entrant corner.

- f. The perimeter band along the right perimeter wall was damaged. Note, the rear section of the perimeter band had been previously sistered.
 - g. Several piers were noted damaged or with deteriorated mortar at multiple locations throughout the crawlspace.

5. At the piers noted "REPOINT PIER" on the attached sketch, we recommend re-pointing the piers or we recommend installing a fibrous cement coating on the piers.

6. At the piers noted "REBUILD PIER" on the attached sketch, we recommend replacing the damaged piers with new mortared 8"x16" CMU block piers. The new piers are to be supported by a minimum 12"x20"x8"-thick concrete footings on firm, dry soils. Note, all exterior footings are to be installed a minimum 12" below grade to the bottom of the footing and all interior footings are to be installed a minimum 8" below grade to the bottom of the footing.

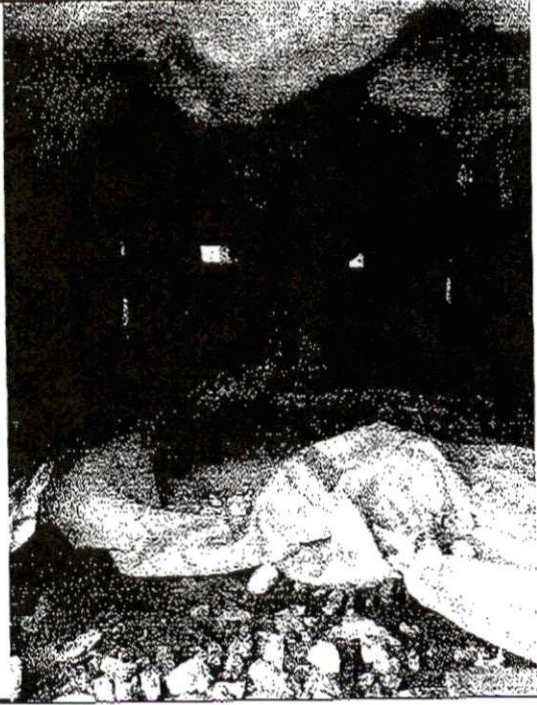
<p>Photo No. 2</p>

2. In the crawl space, drop girders generally comprised of a wide flange beam and smart jacks supported by an engineered fill were installed at multiple locations at the mid-span below floor joists. Separations were typically observed between the existing floor joists and new drop girders and the drop girders were noted out of plumb in the front right section of the crawlspace. Several of the drop girders were noted supporting damaged floor framing members and individual smart jacks were installed below damaged floor framing members in multiple locations.

<p>Description A typical view of a smart jack and steel beam drop girder.</p>

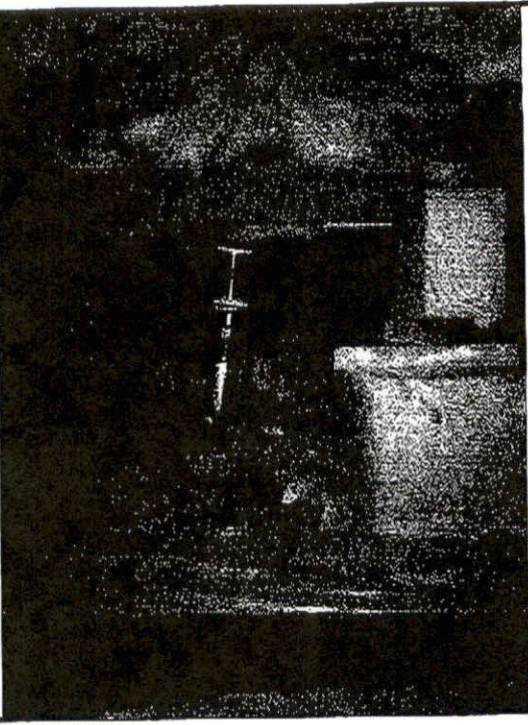
<p>Photo No. 3</p>

<p>Description A view of an out of plumb smart jack and steel beam drop girder.</p>

7. We recommend re-plumbing the leaning drop girders (comprised of smart jacks and beams) and tightening the smart jacks to ensure all affected floor joists are bearing on the new beams.

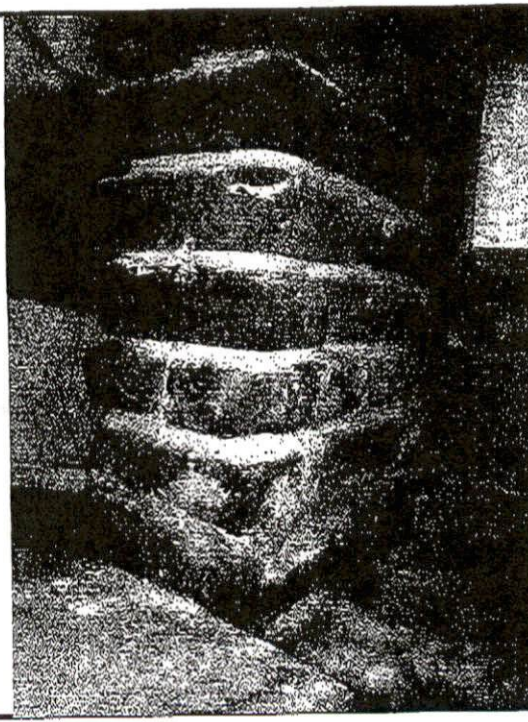
<p>Photo No. 4</p>

The deteriorated and damaged piers noted above are a significant structural concern. We have provided recommendations below to address these issues.

<p>Description A view of a pier with deteriorated mortar to be re-pointed.</p>

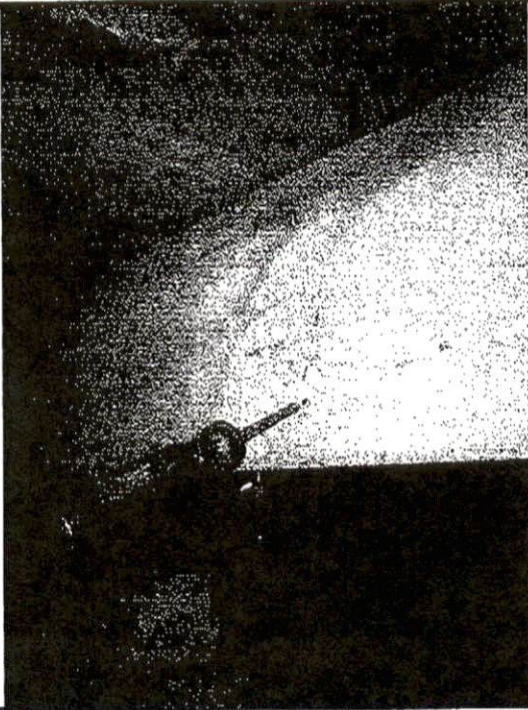
<p>Photo No. 5</p>

- k. Note, visual inspection of all floor framing components was limited due to the installation of insulation. Visual inspection of the right section of crawlspace was limited due to the numerous installed temporary supports. Several of the damages observed to the floor joists and girders appeared to be a result of wood destroying insect damage.

<p>Description A view of a damaged floor joist.</p>

1. We recommend fully sistering the damaged, partially sistered, and cut floor joists for the full length (bearing point to bearing point). The new sistered member should match the size of the existing joist and be attached with (3) 16d nails at 16" on-center.

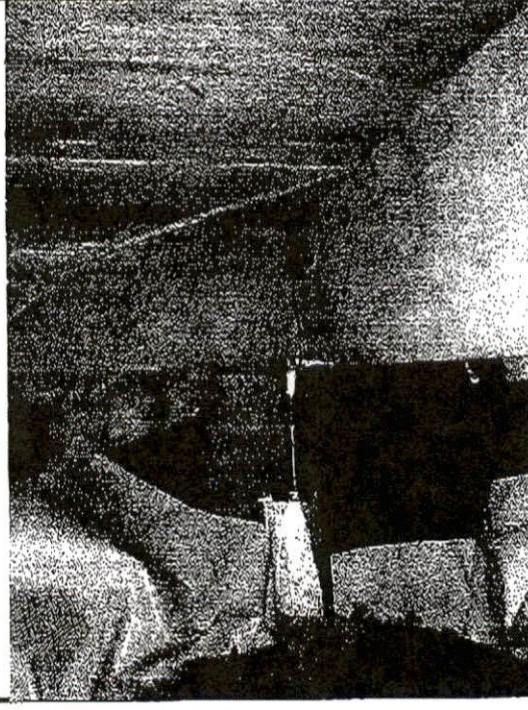
<p>Photo No. 6</p>

<p>Description A view of damaged floor joists to the rear of the masonry boxout.</p>

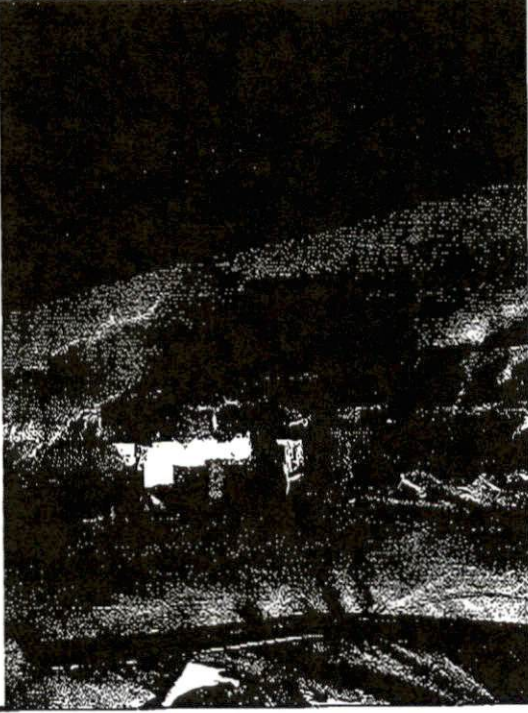
<p>Photo No. 7</p>

<p>Description A view of a damaged floor joist.</p>

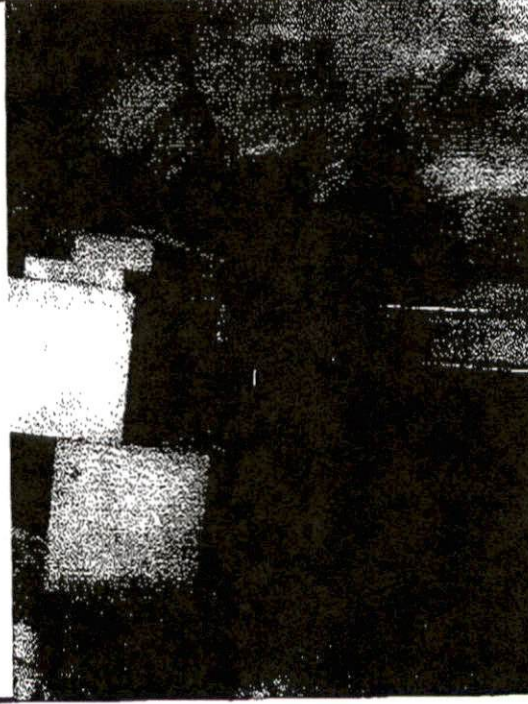
<p>Photo No. 8</p>

<p>Description A typical view of floor joists not bearing on the new smart jack and steel beam drop girders.</p>

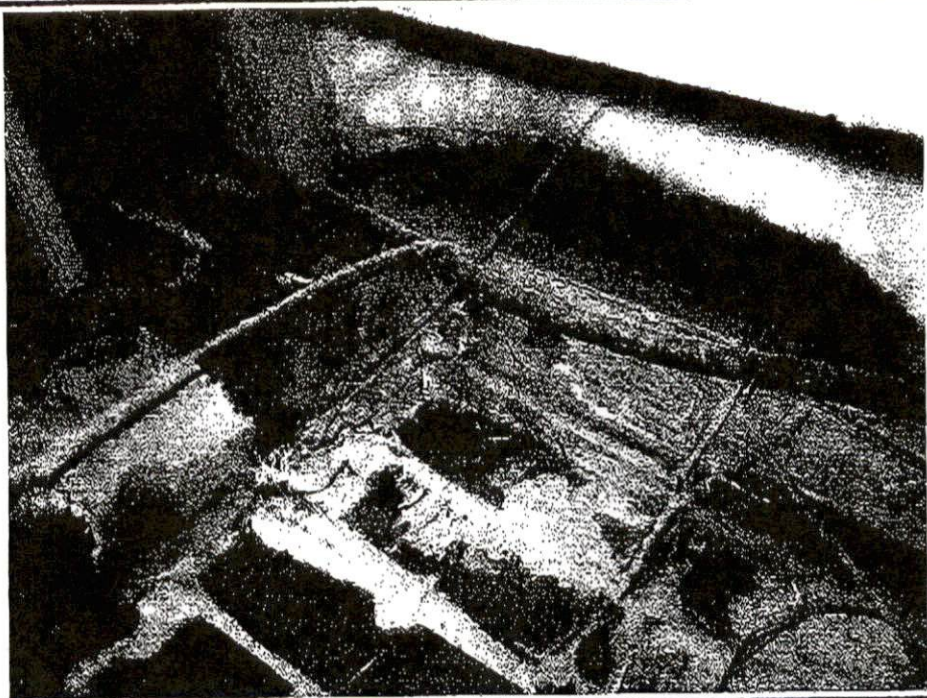
Photo No.
9

Description
A view of a damaged ledger board at the rear left of the crawlspace.

2. At the damaged ledger board, we recommend attaching the floor joists to the perimeter band with Simpson Steel Clip Angles (or equivalent).
3. We recommend replacing the perimeter band along the right perimeter wall with a new pressure treated 3-2x8 member.

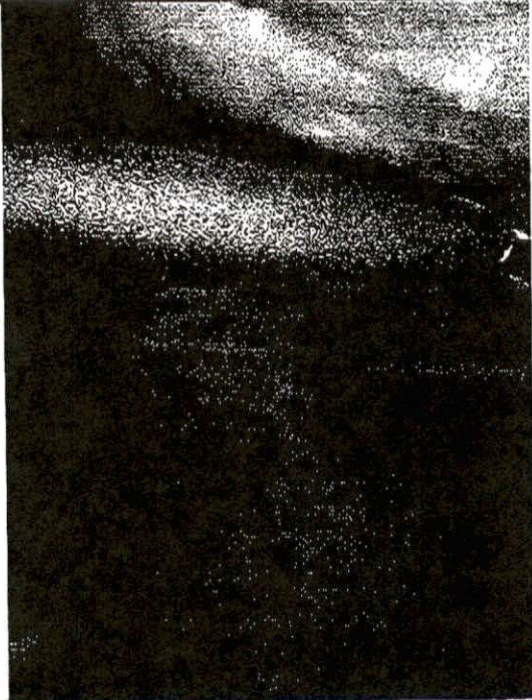
Photo No.
10

Description
A view of a pier with deteriorated mortar.

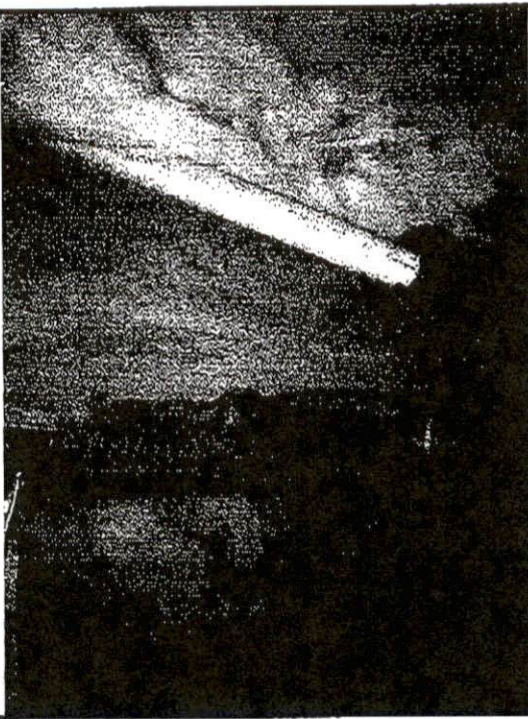
<p>Photo No. 11</p>

<p>Description A view of a damaged girder span.</p>

4. We recommend replacing the damaged sections of central girder with new pressure treated 2-2x8 members.
 - At the girder central girder spanning front to rear (approximate 7'-6" span) located approximately 20'-0" from the rear perimeter wall, we recommend centering the smart jack directly below the splice to support both ends of the girders. We also recommend installing a new mortared 8"x16" CMU pier at the mid-span supported by a new 12"x20"x8"-thick concrete footing installed a minimum of 8" below grade on firm, dry soils. Note, a smart jack may also be installed per manufacturer's specifications at the mid-span.

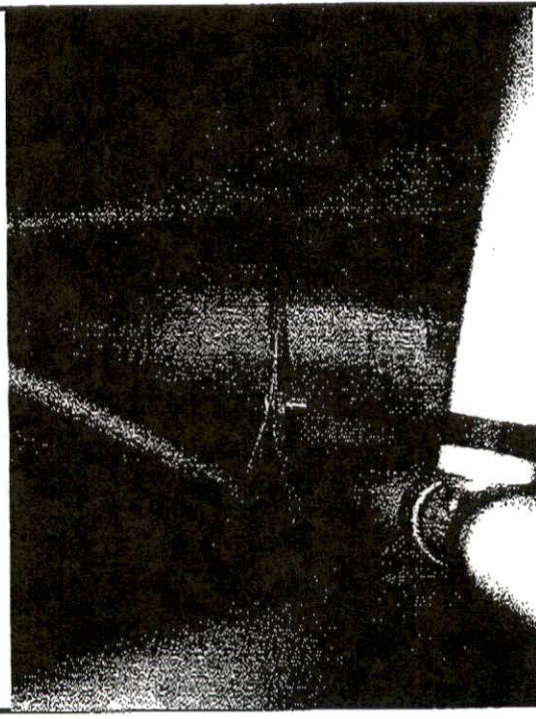
<p>Photo No. 12</p>

<p>Description A view of a cut section of central girder.</p>

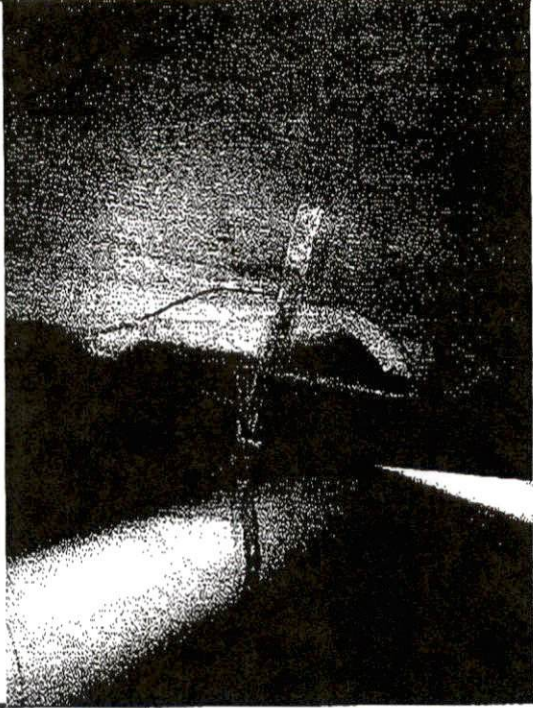
<p>Photo No. 13</p>

<p>Description A view of a cut floor joist.</p>

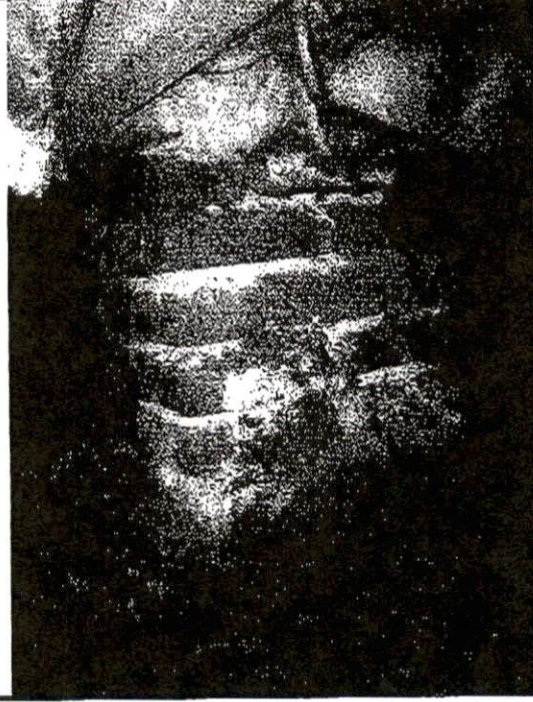
<p>Photo No. 14</p>

<p>Description A view of a damaged pier to be re-built.</p>

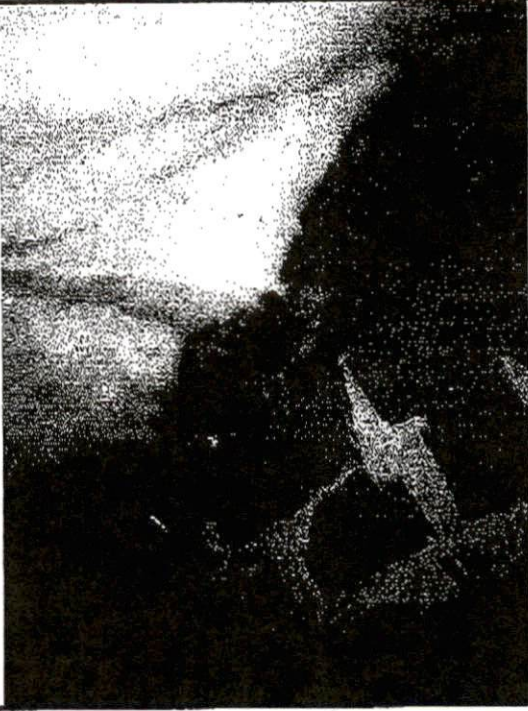
<p>Photo No. 15</p>

<p>Description A view of damaged right perimeter band.</p>
