August 26, 2019

Subject: Residential structural inspection – Linda Santos
27 Strike Eagle Dr.
Broadway, North Carolina 27505

Project No.: RB-195809

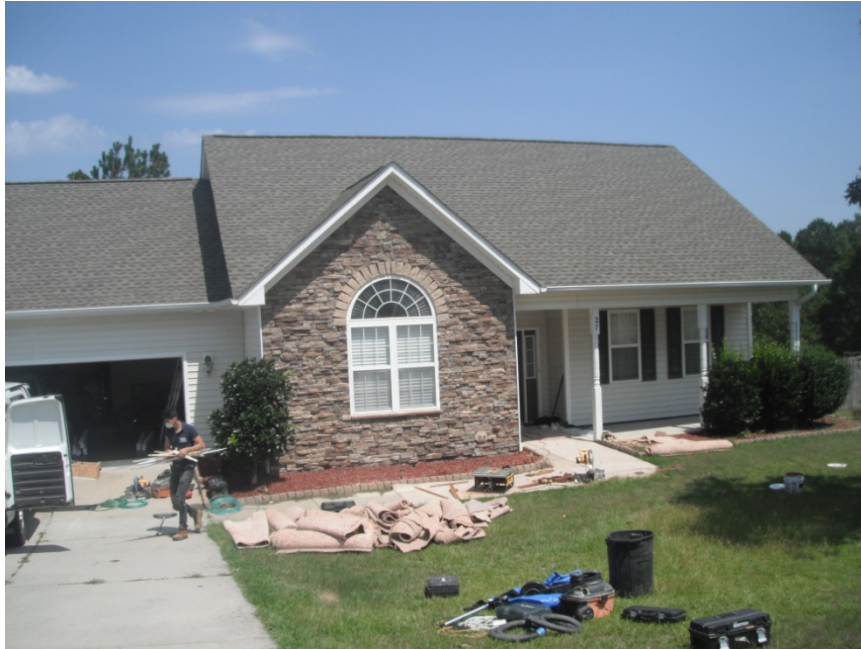
Photograph Number 1 - Partial front elevation view of the subject residence.

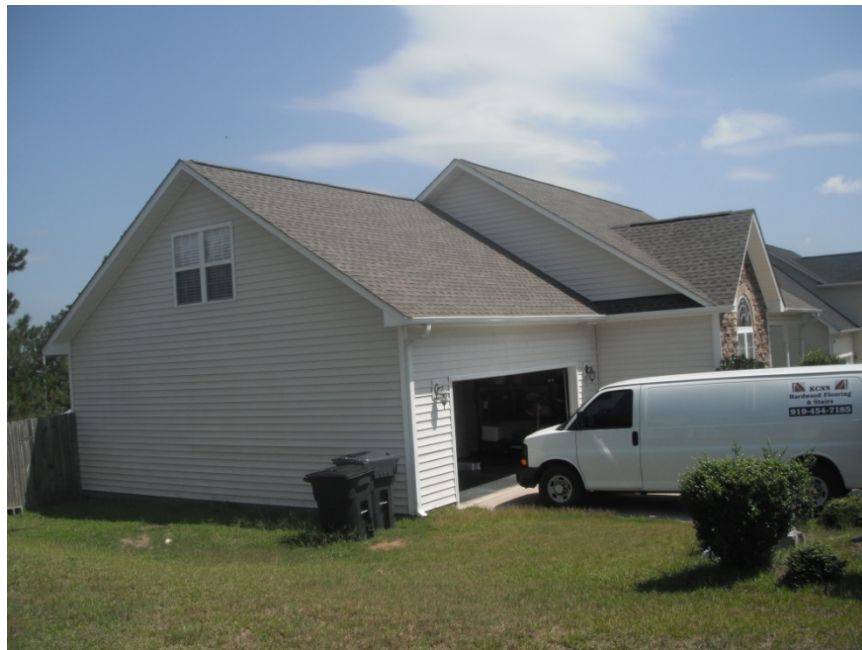
Photograph Number 2 - Left side elevation view.

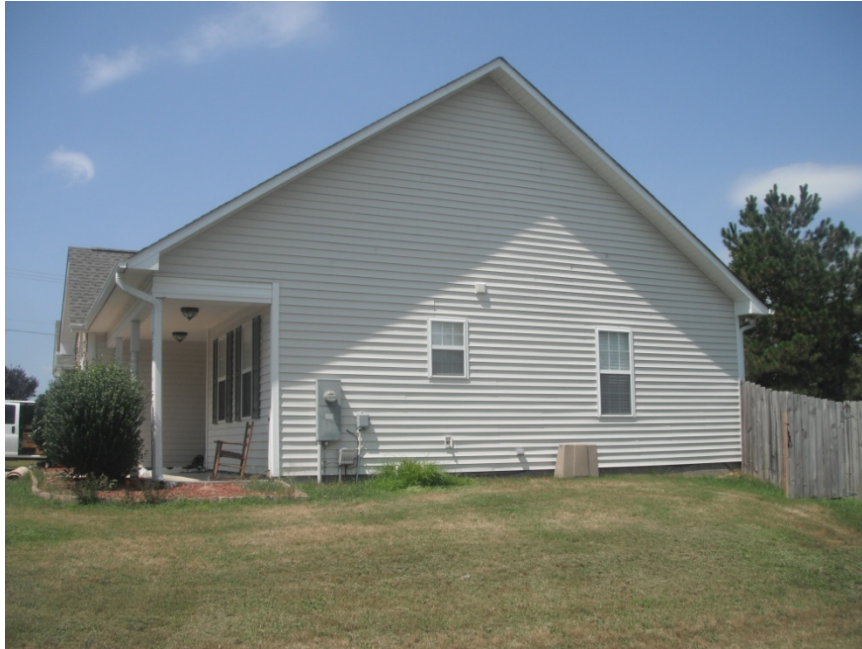
Photograph Number 3 - Right side elevation view

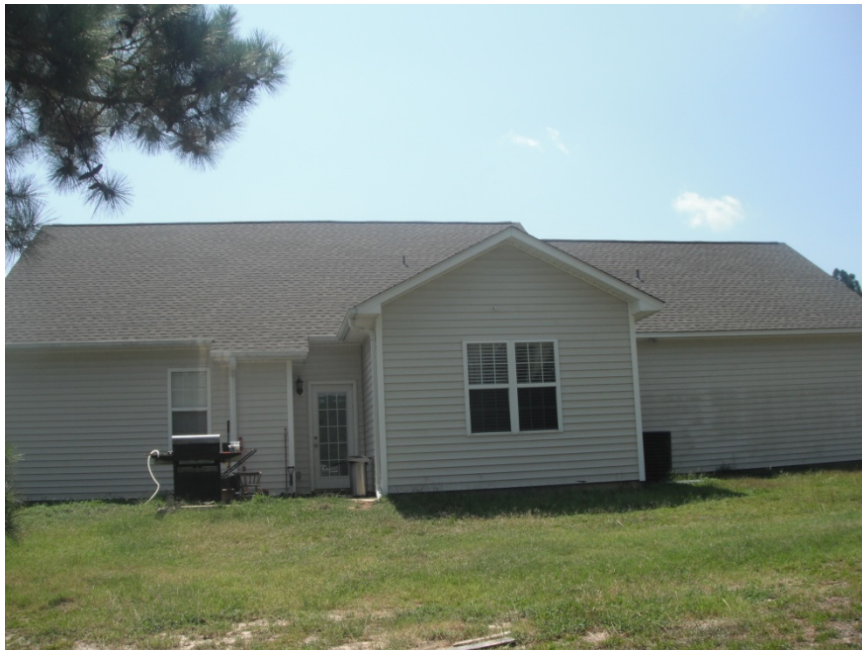
Photograph Number 4 - Rear elevation view.

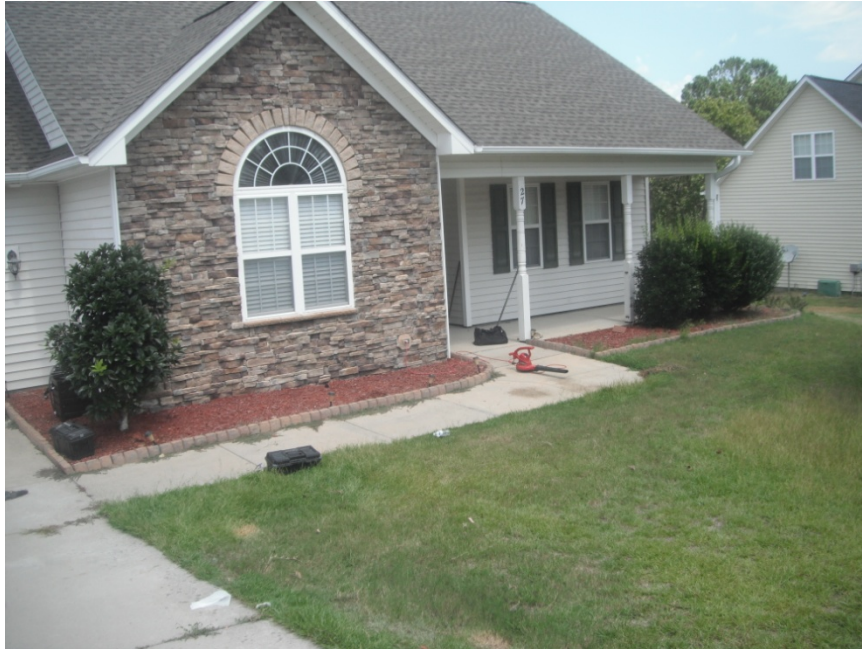
- The single-family residence was constructed upon a concrete slab foundation using typical construction methods. The residence was constructed with an attached garage located at the left end. The house is a one-story residence that contains a bonus room located over the garage. Site drainage is from front-to-back and left-to-right with an area in the front yard that did not have positive site drainage.

Photograph Number 5 - View of drainage collection area – front yard.

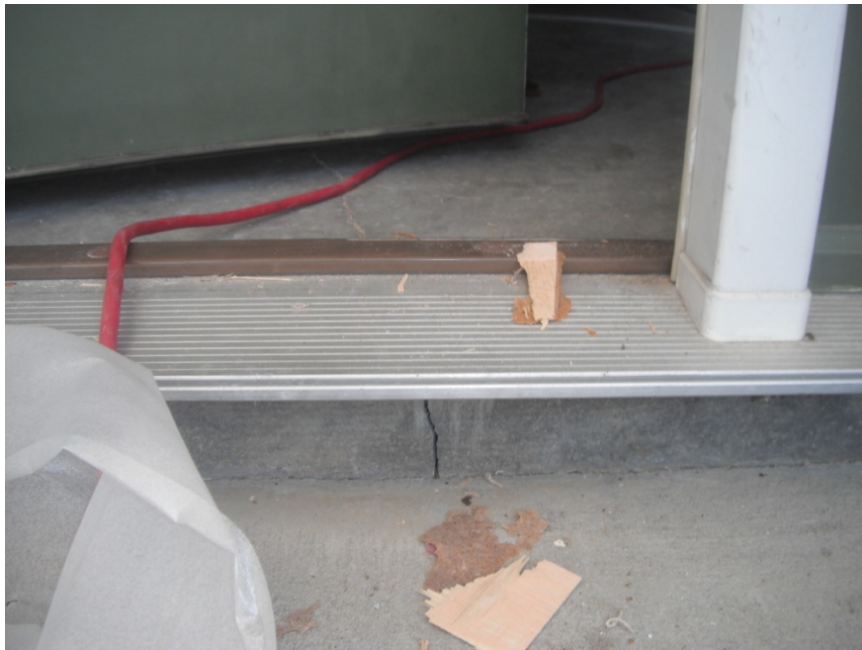
- The concrete foundation slab contained isolated 1/16-inch to 1/4-inch open vertical cracks on the exposed face of the slab. The front patio concrete slab has visibly settled and the front, right porch roof column has been shimmed. Flooring was in the process of being removed at the time of our inspection so the top of the foundation slab was mostly exposed. There was significant cracking throughout the foundation slab that measured hairline to 5/16-inch in width and the cracking in the living room area contained a 1/4-inch vertical displacement over the crack interface. See sketch for approximate crack locations.

Photograph Number 6 - View of slab crack located below front entrance door

- RB Engineering, Inc. considers the foundation damage observed to be a major structural defect per your warranty definition. A structural foundation repair is recommended to stabilize the right end of the foundation slab using underground helical or push piers, pressure grouting a portion of the foundation slab and repairing the slab cracks using a non-shrink epoxy.

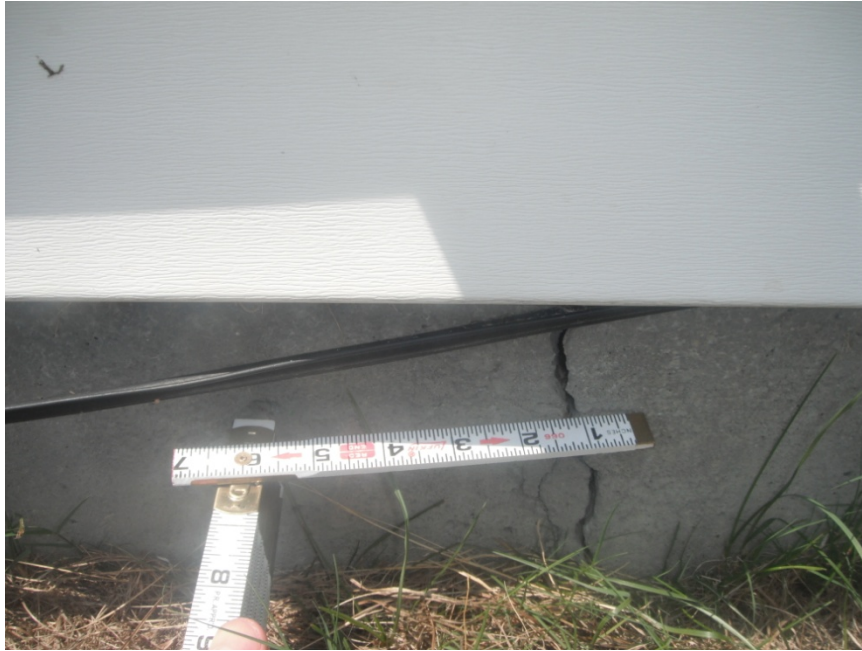
Photograph Number 7 - View of slab crack - right exterior

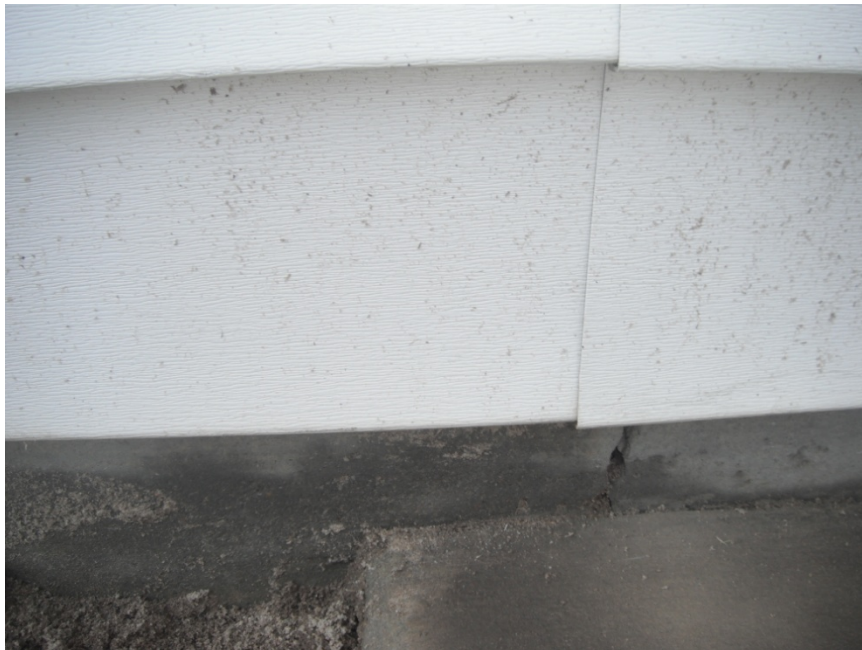
Photograph Number 8 - View of slab crack - rear exterior

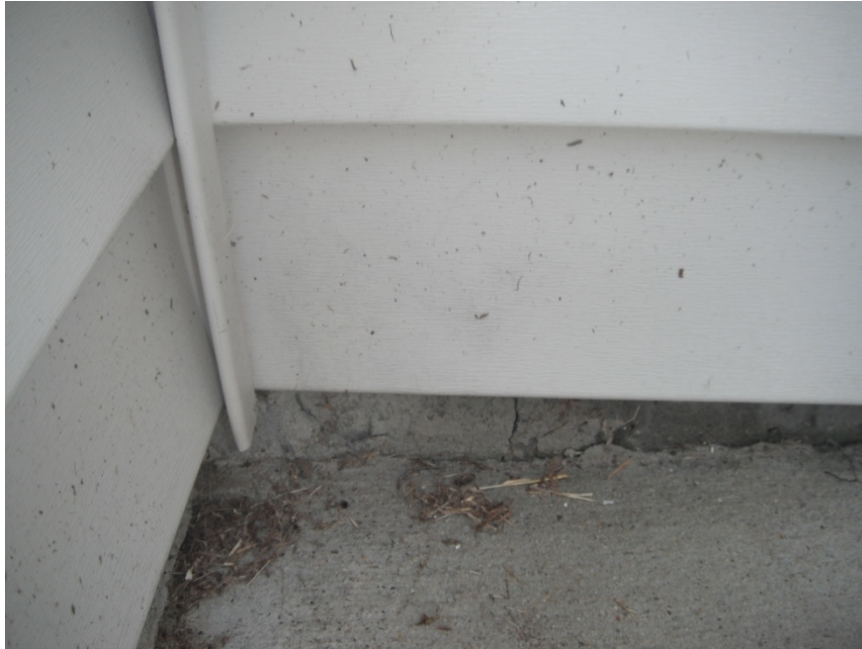
Photograph Number 9 - View of slab crack - rear exterior

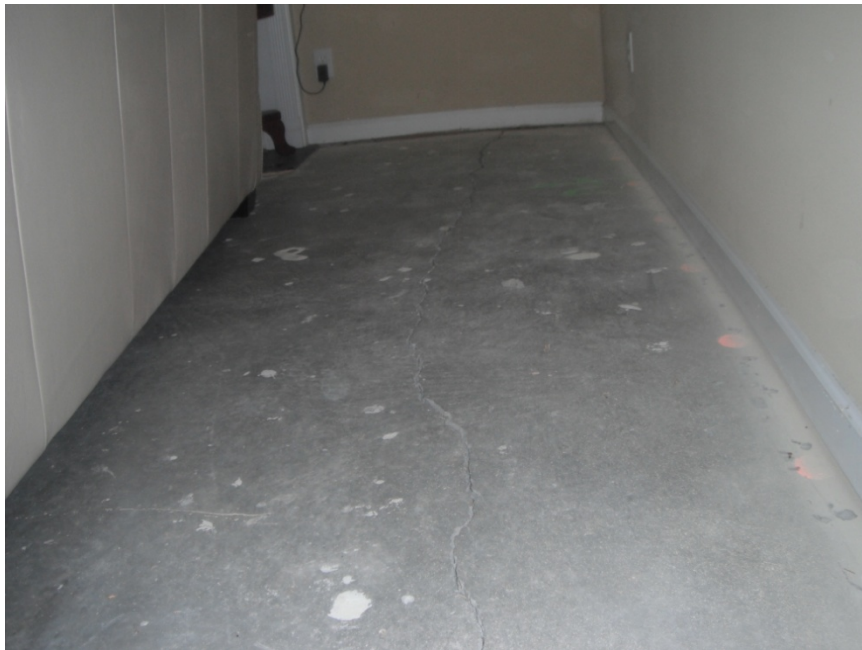
Photograph Number 10 - View of slab crack extending front to rear in living room area.

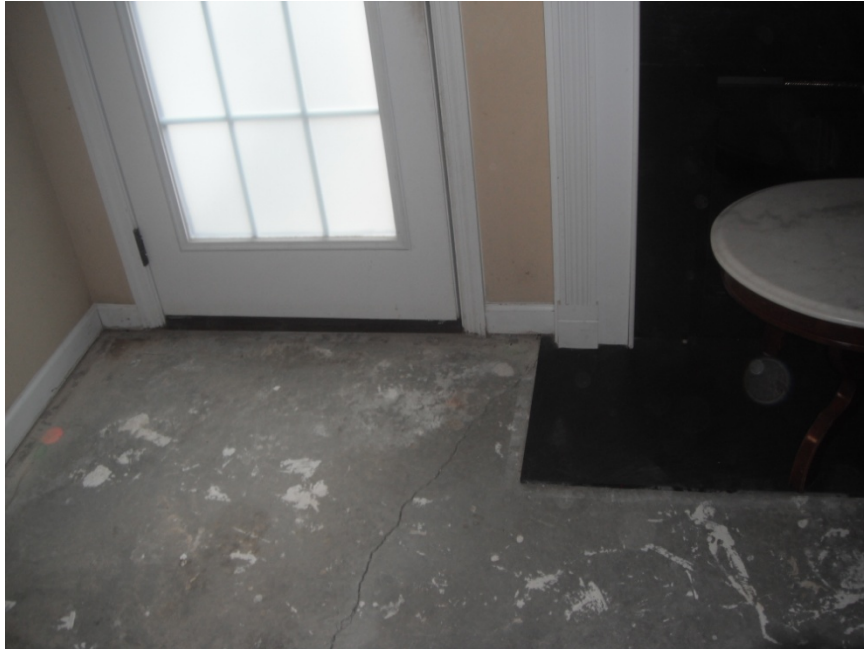
Photograph Number 11 - View of slab cracking at rear chimney area.

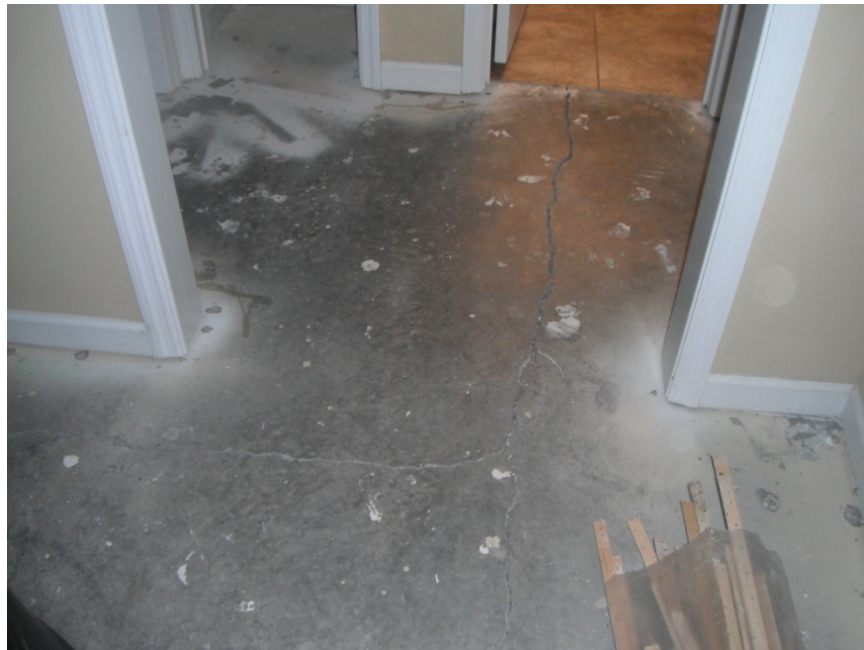
Photograph Number 12 - View of slab cracking.

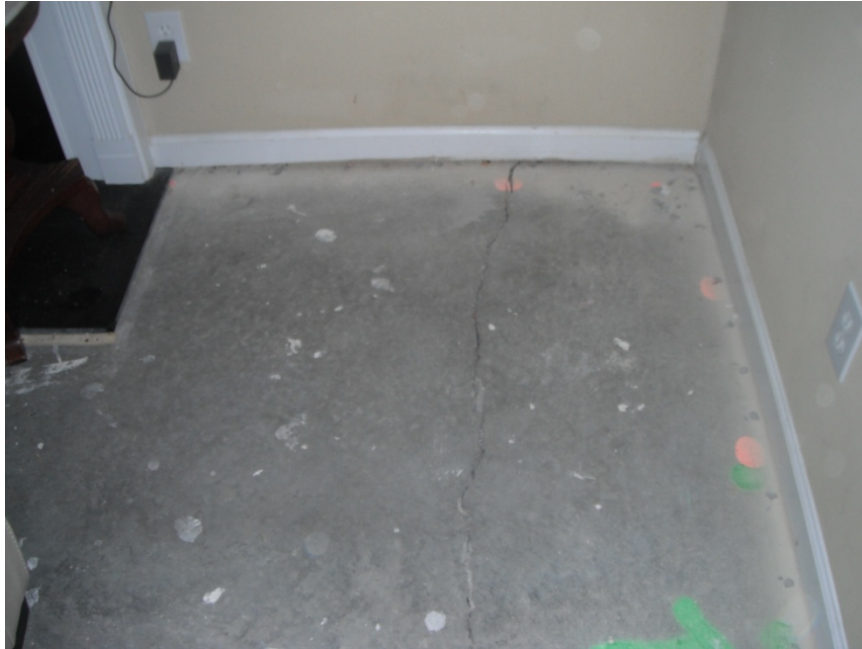
Photograph Number 13 - View of slab cracking.

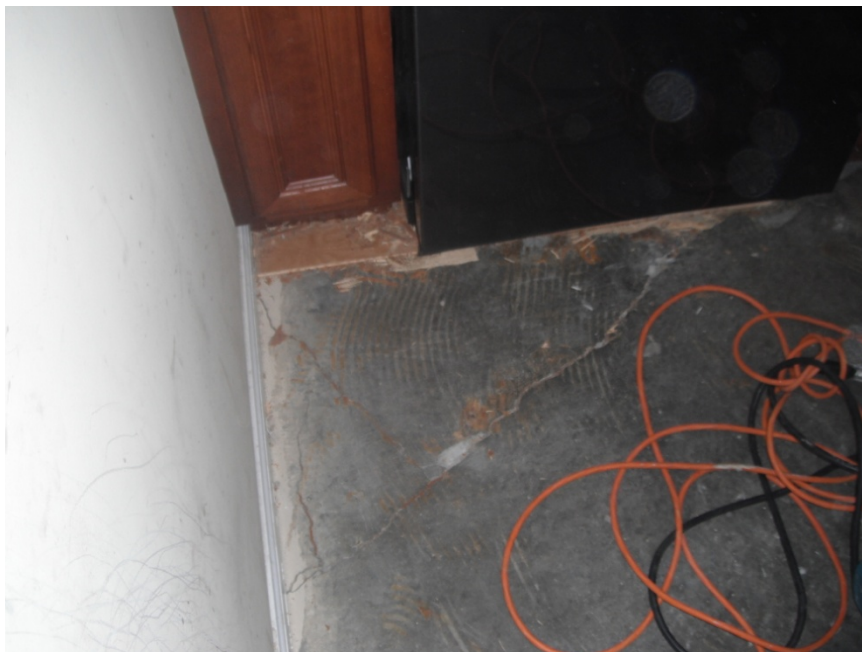
Photograph Number 14 - View of slab cracking.

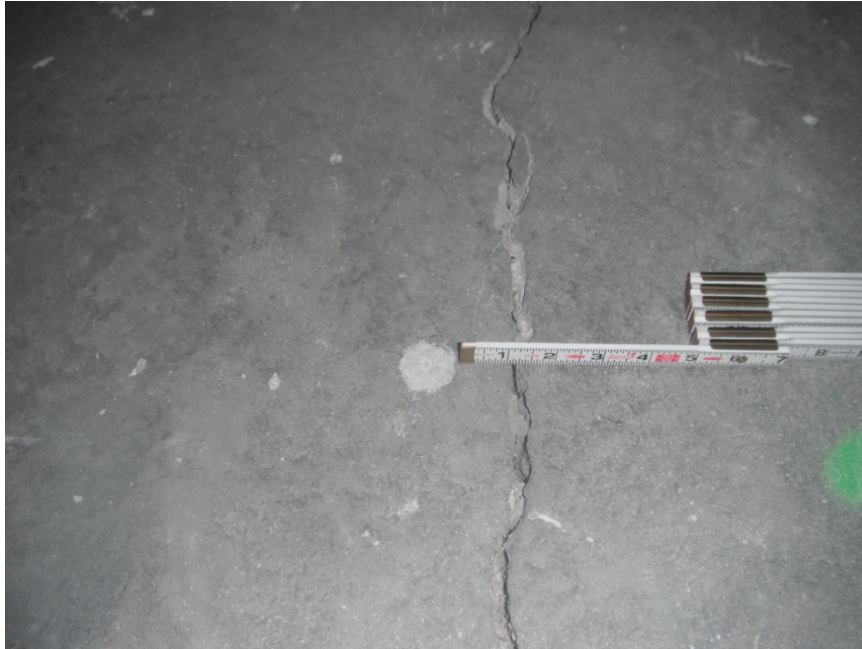
Photograph Number 15 - Close up view of slab cracking.

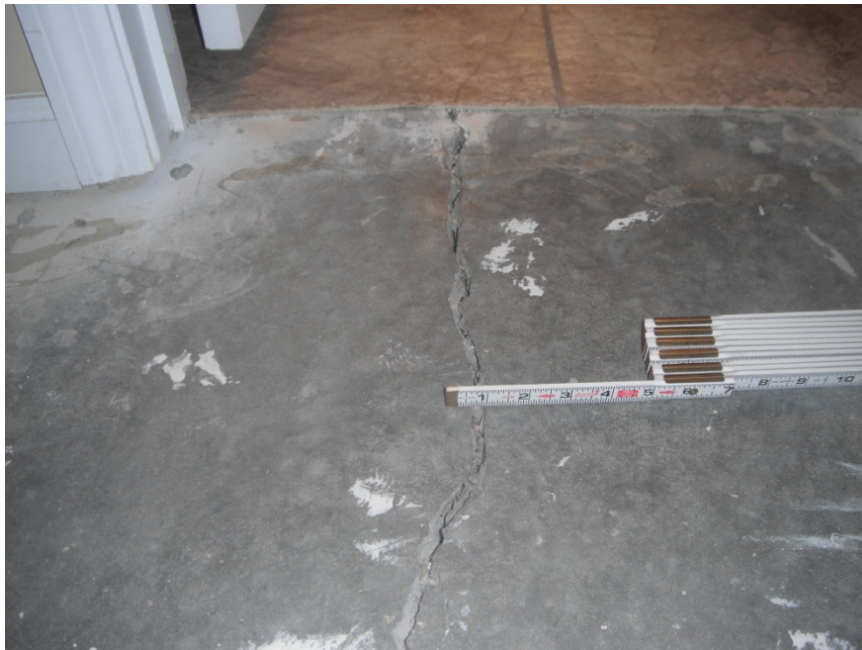
Photograph Number 16 - Close up view of slab cracking.

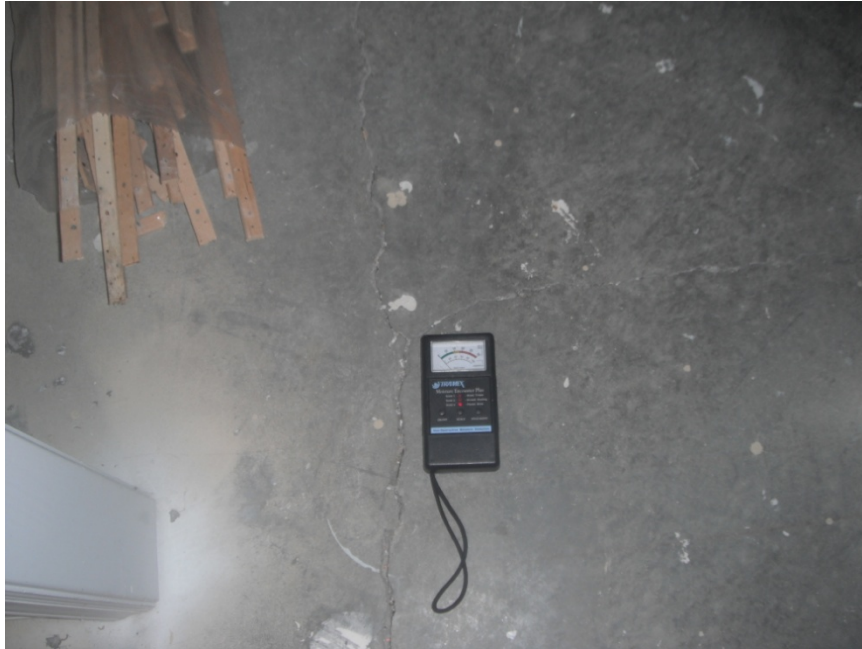
Photograph Number 17 - View of normal moisture reading in slab

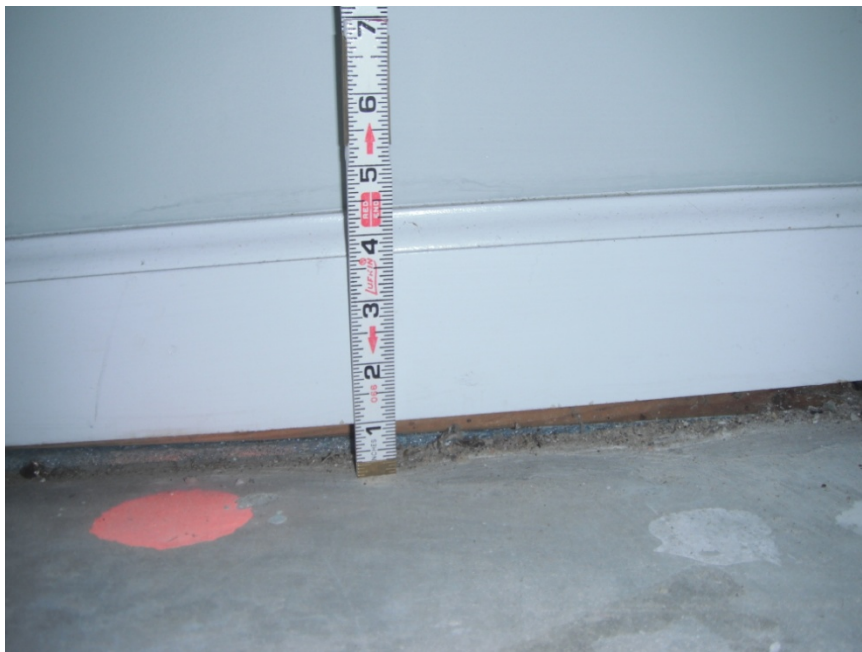
- The **right portion of the foundation slab has differentially settled over 2 inches** allowing for separations to develop between the concrete slab and the wall framing. This creates a structural concern regarding how the residential loads are being distributed to the supporting soils. While the house is not currently unsafe, unsanitary or otherwise unlivable - the amount and type of slab movement that has occurred is significant and has the potential to produce an adverse vital effect on the structural integrity of the residence. Based upon our observations, we believe that the fourth criterion for a major structural defect has also been met.

Photograph Number 18 - View of separation between slab and wall framing

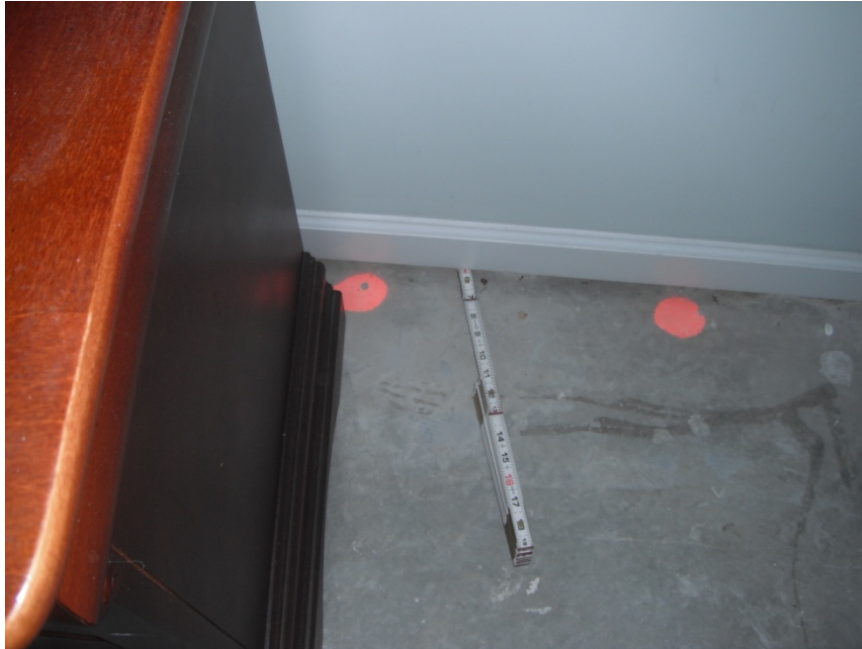
Photograph Number 19 - View of separation between slab and sole plate

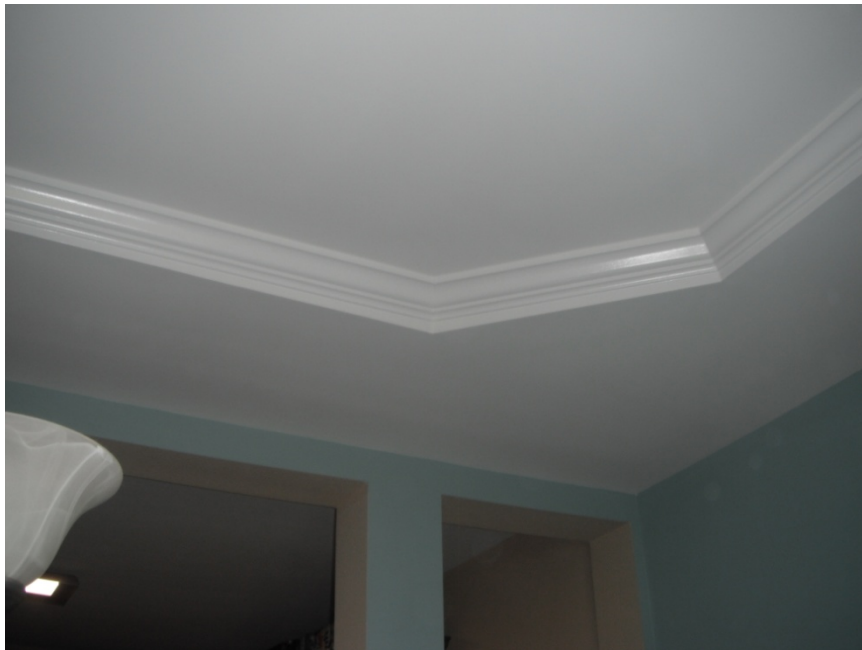
Photograph Number 20 - View of interior ceiling – good condition

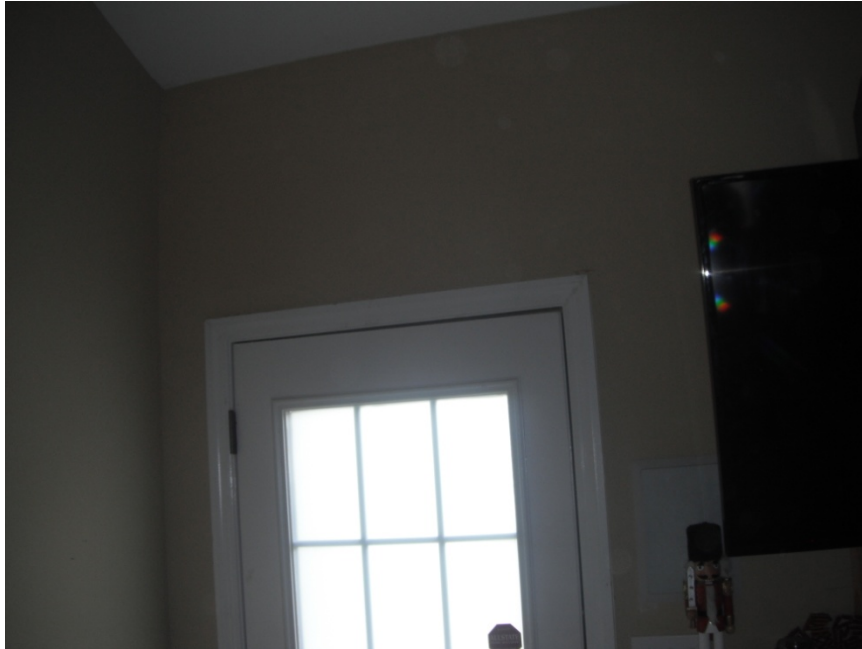
- There were minor interior disturbances noted that consisted primarily of drywall issues (isolated nail pops, minor drywall cracking), a misaligned rear exterior door, and floor sloping. Using a rotary laser level, relative interior floor measurements were taken and revealed moderate to severe vertical floor misalignments on the order of over 2-inches with the low area measured toward the back, right corner of the house. The slab has visibly settled in this area evidenced by the gap between the base trim and the slab and separations have developed between the foundation slab and the wall sole plate. See the attached sketch for relative floor elevations.

Photograph Number 21 - View of rear entrance door misalignment

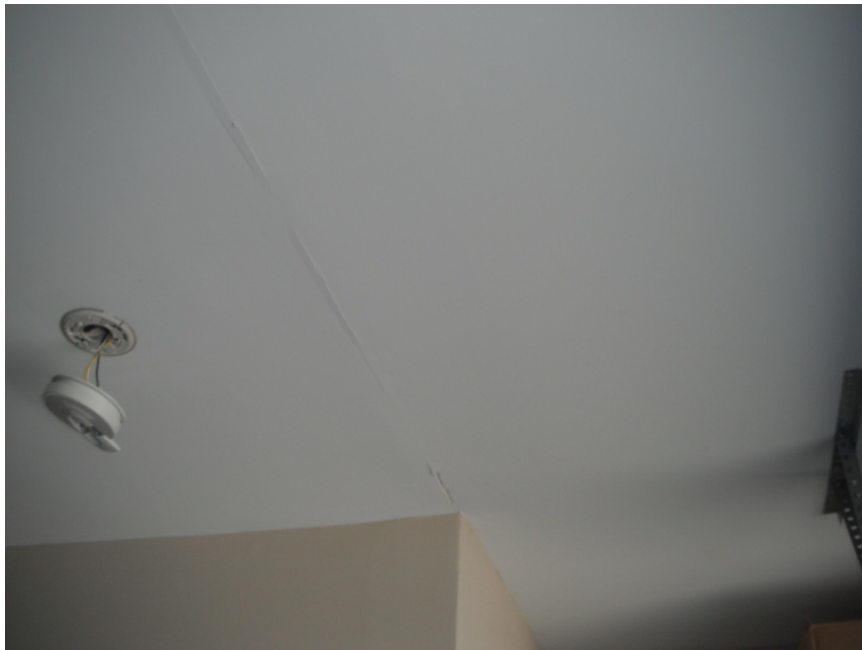
Photograph Number 22 - View of interior drywall crack.

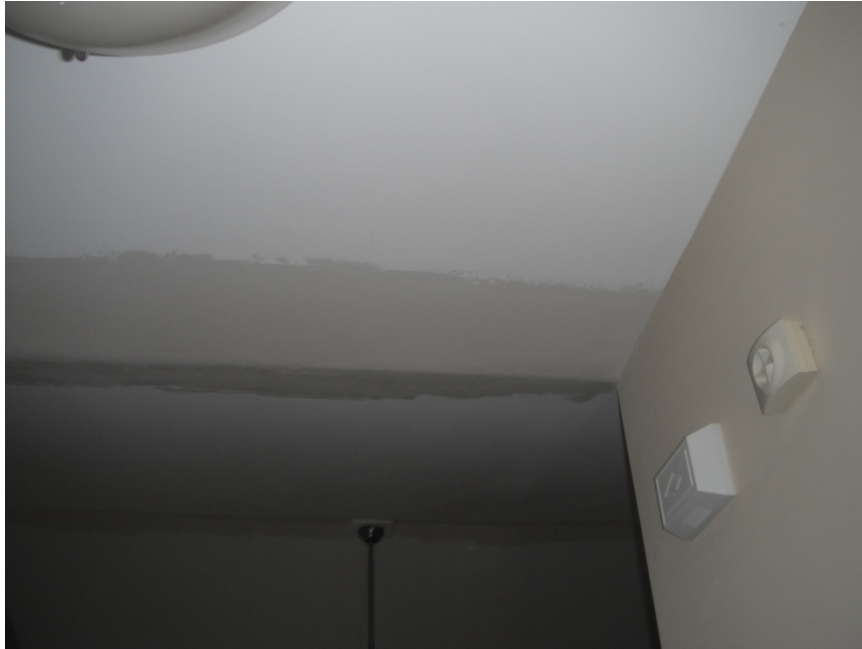
Photograph Number 23 - View of interior drywall repair

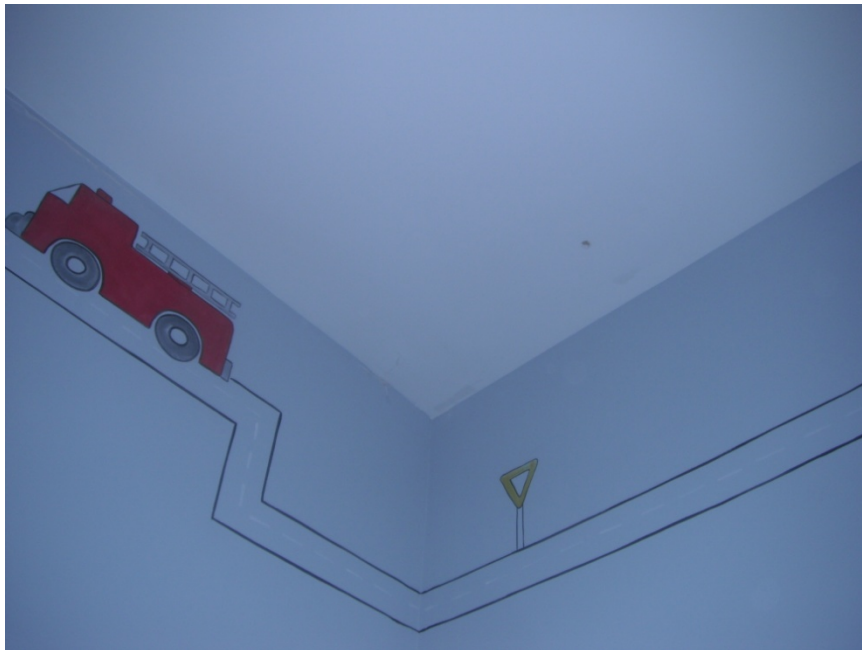
Photograph Number 24 - View of isolated drywall nail pop

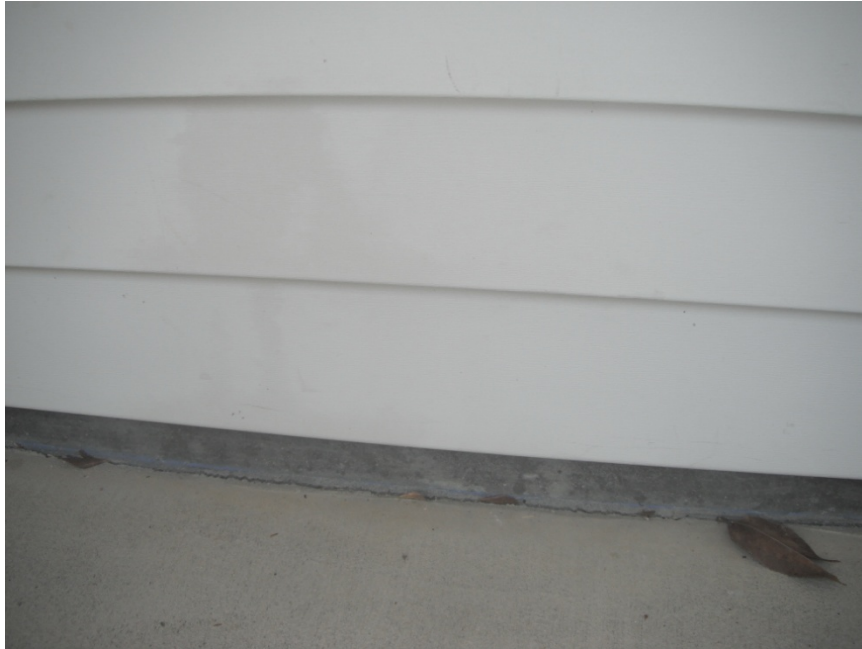
Photograph Number 25 - View of chalk line along front porch – slab settlement.

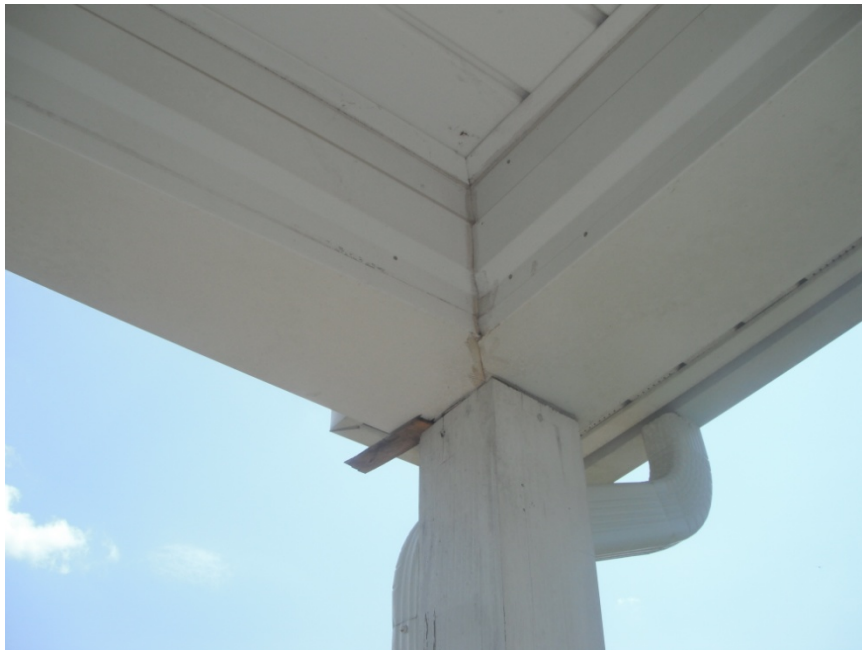
Photograph Number 26 - View of shim at front porch corner post

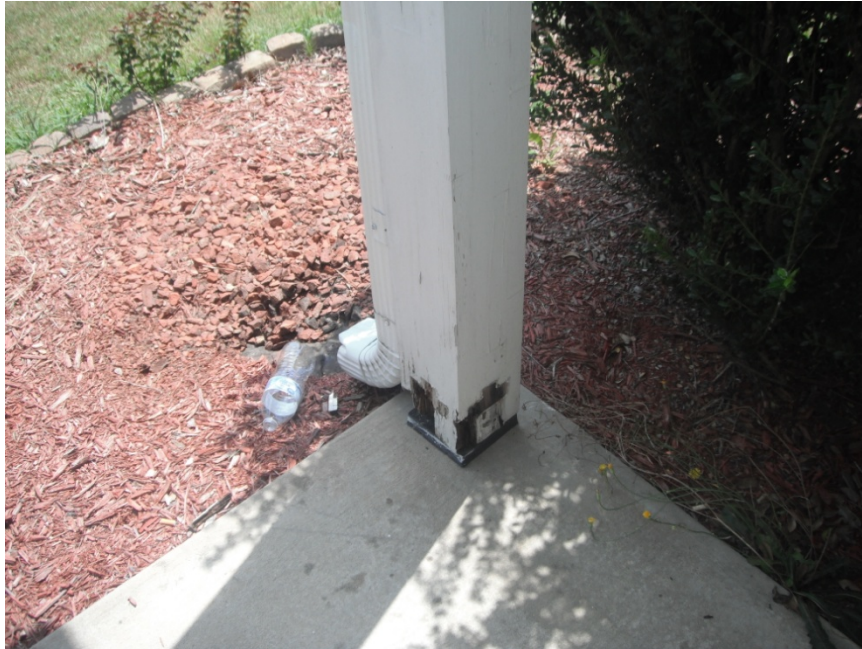
Photograph Number 27 - View of deterioration at front porch corner post

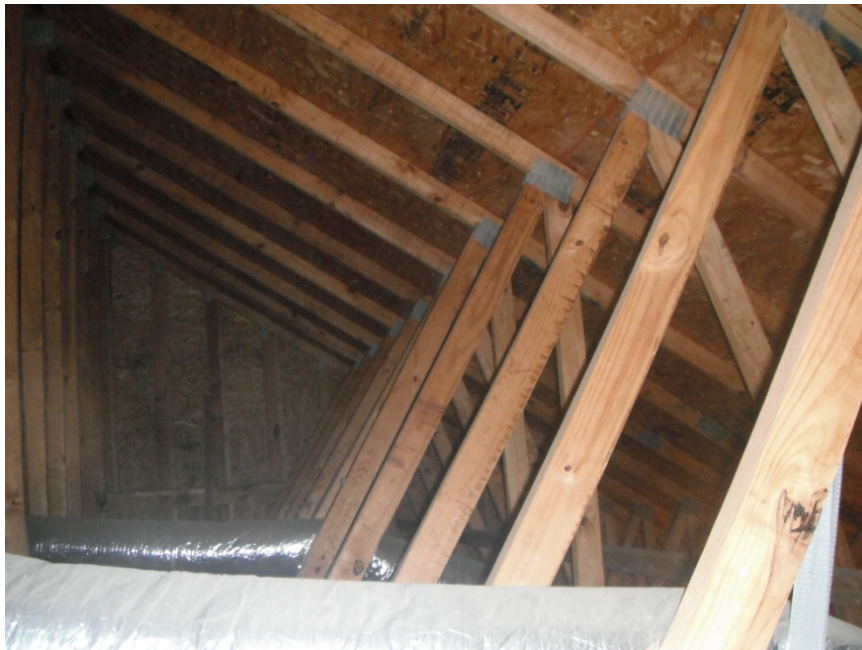
- The roof system is framed using timber roof trusses and OSB roof sheathing. The roof trusses were in good physical condition with no structural issues noted. A minor water leak in the HVAC condensate line was noted and was reported to Ms. Santos.

Photograph Number 28 - View of roof trusses – good condition

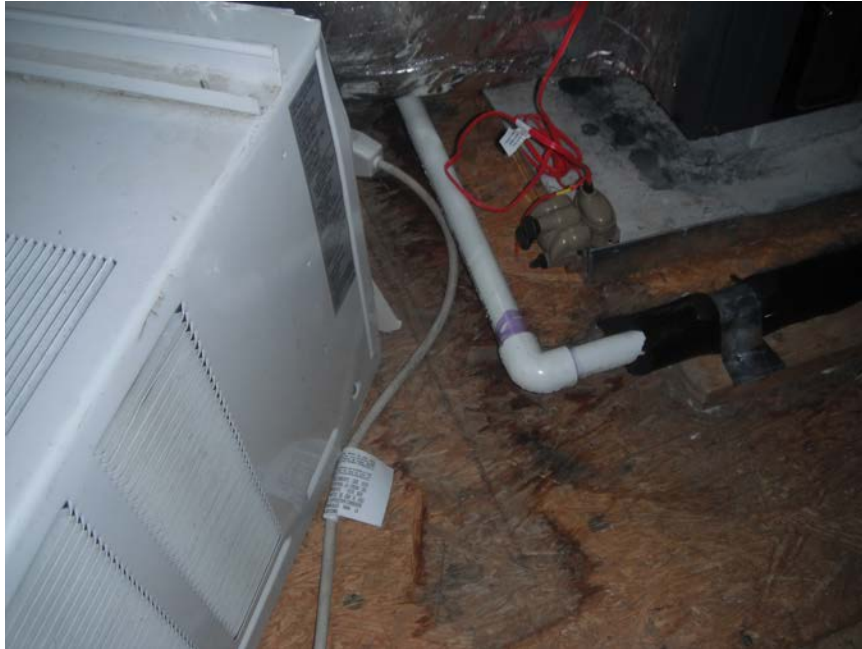
Photograph Number 29 - View of condensate line leak in the attic
