Daniel C. Smith, PE  
Consulting Engineers  
13237 Melvin Arnold Rd  
Raleigh, NC 27613  
919-844-6050

DCSPE 7473

975 NC HWY 24

BLDG PLAN

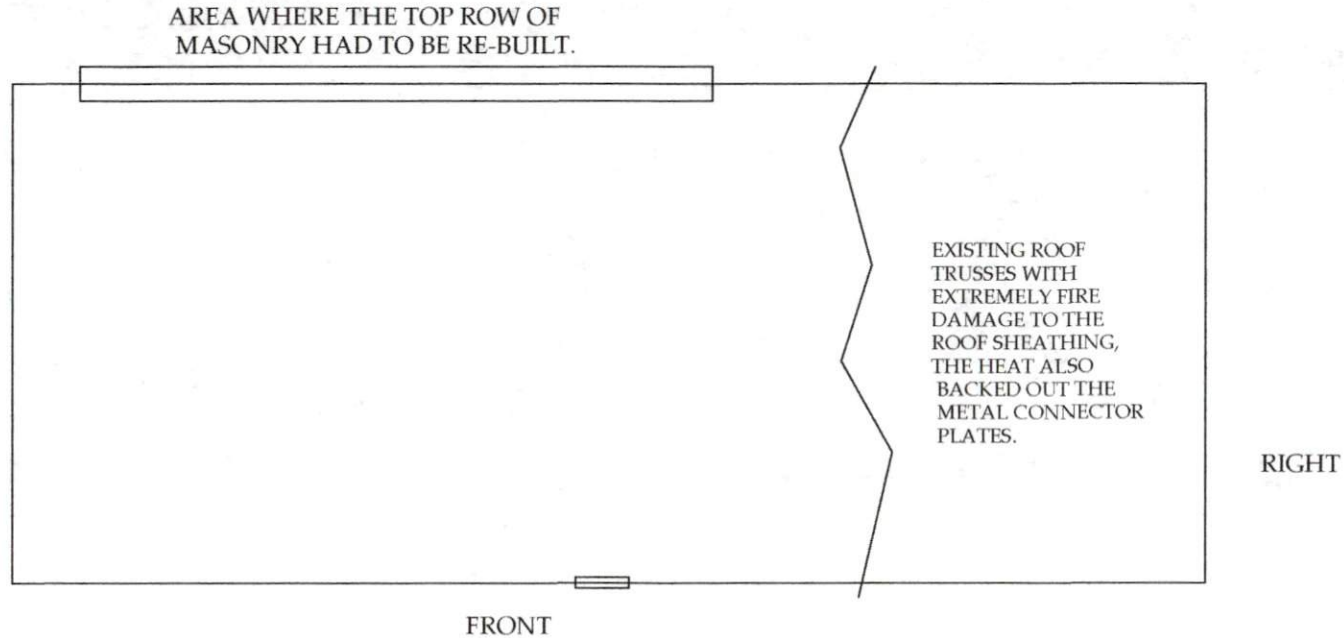
BUILDING PLAN VIEW

WE ASSUME THAT THE REPAIR TO THE MASONRY TOP ROW WAS FROM THE BURNED ROOF TRUSSES COLLAPSING INTO THE BUILDING AND RIPPING OFF THE TOP MASONRY ROW.

IN SOME LOCATIONS THE ANCHOR BOLTS TO THE MASONRY WALLS ARE NOT SECURING THE DOUBLE TOP PLATE. PER CODE THE ANCHOR BOLTS MUST BE SECURED 15" INTO THE MASONRY BLOCK.

ROOF SHEATHING IN RIGHT SIDE AREA NEEDS TO BE REPAIRED, THE SHEATHING MAY NOT BE SAFE TO WALK ON.

ADD WASHERS AND NUTS TO STUDS MISSING.

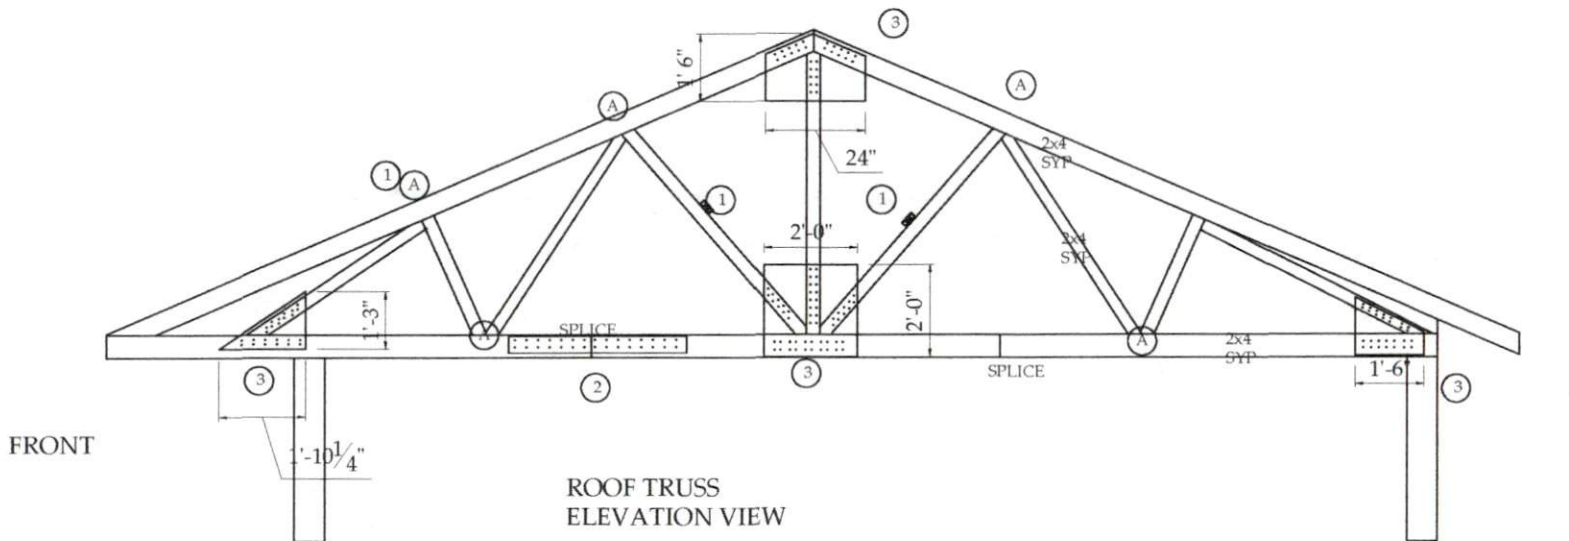
- A. METAL CONNECTOR PLATES ARE STRUCTURALLY ADEQUATE AS INSTALLED.

1. ADD 2x4 BRACING AT MID-SPAN OF THE LABELED WEBS, SECURE WITH 2 - 10d RING SHANK NAILS AT EACH TRUSS
2. SCAB 2x4 - 4' LONG TO BOTH FACES OF THE SPLICES. SECURE WITH 3" LONG RING SHANK NAILS AS SHOWN, 3" O.C.
3. USING  $\frac{5}{8}$ " THICK OSB CUT PER SHOWN DIMENSIONS. APPLY SCAB TO BOTH FACES NAIL WITH 2" LONG RING SHANK NAIL 2" O.C.

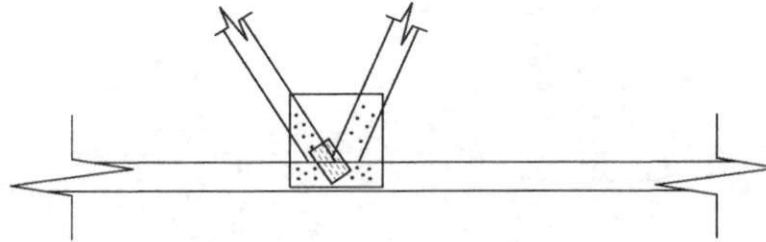
LOOSE METAL CONNECTOR PLATE  
ELEVATION VIEW

IF A CREDIT CARD CAN BE SLIPPED BEHIND A METAL CONNECTOR PLATE, IT HAS LOST 50% OF IT'S STRENGTH.

DO NOT PUT NAILS THROUGH THE METAL CONNECTOR PLATES (AS SHOWN)

NEED TO USE  $\frac{3}{4}$ " THICK OSB, 12" x 12"

USE 2 $\frac{3}{4}$ " LONG - RING SHANK NAILS. 6 NAILS INTO EACH WEB AND 10 NAILS INTO THE CHORD (TOP OR BOTTOM CHORD).
