BUILDING PLAN VIEW

Daniel C. Smith, PE
Consulting Engineers
13237 Melvin Arnold Rd
Raleigh, NC 27613
919-844-6050

PROJECT NUMBER
DCSPE 7473
SITE ADDRESS
975 NC HWY 24 SANFORD N.C.
DATE
2-14-2020
REVISIONS
-
PAGE TITLE:
BLDG PLAN
SCALE:
0/0" = 1'-0"
PAGE NUMBER
S-1

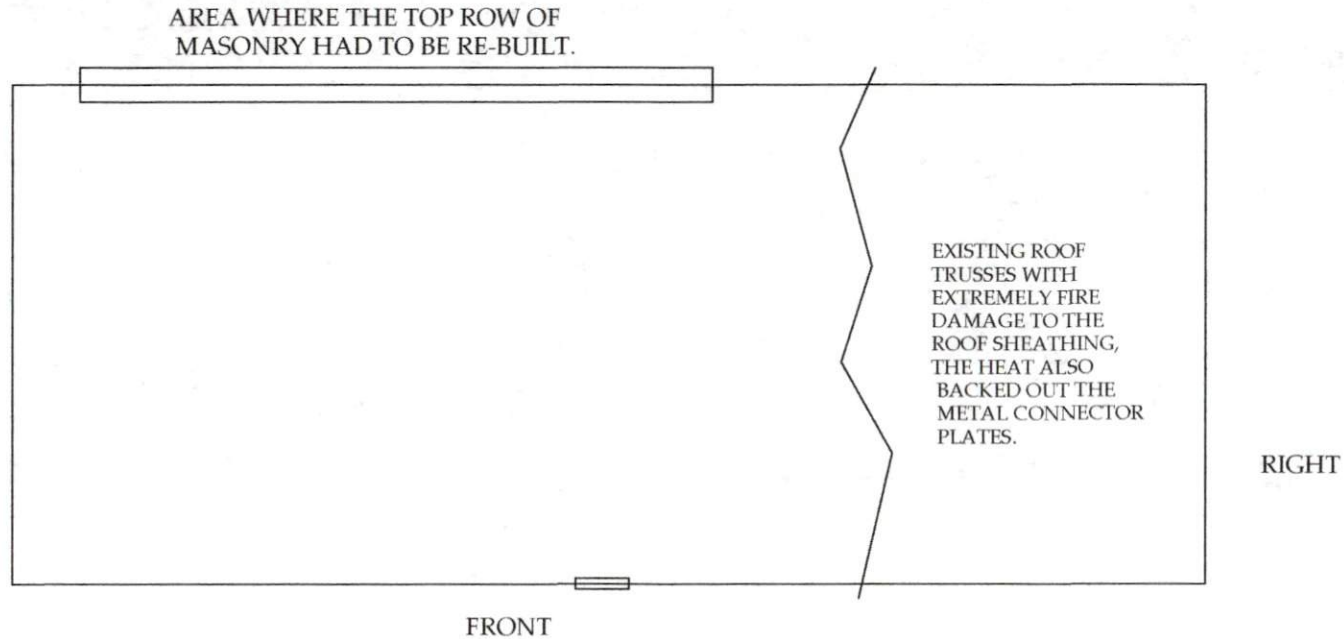
WE ASSUME THAT THE REPAIR TO THE MASONRY TOP ROW WAS FROM THE BURNED ROOF TRUSSES COLLAPSING INTO THE BUILDING AND RIPPING OFF THE TOP MASONRY ROW.

IN SOME LOCATIONS THE ANCHOR BOLTS TO THE MASONRY WALLS ARE NOT SECURING THE DOUBLE TOP PLATE. PER CODE THE ANCHOR BOLTS MUST BE SECURED 15" INTO THE MASONRY BLOCK.

ADD WASHERS AND NUTS TO STUDS MISSING.

ROOF SHEATHING IN RIGHT SIDE AREA NEEDS TO BE REPAIRED, THE SHEATHING MAY NOT BE SAFE TO WALK ON.

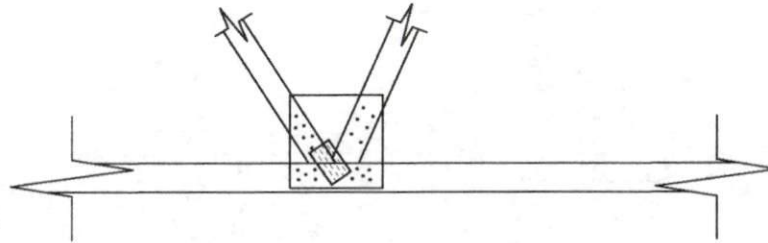
LOOSE METAL CONNECTOR PLATE
ELEVATION VIEW

IF A CREDIT CARD CAN BE SLIPPED BEHIND A METAL CONNECTOR PLATE, IT HAS LOST 50% OF IT'S STRENGTH.

DO NOT PUT NAILS THROUGH THE METAL CONNECTOR PLATES (AS SHOWN)

NEED TO USE $\frac{1}{2}$ " THICK OSB, 12" x 12"

USE 2 $\frac{1}{2}$ " LONG - RING SHANK NAILS. 6 NAILS INTO EACH WEB AND 10 NAILS INTO THE CHORD (TOP OR BOTTOM CHORD).

THIS REPAIR DOES NOT REPLACE THE REPAIRS ON THE OTHER SHEET
