RE: Daily Field Report for 02/17/2021
18446 NC 27 West (CMT) Cameron, NC
Building & Earth Project No : RD210063

Field Observations Report

Project Name: 18446 NC 27 West (CMT) Cameron, NC	Project Number: RD210063
Client Name: Clayton Homes	Placement#: FO-1
Contractor: Clayton Homes	Technician: Frank Hamlin
Monitoring: DCP

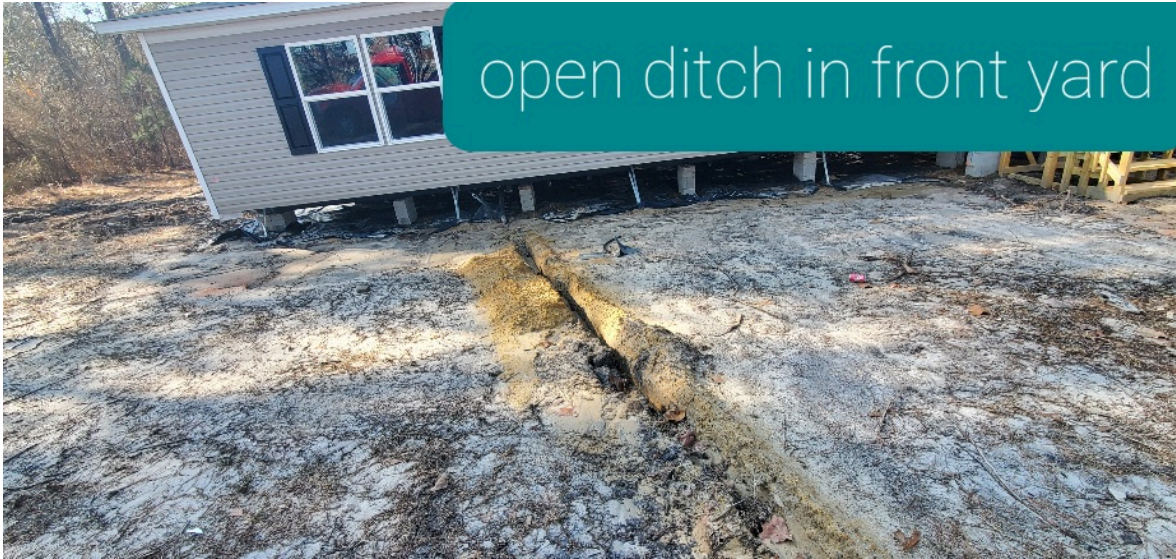
Picture ID	Open ditch in front yard
26452

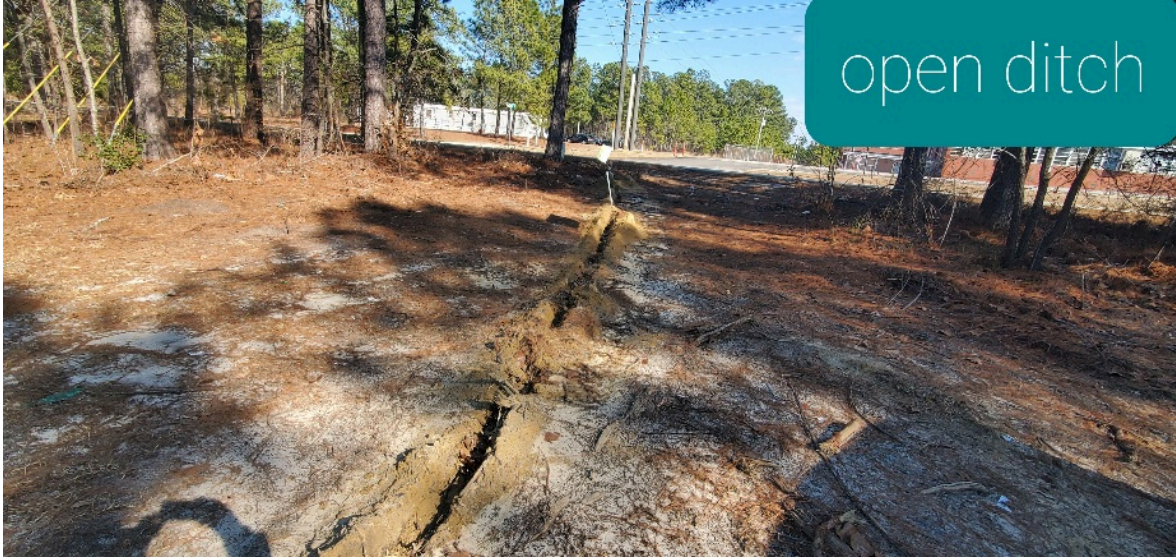
Picture ID	Open ditch front yard 2
26453

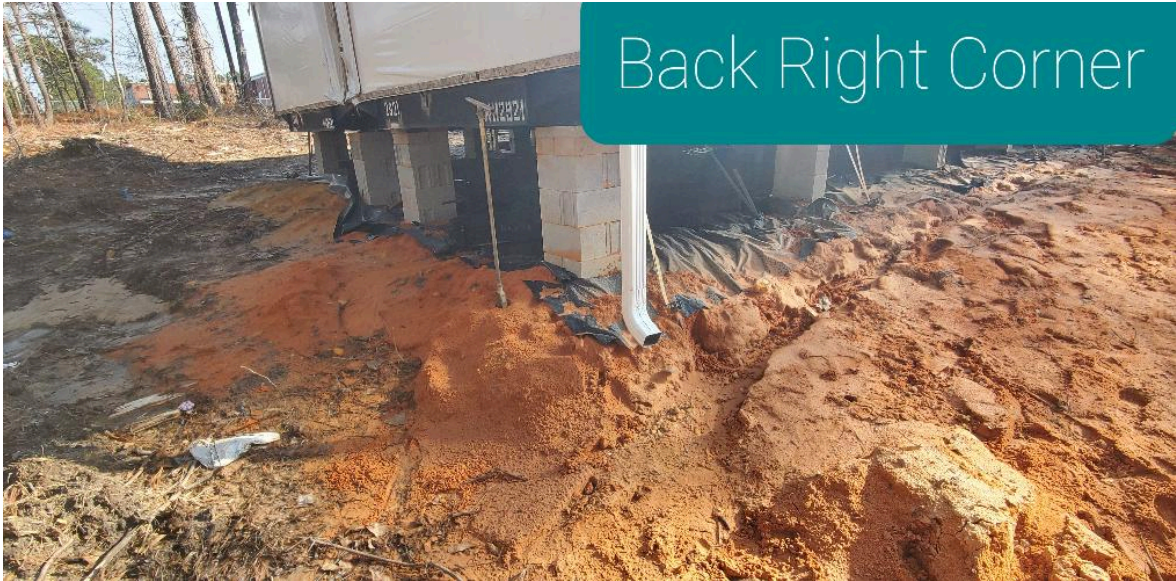
Test 3: Back Right Corner 1' from pier

```
-- Depth----"N"-----Soil Color---USCS-----Notes:
-- FSG --- 1 ----- Brown ----- SC ----- Moist
-- -1' ---- 1.5 ---- Brown ----- SC ----- wet
-- -2' ---- 2 --- Blackish tan ---- SC ----- Wet
-- -3' ----- 9 --- Blackish tan ---- SC ----- Wet
```

Based on our observations and test results, the required bearing capacity of 2,000 psf is available at Test Location #1 and #2 on this date. However, bearing capacity of 2,000 psf is not available at Test Location #3 to a depth of -2' (Back Right Corner) as we encountered loose/wet soils. See attached photos.

Picture ID	Back Right DCP
26454

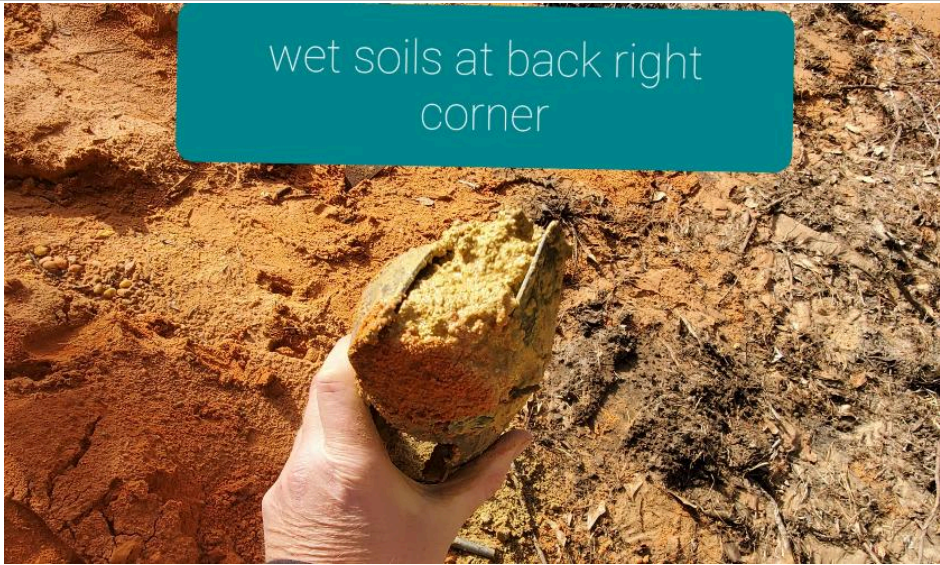
Picture ID	Caption
26449	<p>Wet soils from back right</p>

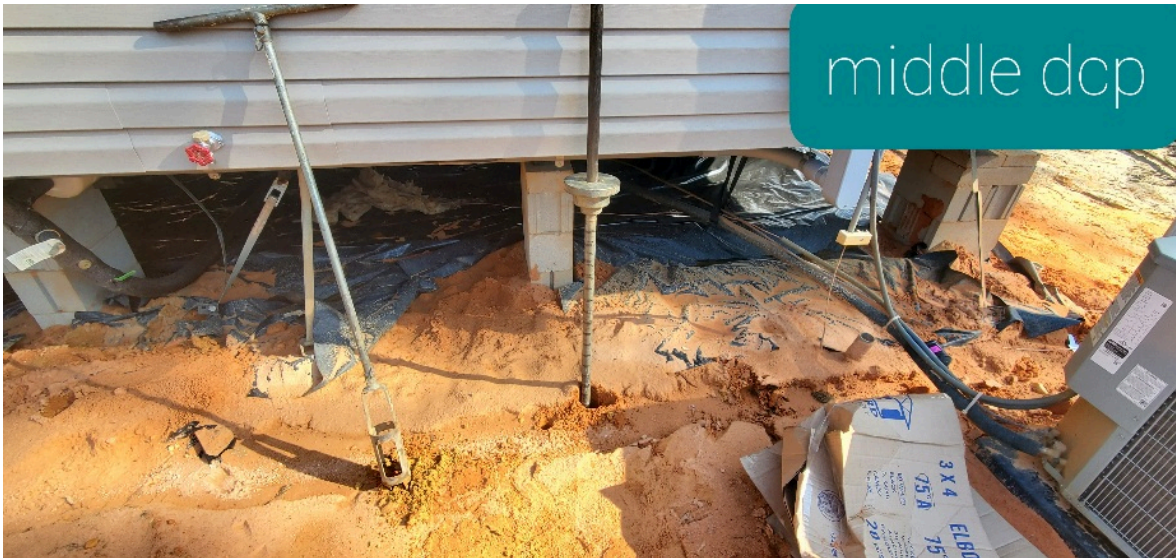
Test 2: Back Middle 2' from pier

```
-- Depth----"N"-----Soil Color-----USCS-----Notes:
-- FSG --- 11 ----- Brown ----- SC ----- Moist
-- -1' ---- 15+ ---- Brown ----- SC ----- Moist
-- -2' ---- 15+ --- Blackish tan --- SC ----- Moist
-- -3' ---- 15+ --- Blackish tan --- SC ----- Moist
```

26451	<p>Middle DCP</p>
