Subject: **Structural Inspection
387 Gainsborough Lane
Cameron, North Carolina
NSE Project #2100625**

On September 4, 2021, Neal Smith Engineering, Inc. (NSE) performed a structural inspection at the above subject location. The purpose of the inspection was to evaluate the existing construction of a deck.

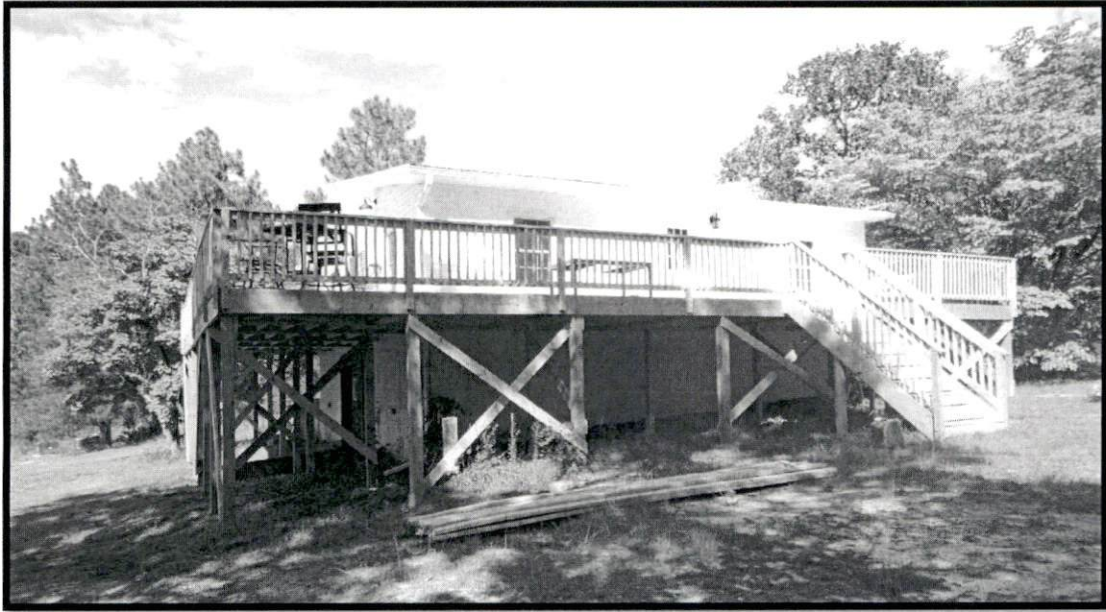
Photo #1 - This is an overall photo of the deck.

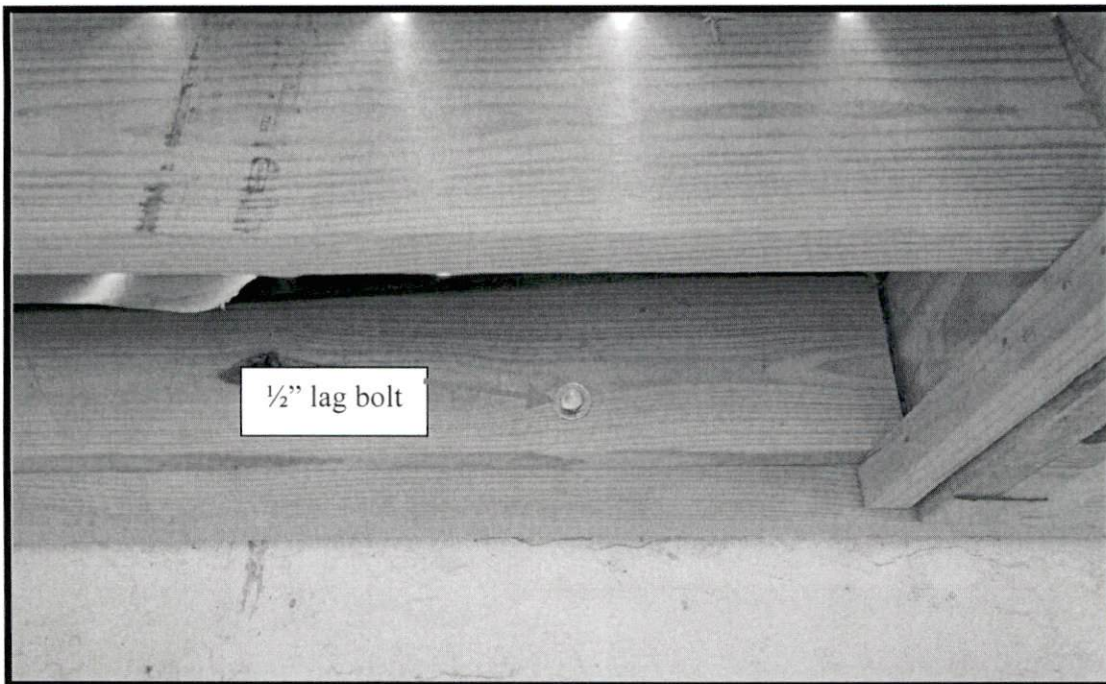
Photo #2 – A double 2X joist was lag bolted into the existing house band board. The bolts averaged 4'-6" on center.

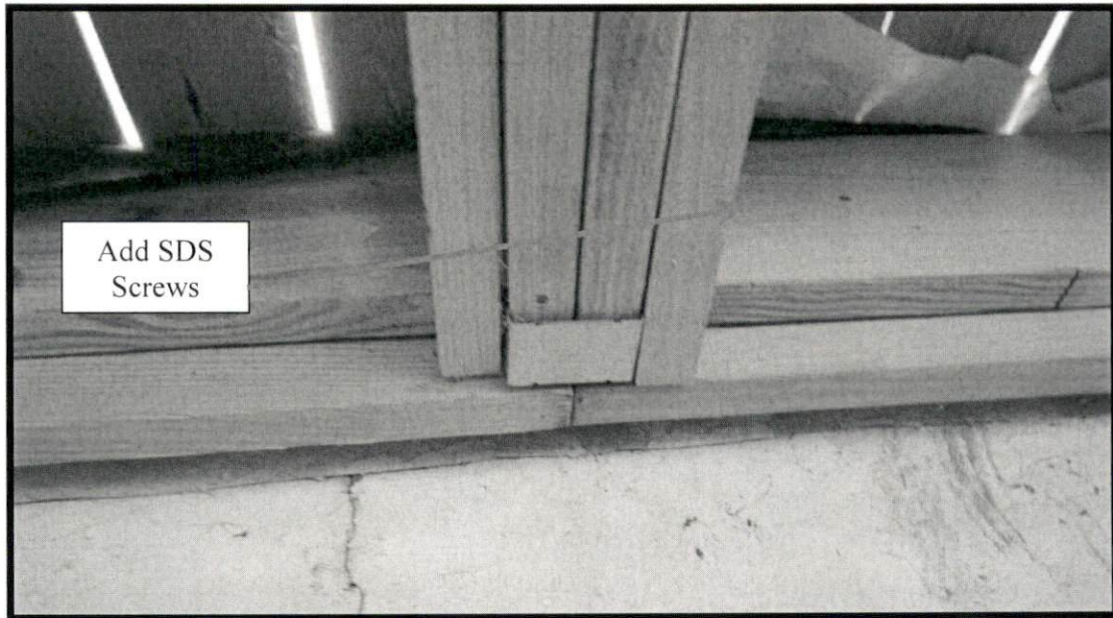
Photo #3 – The girders framed into the 2X band with a Simpson LU210-2 clip.

The lag bolts at the girder connection are inadequate. Add (3) ¼ x 6” Simpson SDS screws on each side of the girder. Another option is to provide (1) 5/8” galvanized through bolt on each side at each girder location. The end girders will only have ½ the screws or bolts, they also only have ½ the load.
