Cody Johnston, PE
 Stonewall Structural Engineering, PLLC
 4800 Falls of Neuse Rd. #120
 Raleigh, NC 27609
 (919)407-8663

Re: Structural Observation — 1434 Main Street, Lillington, NC 27546

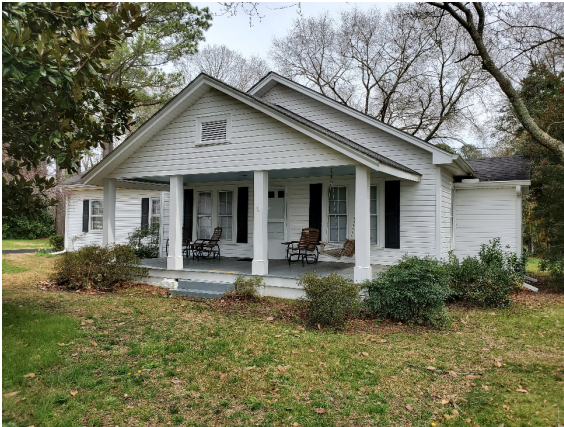
*Picture 1 – 1434 Main Street,
Lillington, NC*

At your request, on March 18, 2021 we performed a visual structural observation of structural concerns identified by *Pillar to Post Home Inspections* in their report dated 1/12/2021 for the Lillington residence noted above. The structure is a conventionally framed, detached, single family residence with raised first floor framing over a pier/curtain wall foundation system (*see picture 1*).

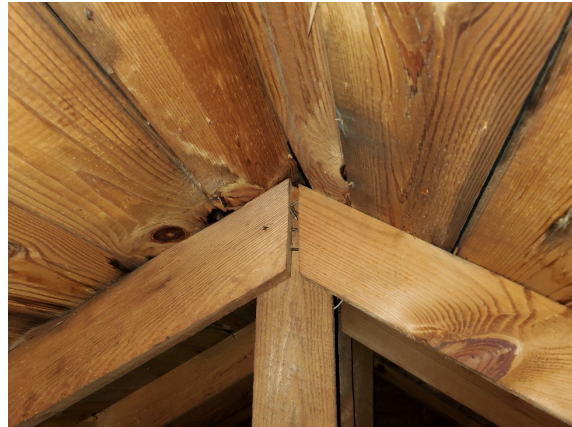
- The original roof structure was constructed with site-built roof trusses. The trusses are sagging but are functioning as intended. Gaps were noted between various top chords at the ridge of the original portion of the home (*see pictures 2 for example*). Additionally, diagonal members were removed from right span of the 2nd-4th trusses from the back gable, and from the left span of the backmost truss (*see picture 3 for example*).

Picture 2 – Gaps between top chords

- Reinforce the upper ends of members where there is a gap between chords at the ridge by installing 3/4” thick OSB gusset plates sandwiched on both sides of the opposing members. The gusset plates should be shaped to the roof pitch at the top, should extend along each member for at least 24”, and should be fastened to the covered members using (2)10d common nails at 4” o.c. with staggered nailing from each face to avoid conflict (*see detail 1*).

- Securely reinstall the vertical member after the gusset plates have been installed.
 - Where noted to be missing, install 2x4 diagonal members with (3)10d common nails at each end.

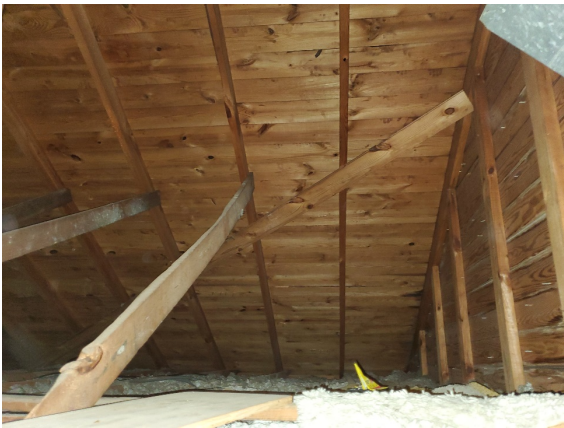
Picture 3 – Missing diagonal

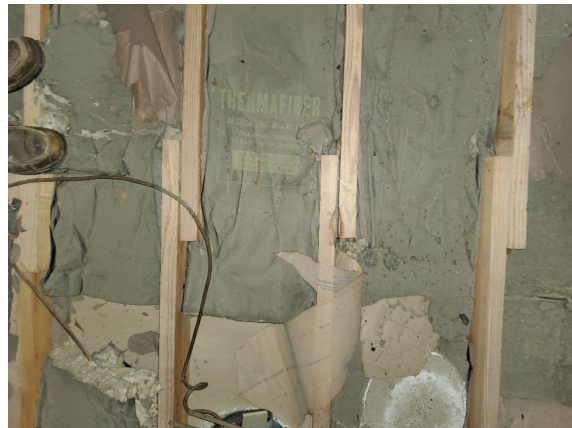
- Ceiling joists were minorly out of plumb over the addition that is the left portion of the structure (*see picture 4 for example*).
 - This is not a matter of significant structural concern. No work is required for this item.

*Picture 4 – Minorly twisted/rotated ceiling
joists*

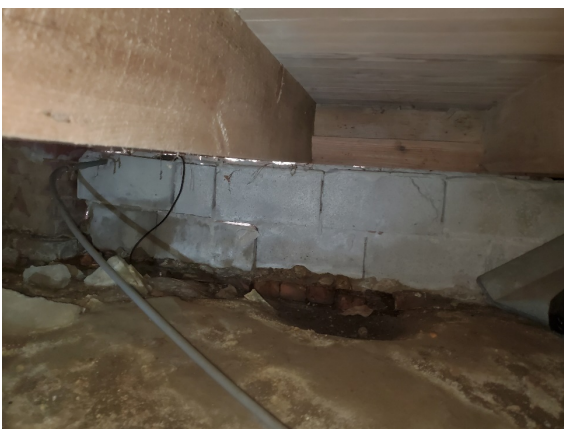
- Masonry cracks were noted in the non-structural curtain wall of the original portion of the home (*see picture 5*).
 - These cracks are in the non-structural portion of the wall. Therefore, they are not a matter of structural concern.

Picture 5 – Example of cracks in curtain wall

- *The cracks may be repointed, or the curtain wall may be removed and replaced at the owner's discretion.*
- The rim beams at the front corners of the original porch were deteriorated.

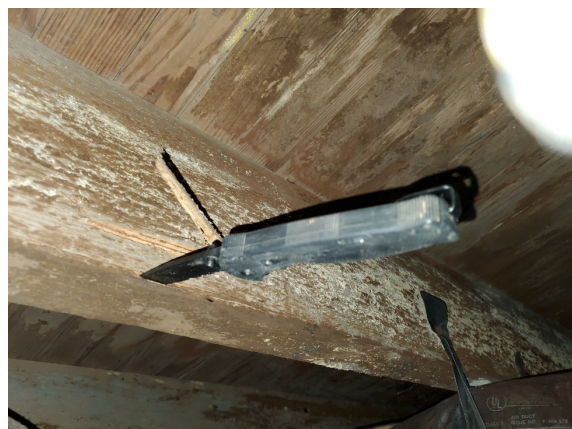
- Probing revealed the floor joists beneath the middle bedroom that is at the right of the original portion of the home were deteriorated beyond allowable limits (*see picture 6 for example*). Also, measurement by laser level indicated they were sagging as much as approximately 1" at mid-span.

Picture 6 – Example of deteriorated joist

- *Reinforce each of the deteriorated joists noted above with an additional full depth ply of 2x #2 Southern Yellow Pine (SYP), fastened to the side of the deteriorated joists using (3)10d common nails at each end and at 12" on center staggered top and bottom along the lengths of the joists. Sistered material should span continuously between end supports.*

- *Add dropped girder beneath the middle of this joist span using a built-up (3)2x8 #2 SYP beam. The new girder should span from the chimney to the back wall of the middle bedroom and should be supported by 8"x16" hollow CMU piers with solid 4" caps spaced approximately 6' on center over 24"x24"x10" thick poured concrete footings set at least 12" into suitable bearing soils. The girder ends may cantilever up to 2' over the end piers.*

- *Install tight fit, full depth 2x blocking or 1x cross-bridging between joists over the dropped girder to prevent rotation of joists over the new bearing line.*

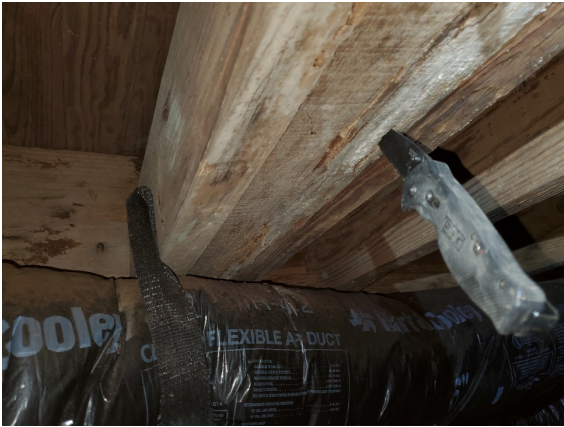
- Probing revealed the back two spans of the beam that is between the original home and the addition was deteriorated beyond allowable limits (*see picture 7 for example*).

Picture 7 – Example of deteriorated beam

- *Remove and replace the above-noted significantly deteriorated portions of the girders using full depth (4)2x #2 SYP material with continuous span between existing masonry girder support piers.*

- *New 8"x16 CMU piers per the specifications noted above may be utilized at the beam mid-spans to facilitate this repair.*
- The presence of HVAC prevented adequate cross ventilation and prevented observation of the rim beam at the HVAC opening. Fungal activity was noted throughout both crawlspaces (*see picture 8*).

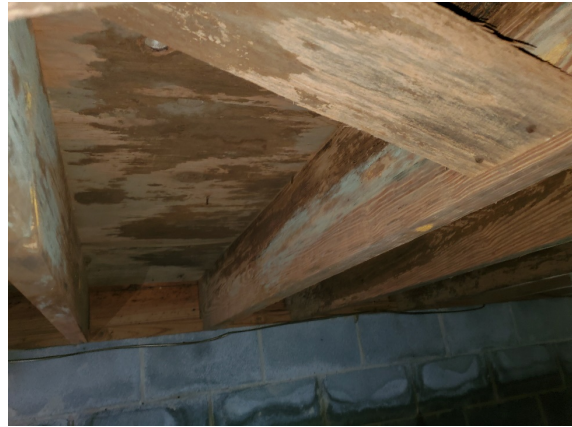
Picture 8 – Example of fungal activity

- *HVAC ducts should be temporarily removed to allow for the direct observation of the framing.*
 - *We recommend consulting with a qualified fungal remediation specialist to test and treat the above-noted growth as deemed necessary.*

- *The crawlspace should be mechanically ventilated or a Code-approved closed crawlspace system with adequate vapor barrier and mechanical drying measures may be installed.*

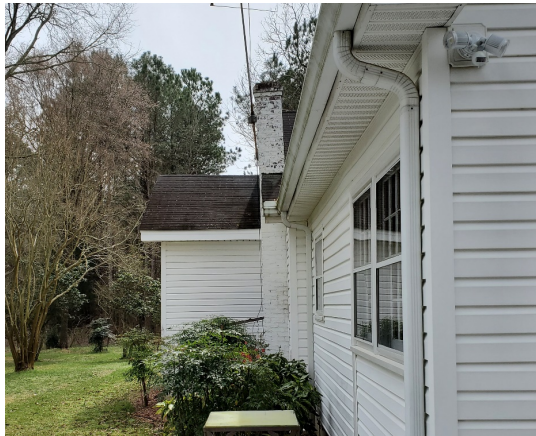
- The chimney at the back of the kitchen was visibly leaning over its height (*see picture 9*).
 - *The chimney should be monitored for signs of further movement. If significant movement persists, it should be deconstructed.*

Picture 9 – Chimney visibly leaning

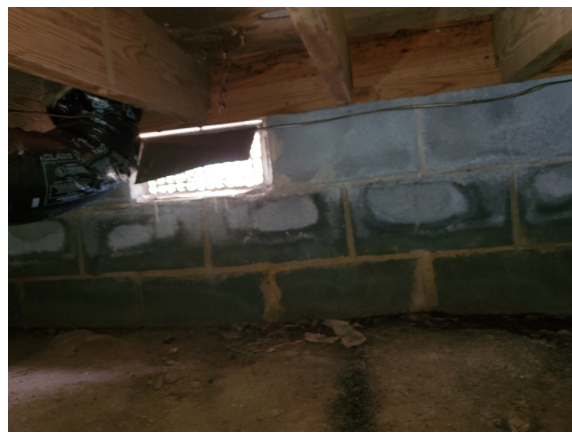
- No pilasters or rim beams were installed on the curtain wall of the left portion of the home (*see picture 10 for example*).
 - *No significant signs of distress were noted due to this construction error. To reinforce the foundation, dropped girders may be installed along the entire length of the front and back curtain walls to support the joist ends within 1'-6" of the curtain walls.*

Picture 10 – Example of curtain wall without pilasters

- *Girders should be installed per the specifications at the beginning of this report.*
- The pilasters at the front porch of the original home were out of contact with the rim (*see picture 11*).

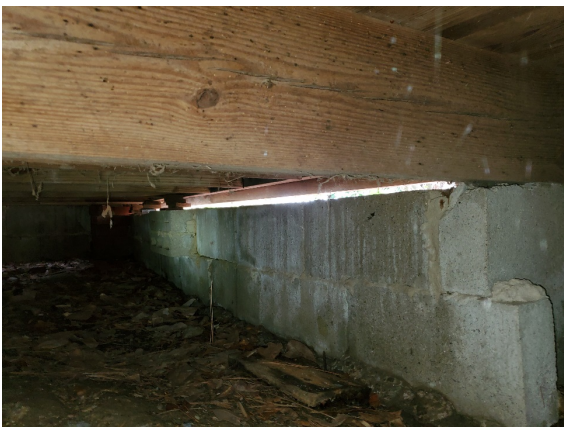
Picture 11 – Rim out of contact with pilasters and curtain wall

- *Install pilasters at 4'-0" o.c. on the left and right walls of the porch. The new pilasters should be 8"x16" solid CMU pilasters that are mortared and anchored to the inside face of the curtain wall using (2) grouted stainless steel brick ties at each pilaster course.*

- *The curtain wall may be removed and replaced at the owner's discretion.*
- The pilaster at the front of the HVAC opening that is at the right of the home was undermined (*see picture 12*).

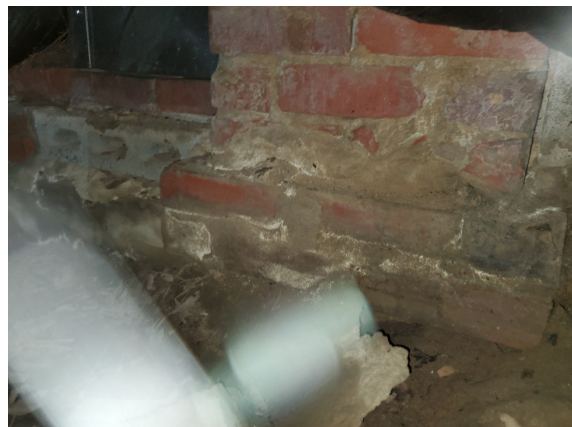
Picture 12 – Undermined pilaster at HVAC

- *This pilaster should be removed and replaced with an 8"x16" CMU pilaster per the specifications above.*
- The pilaster at the front-left corner of the original crawlspace was undermined (*see picture 13*).

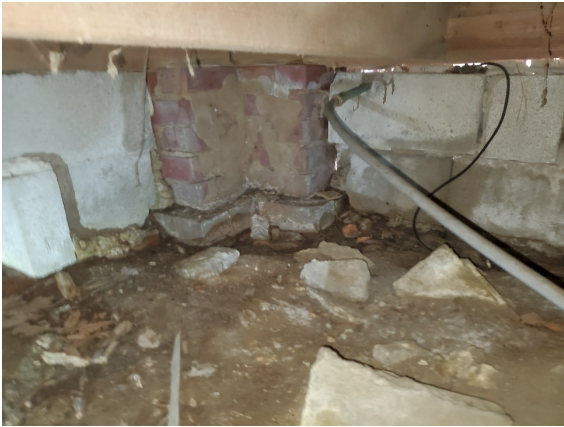
Picture 13 – Undermined pilaster

- *This pilaster should be removed and replaced with an 8"x16" CMU pilaster per the specifications above.*
- The middle pier on the girder beneath the original home was failed (*see picture 14*).

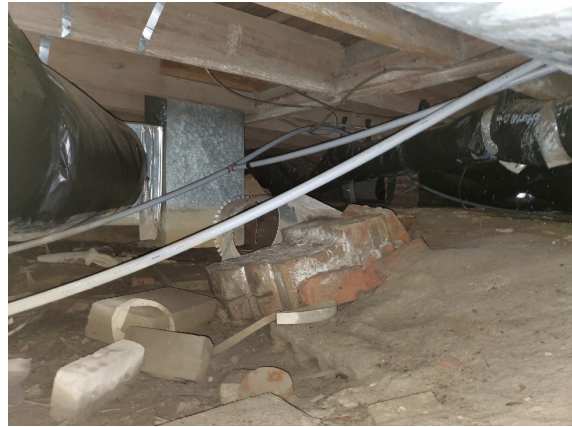
Picture 14 – Failed pier

- *At the splice in the girder, install a new 8"x16" hollow CMU pier with solid 8" cap, centered over a 24"x24"x10" thick poured concrete footing set at least 12" into suitable bearing soils. The contractor should take care that the soils at the base of the footing are not undermined by the excavation that is to the right of this location.*

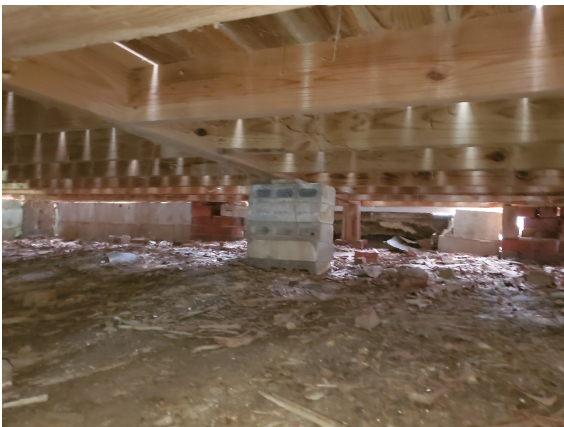
- The pier beneath the front porch was dry-stacked (*see picture 15*).
 - *Remove and replace this pier per the specifications above.*
- Ledger strips throughout the original portion of the home were under-fastened and had slipped (*see picture 16*).

Picture 15 – Dry-stacked pier

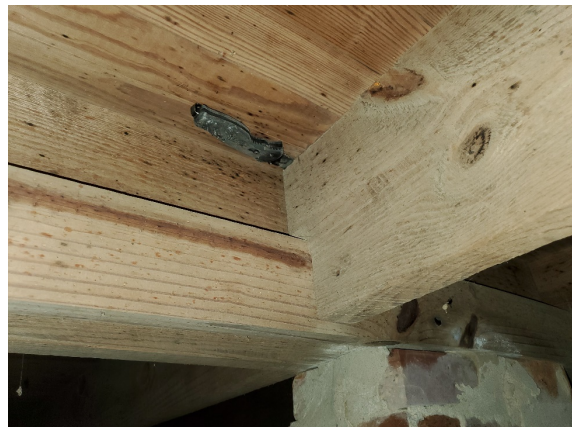
Picture 16 – Example of sagging ledger strip

- *Raise joists to flush with the underside of the floor sheathing where they have currently dropped over inadequate ledger strips at the faces of girders. Refasten ledger strips with (4)10d common nails per joist or remove the failed ledger strips and fasten joists directly to the sides of the girders using Simpson face hangers.*

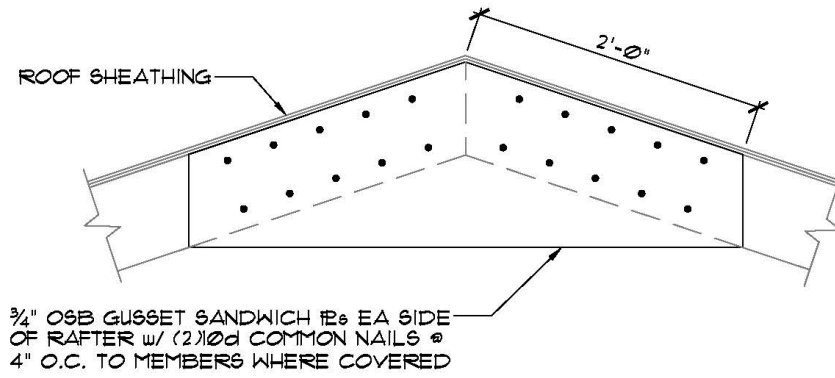
Detail 1 – Repair for gap at ridge
