# Engineer report for wall removal 1 floor

Subject: 275 Lakeland Port  
Carolina Lakes  
Sanford, NC 27335

I visited the construction site at the above address to do an engineering analysis for removing a wall and sizing a header beam.

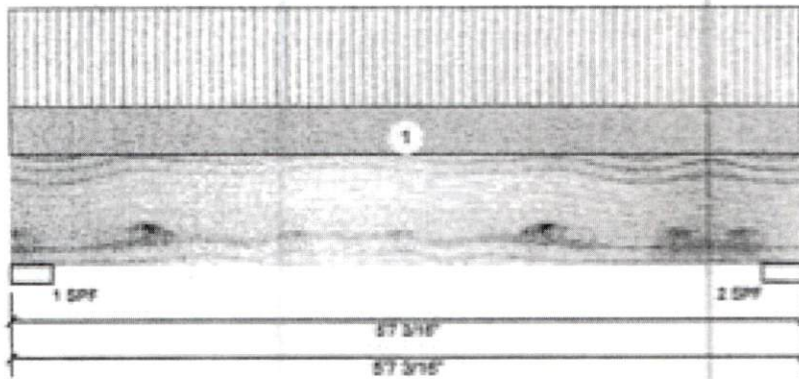
**B1 D FIR-L #1 2.000" X 10.000" 2-Ply - PASSED**

Analysis	Actual	Location	Allowed	Capacity	Comb.	Case
Moment	991 ft-lb	2'9 5/8"	3622 ft-lb	0.253 (25%)	D=L	L
Unbraced	991 ft-lb	2'9 5/8"	3891 ft-lb	0.256 (25%)	D=L	L
Shear	621 lb	1' 3/4"	3330 lb	0.186 (18%)	D=L	L
LL Defl inch	0.009 (L/6602)	2'9 5/8"	0.171 (L/360)	0.055 (5%)	L	L
TL Defl inch	0.014 (L/4402)	2'9 5/8"	0.243 (L/180)	0.041 (4%)	D=L	L

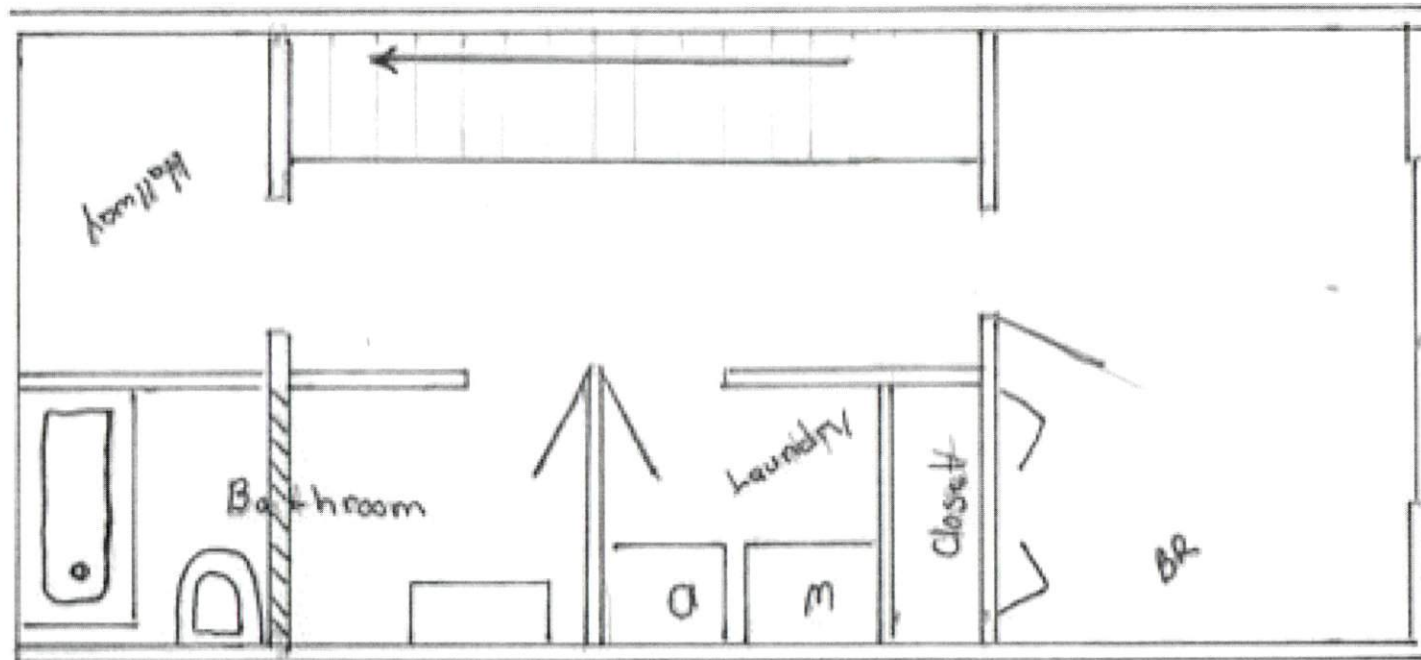
1st Floor plan to convert family room into a bedroom with bathroom and laundry

Wall removed and header put in  
See engineer report

A two-ply 2x10 beam with a 3/8" plywood member between and 5'-7 3/4" long will support the imposed loads. The beam should have double 2x4 columns on each end.
