Licensed Structural
Engineers

Document Number: LSE-2022-1093-STR-RPT-01-02

Executive Summary and Background

This letter summarizes the results of the visual inspection of a manufactured home located at 82 Old Salem Dr, Spring Lake, NC 28390 USA inspected on February 22nd, 2022. The owner hired LSE for an overall inspection.

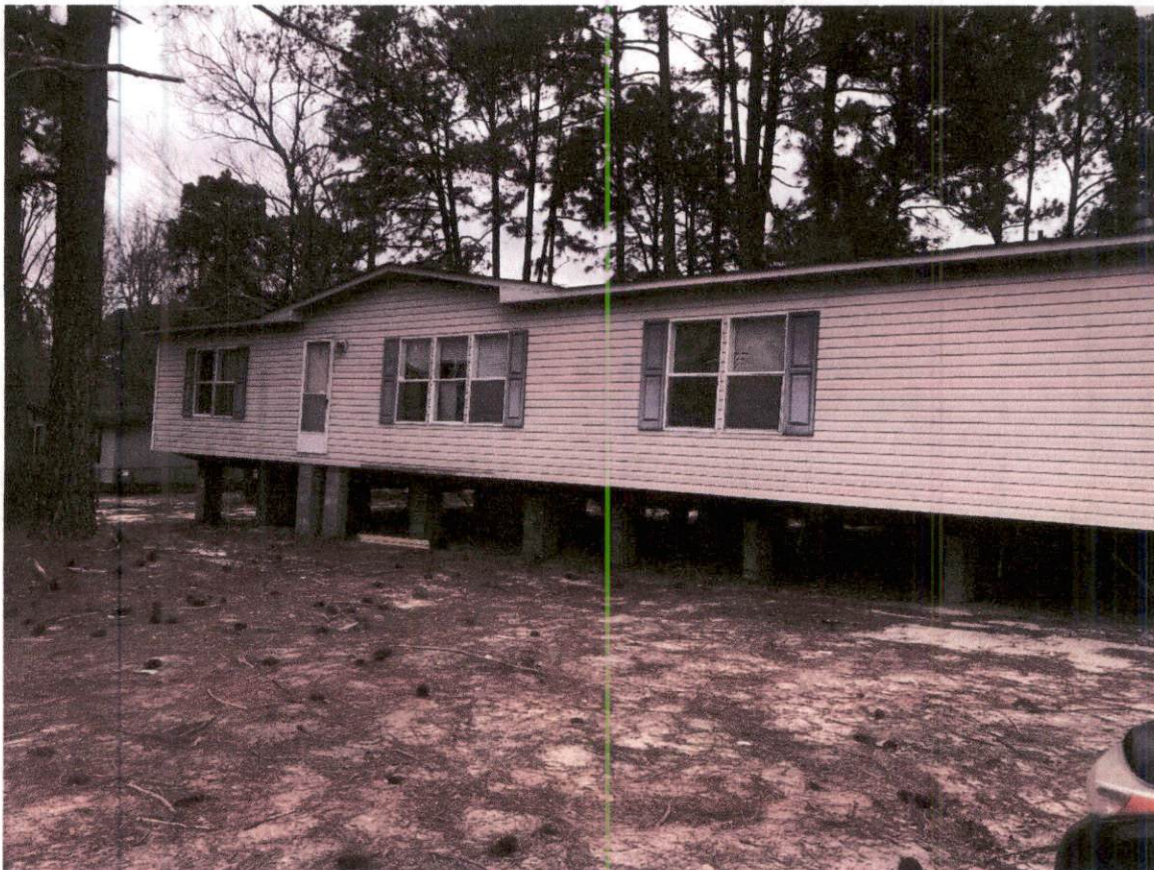
Figure 1. Main entrance of the house facing South (towards Old Dutch Rd)
