Cody Johnston, PE
Stonewall Structural Engineering, PLLC
4800 Falls of Neuse Rd. #120
Raleigh, NC 27609
(919)407-8663

Re: Structural Observation — 2604 Holly Springs Church Road, Broadway, NC 27505

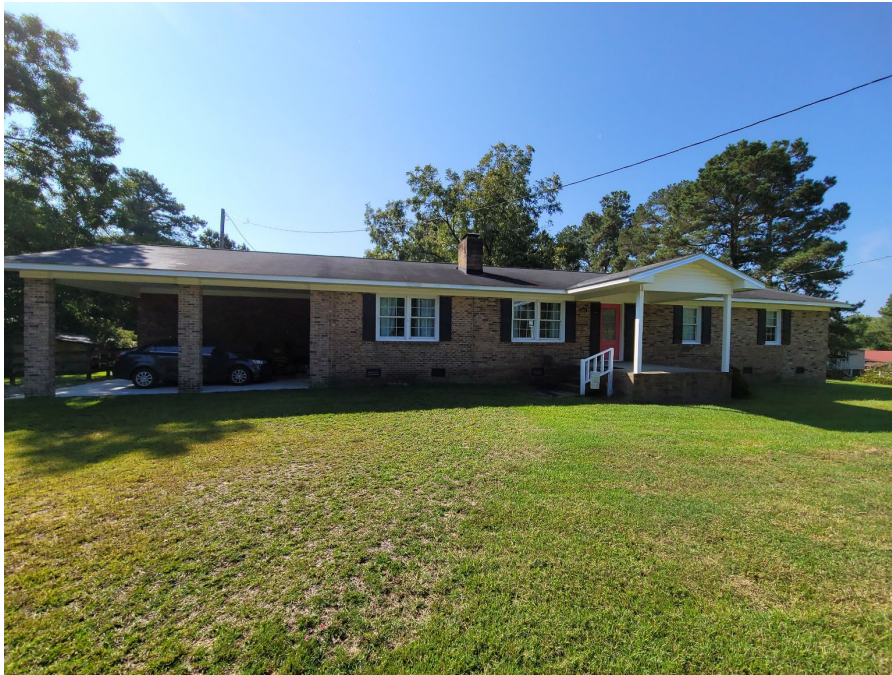
At your request, on September 19, 2022 we performed a visual structural observation of back addition at the Broadway residence noted above. The structure is a conventionally framed, detached, single family residence with raised first floor framing over a pier/girder foundation system with perimeter masonry foundation walls (*see picture 1*).

*Picture 1 – 2604 Holly Springs Church Road
Broadway, NC*

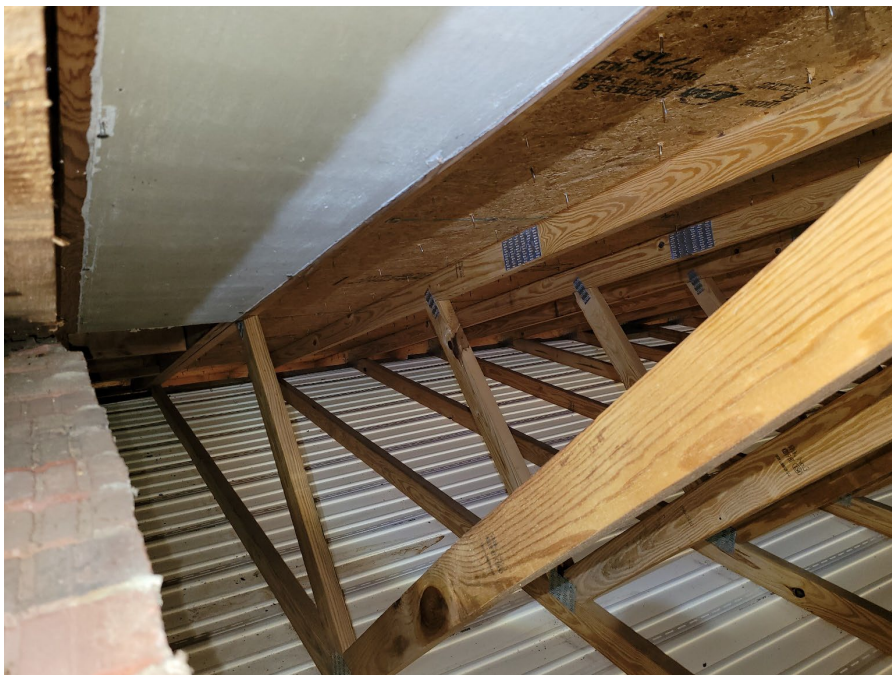
- The roof system of the back addition and carport was constructed with manufactured roof trusses with a profile matching that of the original home with 2' o.c. spacing (*see picture 2 for example*).

Picture 2 – Example of roof trusses over the addition and carport

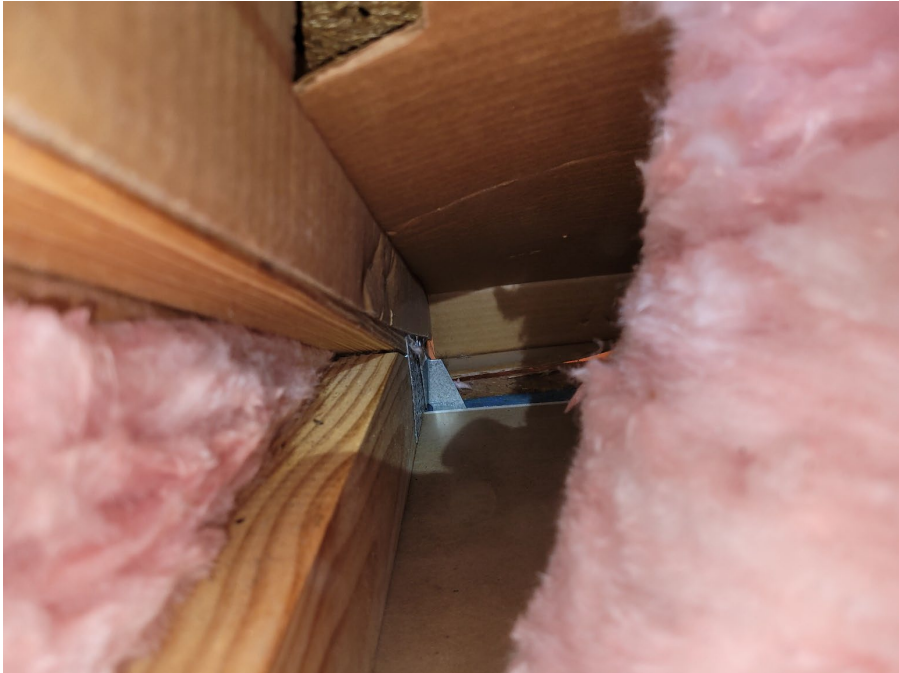
- The front and back ends of the trusses were noted to be fastened using “H2.5A” hurricane ties (*see picture 3 for example*).
 - *No medication is required for this item.*

Picture 3 –Example of “H2.5A” hurricane tie

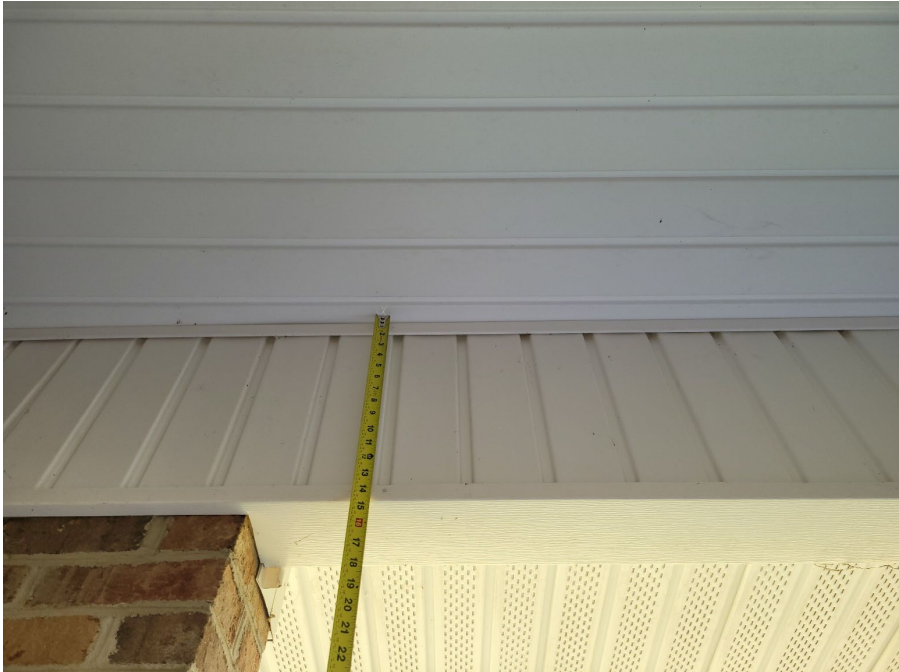
- The front ends of the trusses were supported by dropped beams. The sizes / material of the beams could not be determined due to the presence of finishes (*see picture 4 for example*).

Picture 4 – Example of dropped beam supporting the front ends of the roof trusses

- *Verify/provide that the front of the new roof trusses are supported by at least built-up (2)1¾”x11⅞” LVL (Boise Cascade VersaLam 3100 or equivalent) with continuous span between end supports.*

- *Verify/provide at least 4”x4” #2 SYP posts to support each of the ends of the beams.*
 - *The middle post should be centered over and conventionally fastened to a 26”x26”x10” thick poured concrete footing that is set at least 12” into suitable bearing soils.*

- *The left and right posts should be centered over and conventionally fastened to an 18”x18”x10” thick poured concrete footing that is set at least 12” into suitable bearing soils.*

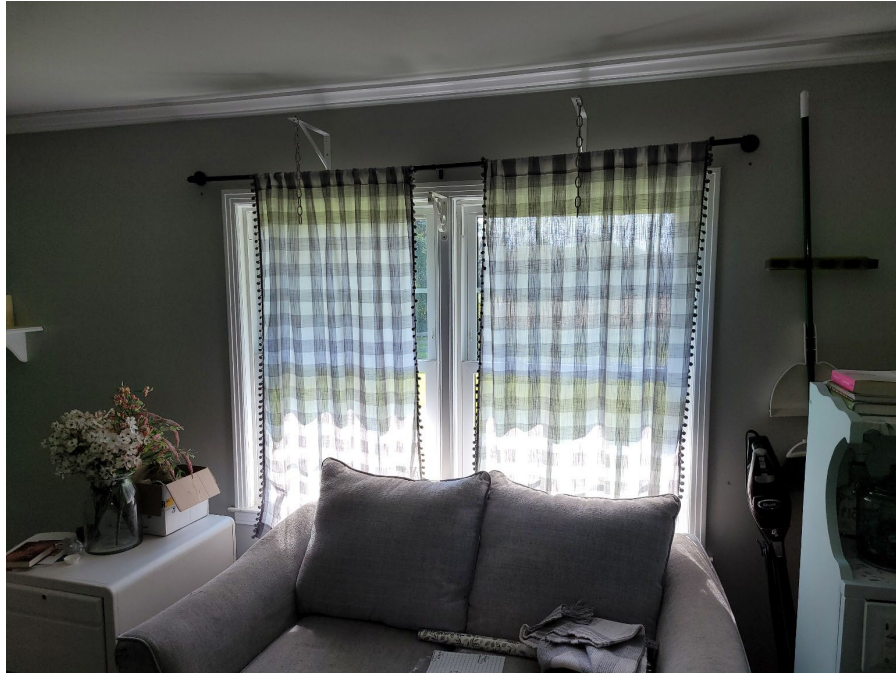
- The wall framing and the headers over the window opening could not be observed due to the presence of finishes (*see picture 5 for example*).
 - *Verify/provide a (2)2x10 #2 Southern Yellow pine (SYP) header over the window in the back wall of the addition.*

Picture 5 – Example of window opening

- *The header should be supported at each end using (1)2x4 #2 Spruce-Pine-Fir (SPF) jack and (1)2x4 king stud.*
- The first floor was conventionally framed with 2x10 joists at 16" o.c. spacing spanning approximately 11' from the front to back foundation walls.

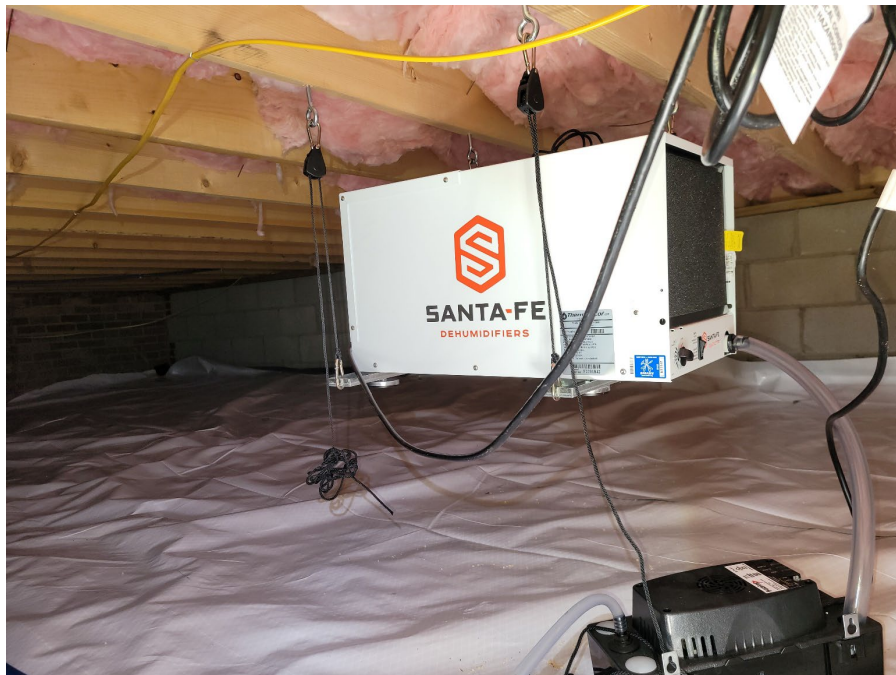
- *No modification is required for this item.*
- Crawlspace soils were covered by a ground vapor barrier, perimeter vents were sealed, and a dehumidifier had been installed in the crawlspace

Picture 6 – Example of dehumidifier

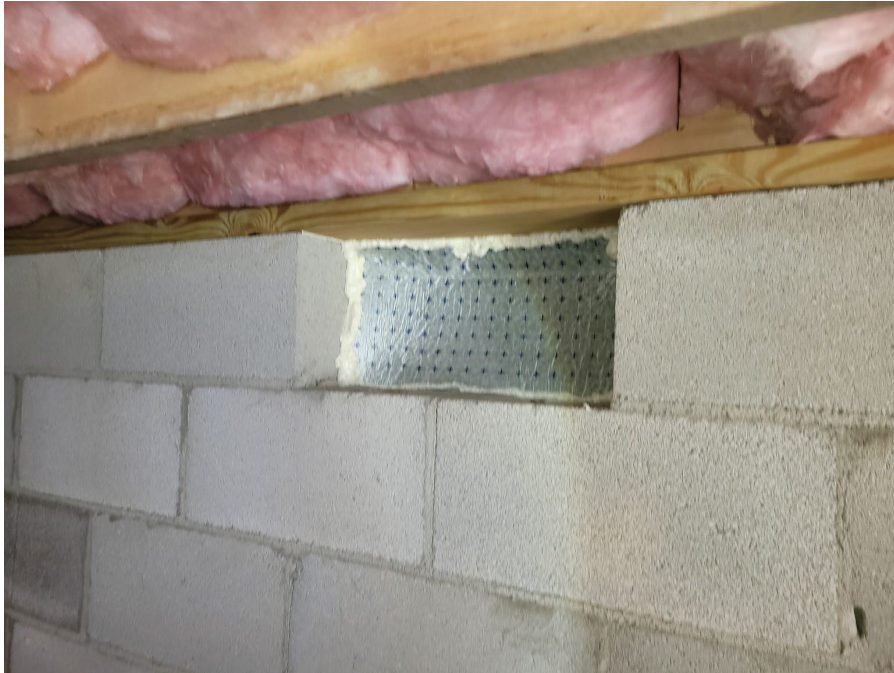
Picture 7 – Example of sealed crawlspace vents
