Reference: Engineering Services 204 Harris Lane Bunnlevel, NC 28323 TE&D Project No.: 2201-020983

1) Structural assessment of existing metal building.

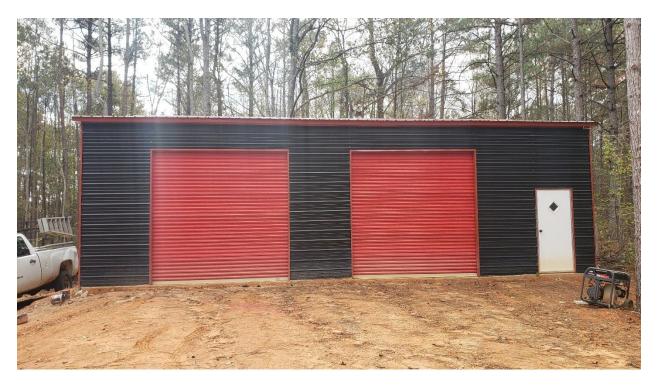
1) We observed the structure consisted of a pre-fabricated metal building measuring approximately 40'-0" x 30'-0". The pre-fabricated metal building was supported by metal stud walls and metal roof trusses at 5'-0" o.c.

Building Assessed

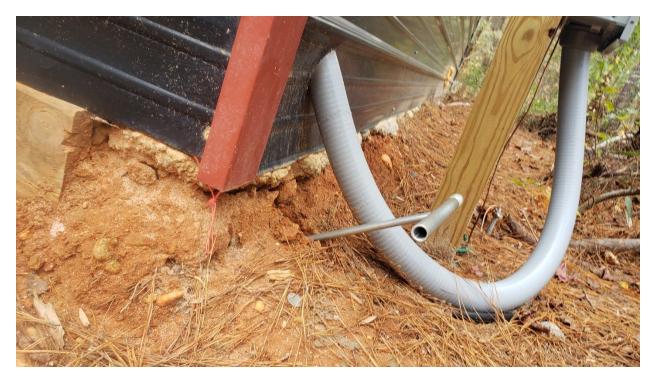
The pre-fabricated metal building was further supported by a 6" slab at existing grade. We did not observe a continuous concrete footing; however, we did observe an approximately 8" deep concrete footing at the rear left corner of the structure. The building was fastened to the slab with 3/8" expansion anchor bolts at the front and rear exterior walls; however, it was observed that several anchor bolts were missing nuts and washers. At the left and right exterior walls, anchor bolts were not installed; however, the pre-drilled holes were filled with #4 rebar where applicable.

Example of missing/inadequate footings

- a. Per 2018 North Carolina Residential Building Code Section R101.2.1, accessory buildings are to be supported by a concrete foundation if the accessory building exceeds 400ft². TE&D recommends installing new 12" wide concrete footings so that the depth meets the minimum 12" frost depth as laid out in R403.1.4 and Table R301.2(1) in the 2018 NC Residential Building Code. The reader is referred to the detail on page 4 of this report for footing installment.

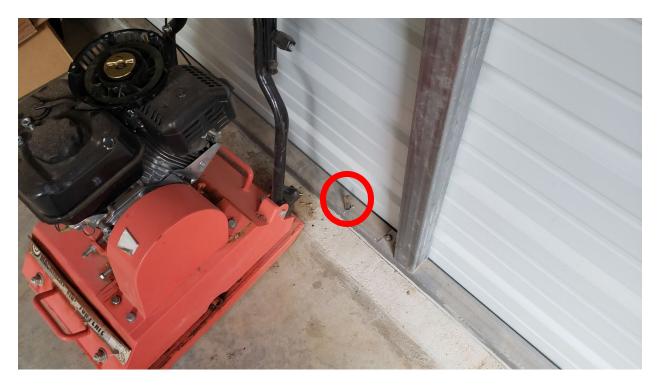
Example of inadequate anchoring configuration/rebar used

- b. The existing anchoring configuration is inadequate to support the anticipated loading conditions. Based on our observations and analysis, the exterior wall framing is to be fastened to the foundation with 1/2" x 8" Simpson Titen HD concrete screws (or equivalent). Screws are to be installed at the center of the sill plates, with a maximum spacing of 6'-0" o.c. and within 12" of plate splices. Due to the proximity of the slab edges, expansion anchor bolts may not be used.

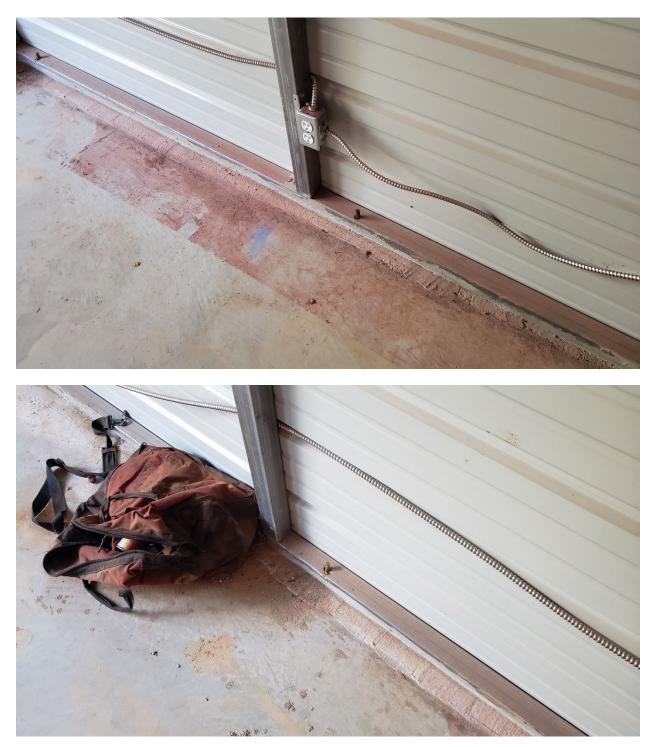
Additional examples of inadequate anchoring configuration/rebar used

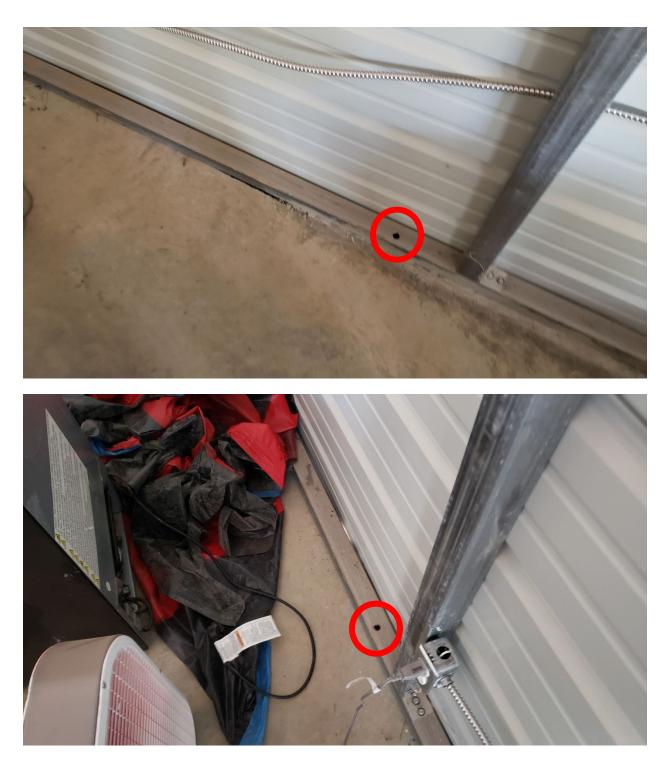
Examples of inadequate anchoring configuration/missing anchors

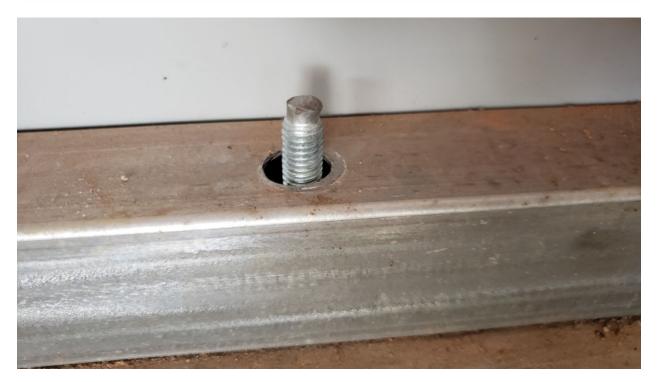
Examples of inadequate anchoring configuration/missing nuts and washers
