Document Number: LSE-2022-982-STR-RPT-01-01

January 31, 2022

This letter summarizes the results of my visual inspection of the house located at 54 Brent Wood Ct, Sanford, NC 27332 USA performed on January 24, 2022. The client requested us to inspect the house after a fire incident. According to the client, the main purpose of this inspection is to evaluate conditions of the roof trusses.

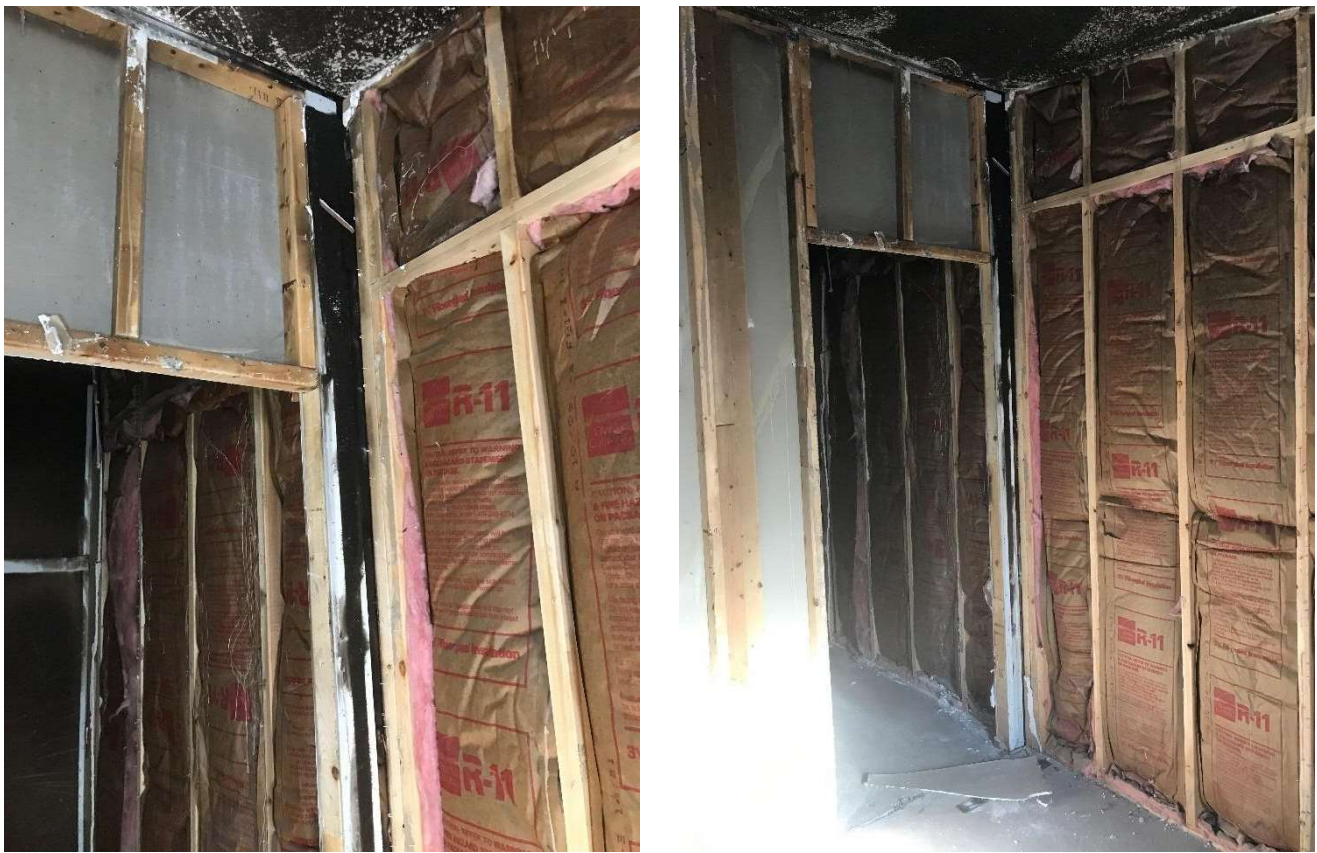
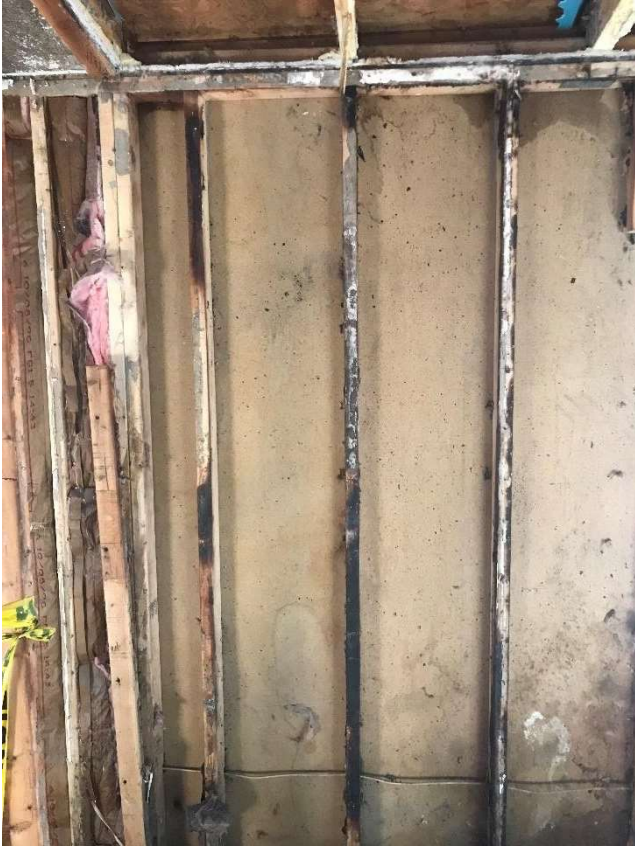
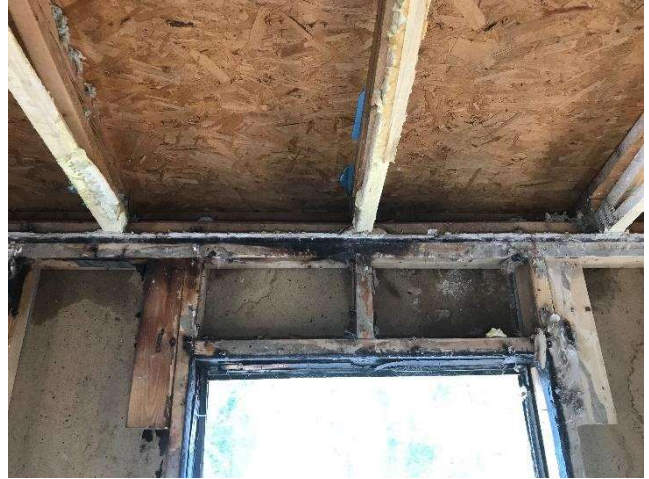
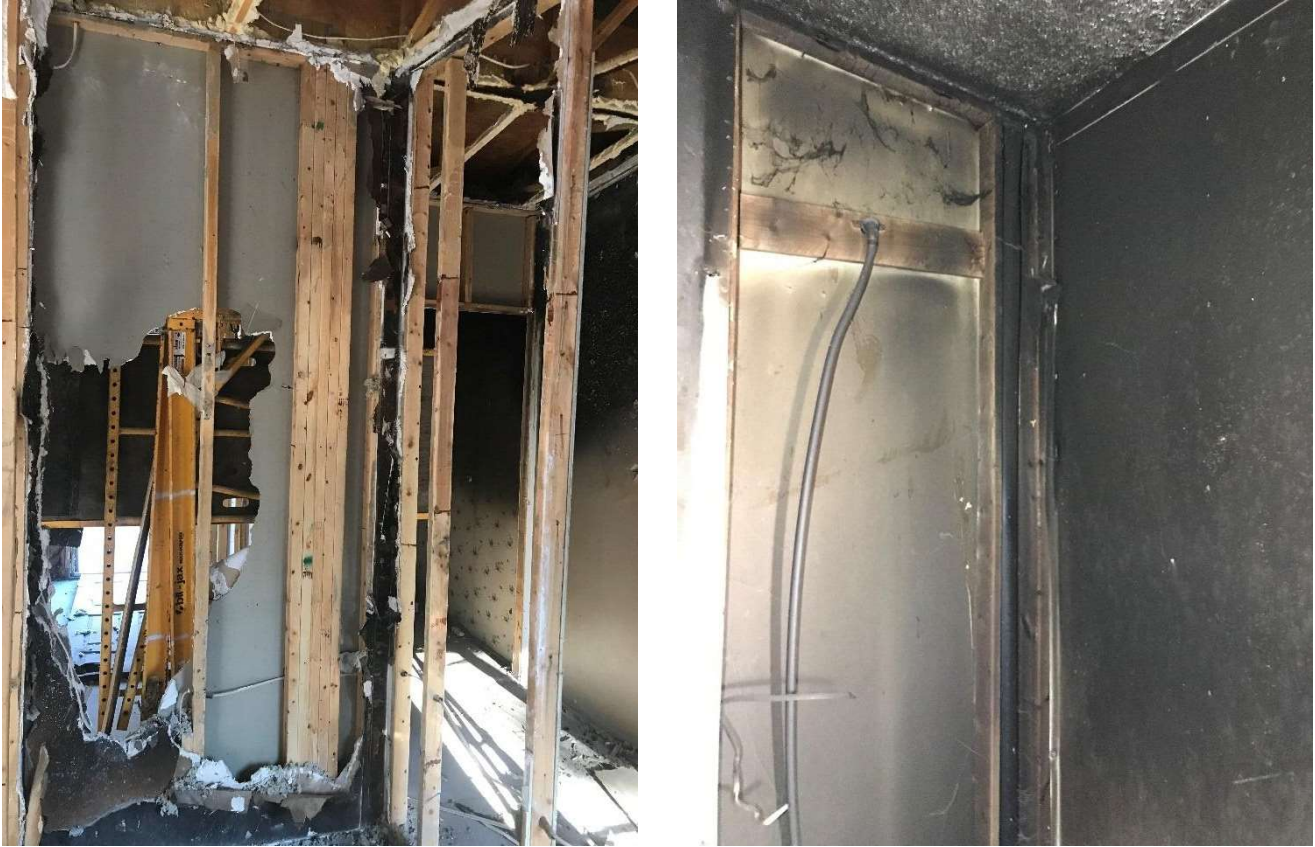
However, there are still a lot of members that are sooty or even burned; all such members need to be replaced. The following pictures show some of these burned members.

Figure 2. Representation of some of the burned members

However, there are still a lot of members that are sooty or even burned due to the fire incident; all such members need to be replaced.

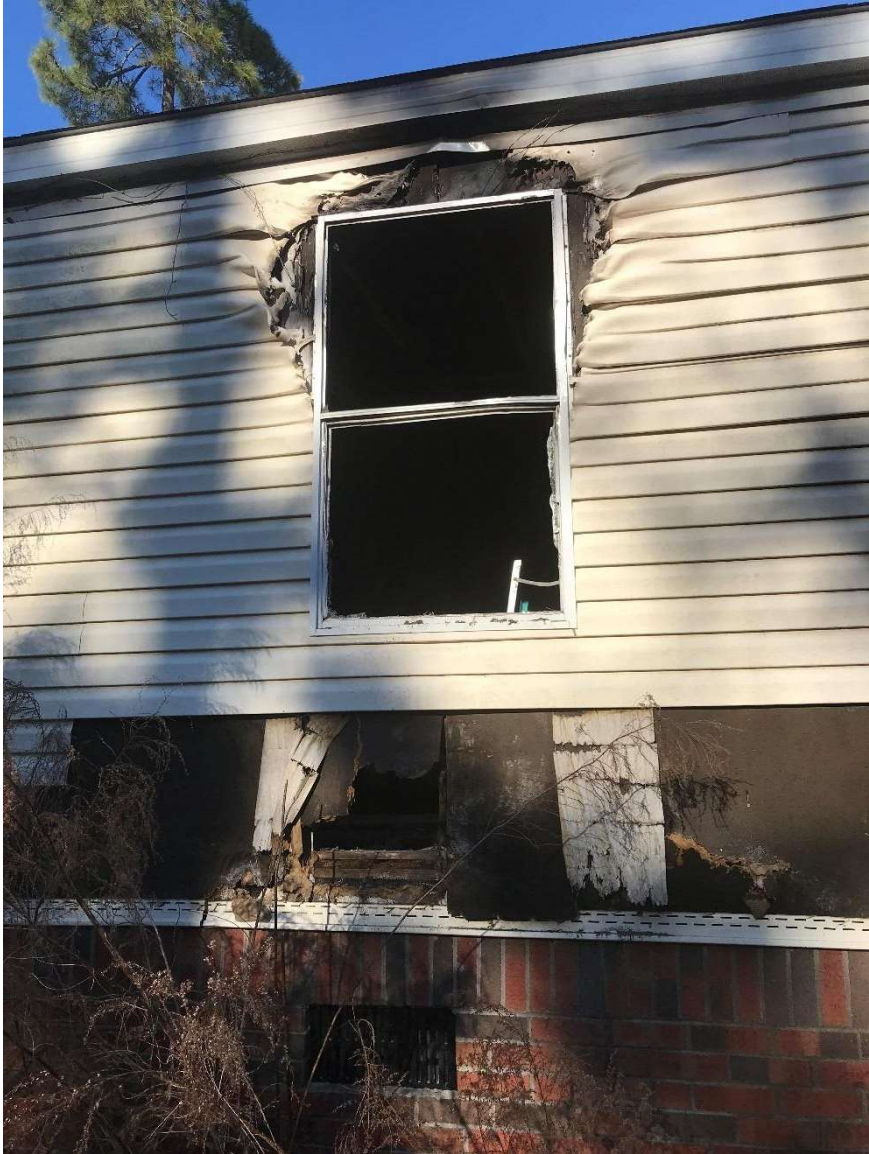
The window on the back of the house along with the wall Framing around this window are damaged and need to be fixed. Moreover, the exterior wall wood board finish below this window is damaged. These elements are shown in Figure 3. It is noted that in general, all such damages that are caused by flooding or fire incident should be repaired.

Figure 3. Window on the back of the house

The window on the back of the house, the wall Framing around this window, and the exterior wall wood board finish below this window are damaged and need to be fixed. It is noted that in general, all such damages that are caused by flooding or fire incidents should be repaired.

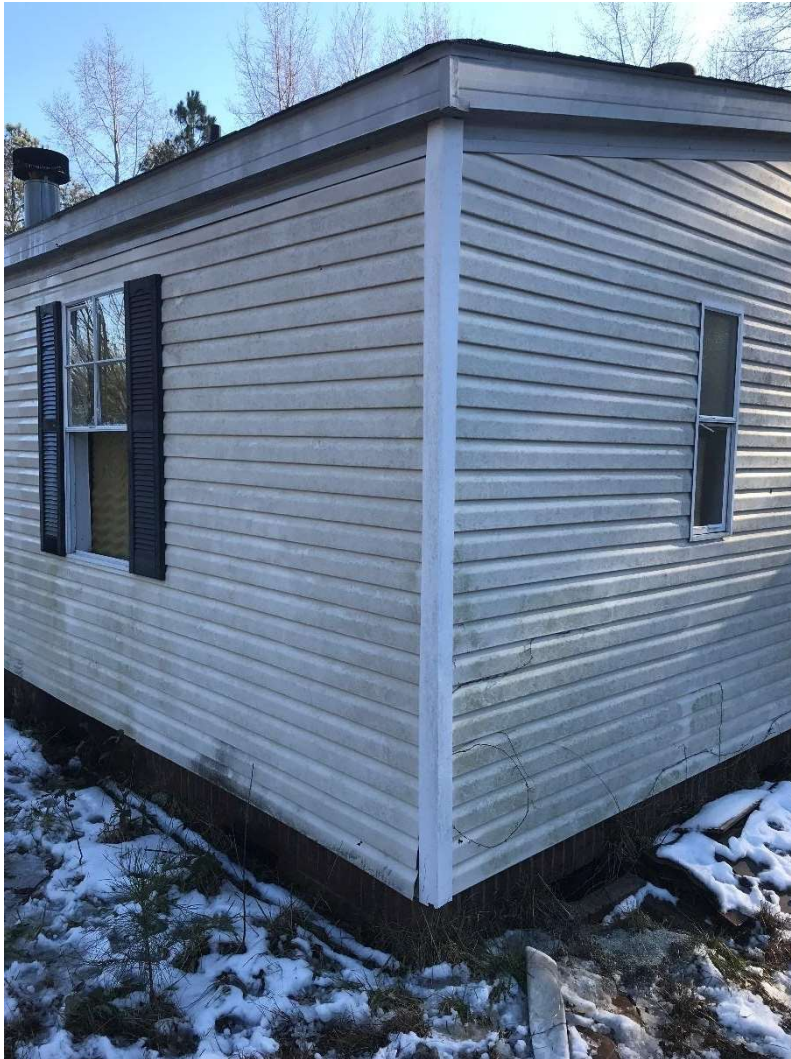
During my inspection, I also noticed that this manufactured home does not have a proper drainage system. Currently, as shown in Figure 4 there are no downspouts to drain the rainwater from the roof area.

Figure 4. Lack of drainage management

This manufactured home does not have a proper drainage system. Currently, there are no downspouts to drain the rainwater from the roof area.

I recommend directing rainwater from the roof toward the opposite side of the foundation by using gutter downspouts, splash blocks, or even French drains.

We recommend directing rainwater from the roof toward the opposite side of the foundation by using gutter downspouts, splash blocks, or even French drains.
