Licensed Structural
Engineers

Document Number: LSE-2022-982-STR-RPT-01-01

This letter summarizes the results of my visual inspection of the house located at 54 Brent Wood Ct, Sanford, NC 27332 USA performed on January 24, 2022. The client requested us to inspect the house after a fire incident. According to the client, the main purpose of this inspection is to evaluate conditions of the roof trusses.

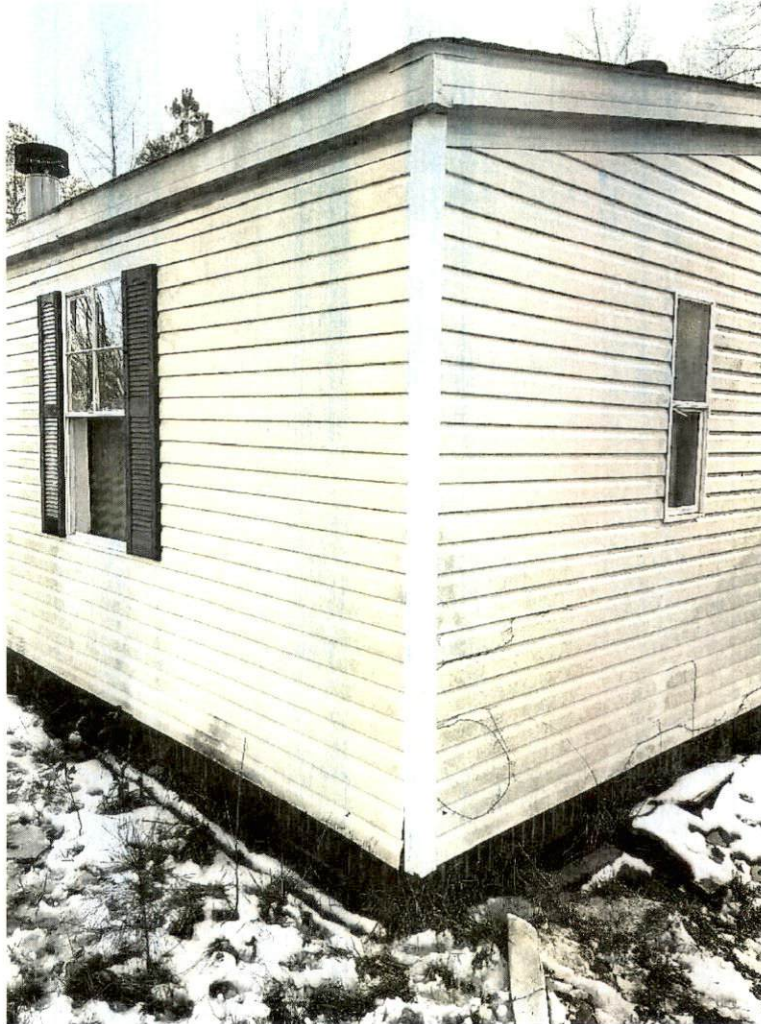
During my inspection, I also noticed that this manufactured home does not have a proper drainage system. Currently, as shown in Figure 4 there are no downspouts to drain the rainwater from the roof area.

Figure 4. Lack of drainage management

This manufactured home does not have a proper drainage system. Currently, there are no downspouts to drain the rainwater from the roof area.

I recommend directing rainwater from the roof toward the opposite side of the foundation by using gutter downspouts, splash blocks, or even French drains.

We recommend directing rainwater from the roof toward the opposite side of the foundation by using gutter downspouts, splash blocks, or even French drains.

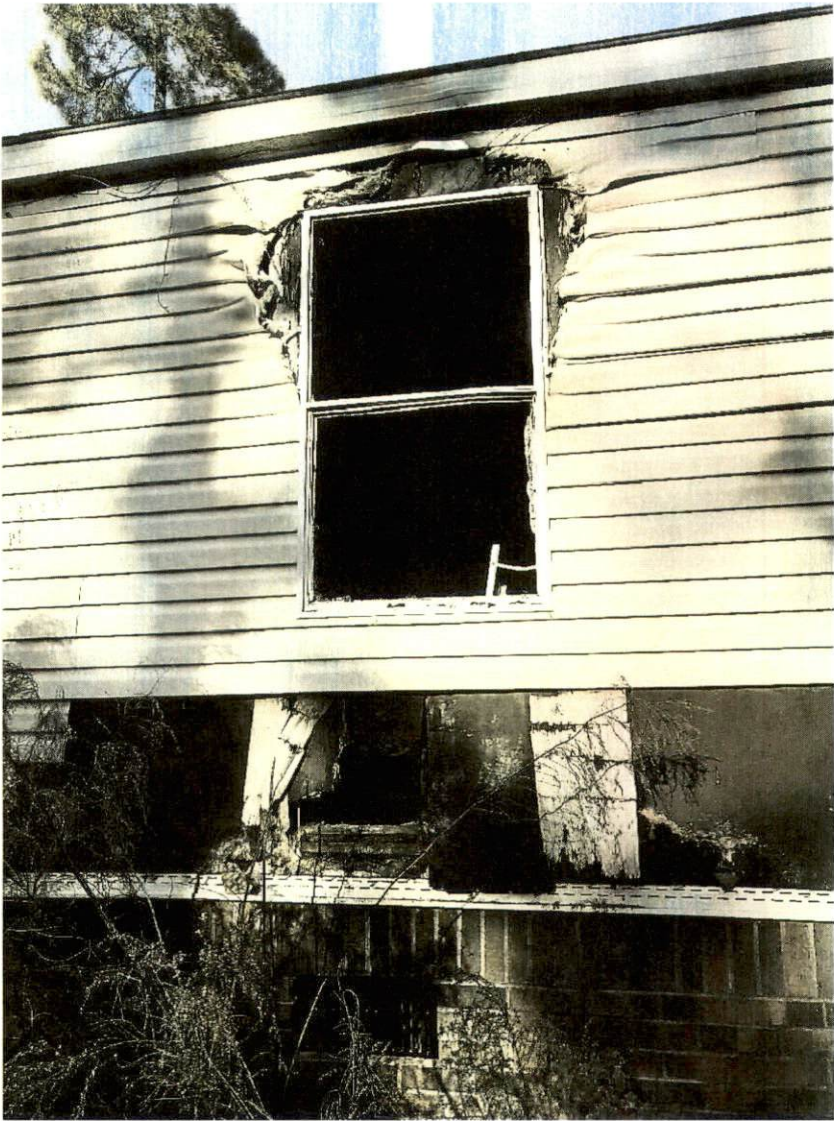
The window on the back of the house along with the wall Framing around this window are damaged and need to be fixed. Moreover, the exterior wall wood board finish below this window is damaged. These elements are shown in Figure 3. It is noted that in general, all such damages that are caused by flooding or fire incident should be repaired.

Figure 3. Window on the back of the house

The window on the back of the house, the wall Framing around this window, and the exterior wall wood board finish below this window are damaged and need to be fixed. It is noted that in general, all such damages that are caused by flooding or fire incidents should be repaired.

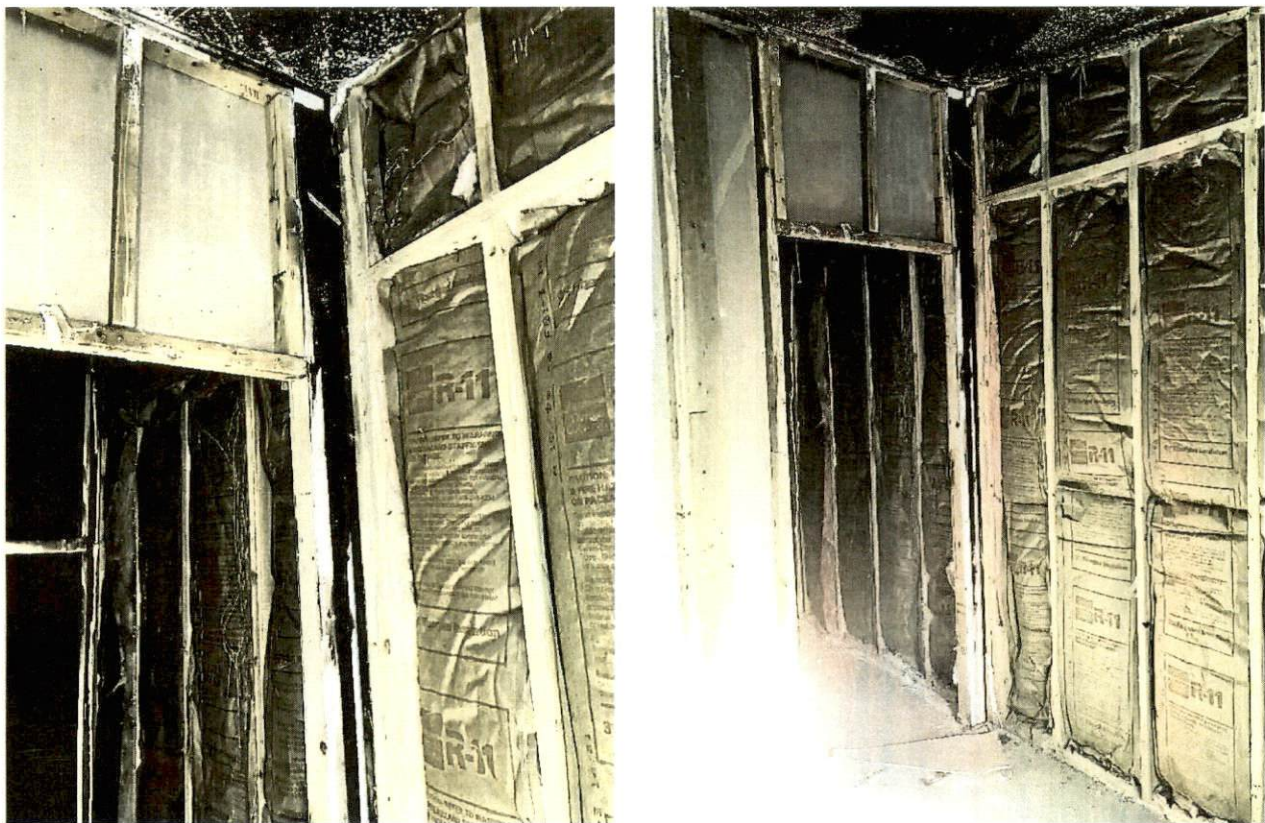
However, there are still a lot of members that are sooty or even burned due to the fire incident; all such members need to be replaced.

However, there are still a lot of members that are sooty or even burned; all such members need to be replaced. The following pictures show some of these burned members.

Figure 2. Representation of some of the burned members

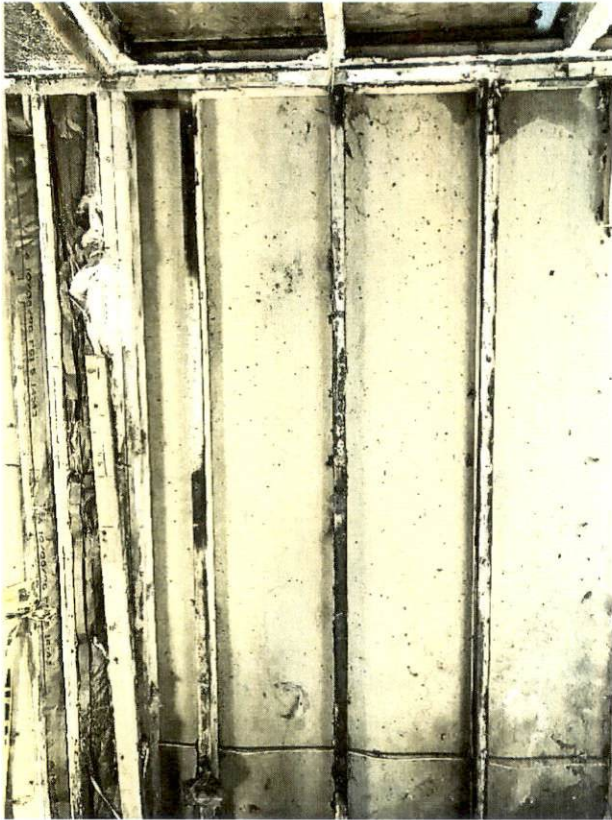
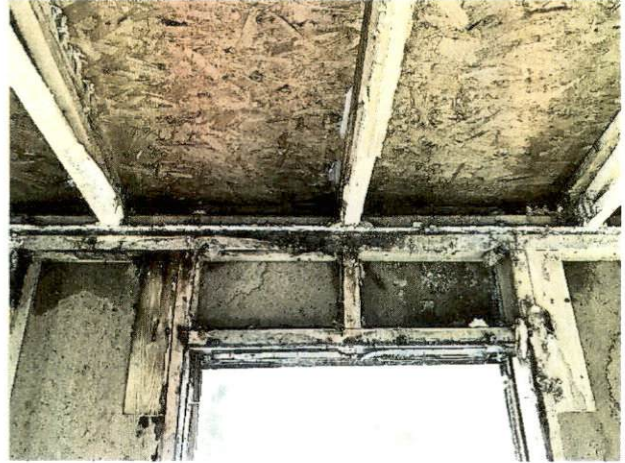
Figure 2. Representation of some of the burned members

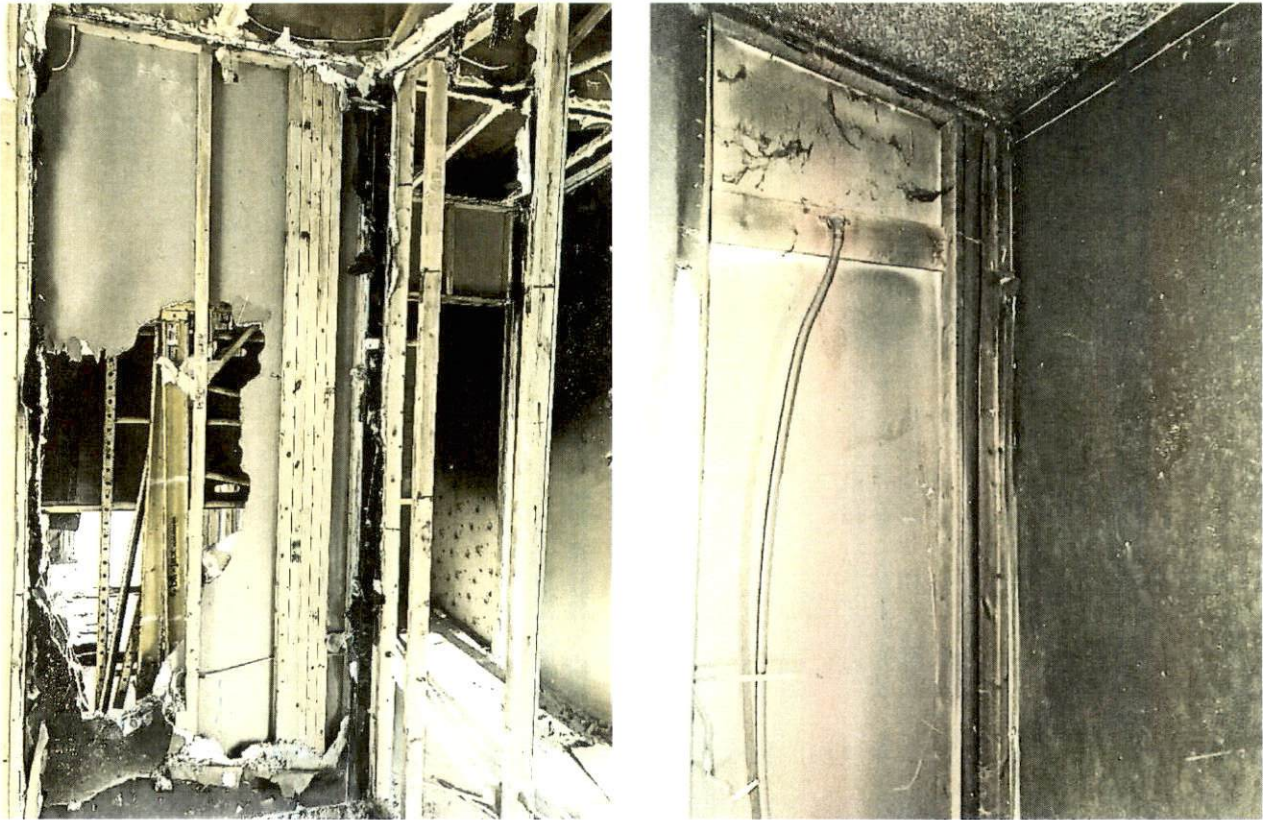
Figure 2. Representation of some of the burned members
