Cody Johnston, PE
Stonewall Structural Engineering, PLLC
4800 Falls of Neuse Rd. #120
Raleigh, NC 27609
(919)407-8663

Brett Vambell
Tarheel Basement Systems
3333 Air Park Rd.
Fuquay-Varina, NC 27526

Re: Structural Observation — 62 Angel Oak Drive, Bunnlevel, NC 28323

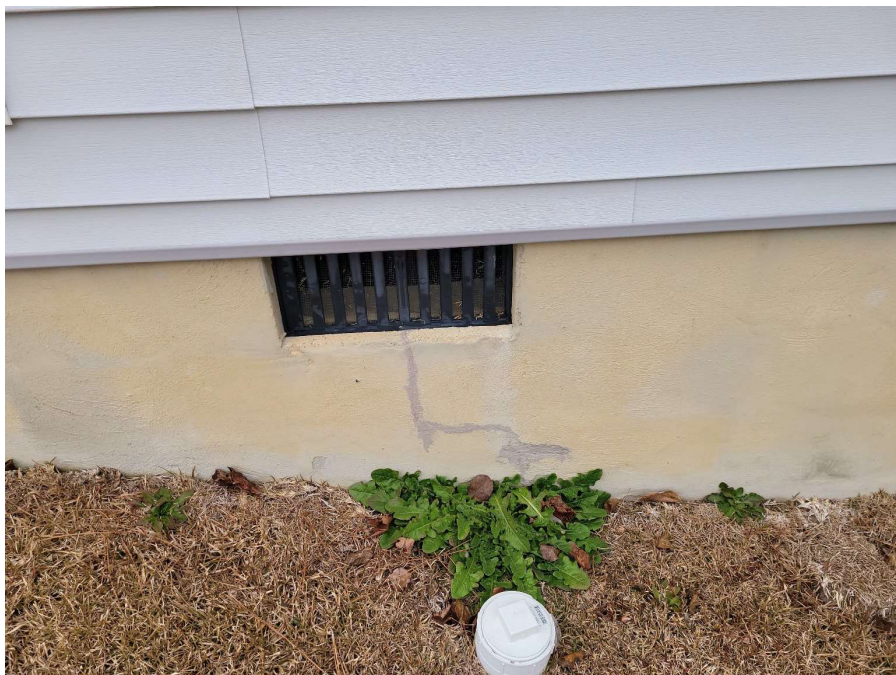
- Minor cracks were noted in the parging on the left, right, and back sides of the home (*see pictures 2-3 for examples*).
 - Measurement by laser level from the bottom of the floor joists indicated that the that the back-right corner of the home was down as much as approximately 1" relative to back-left corner of the home.
 - Additional measurement by laser level from the top of the foundation wall indicated that the foundation wall along the back of the home was level within $\frac{1}{4}$ ".
 - Closer examination of the floor joists revealed that floor joists and the rim band to the right of the fireplace bump out were out of contact with the knee wall top plates due to the knee wall being shorter on the right side of the fireplace bump out compared to the knee wall on the left side of the fireplace bump out (*see pictures 4-5 for examples*).

Picture 2 – Example of parging cracks
