Cody Johnston, PE  
 Stonewall Structural Engineering, PLLC  
 4800 Falls of Neuse Rd. #120  
 Raleigh, NC 27609  
 (919)407-8663

Re: Structural Observation — 62 Angel Oak Drive, Bunnlevel, NC 28323

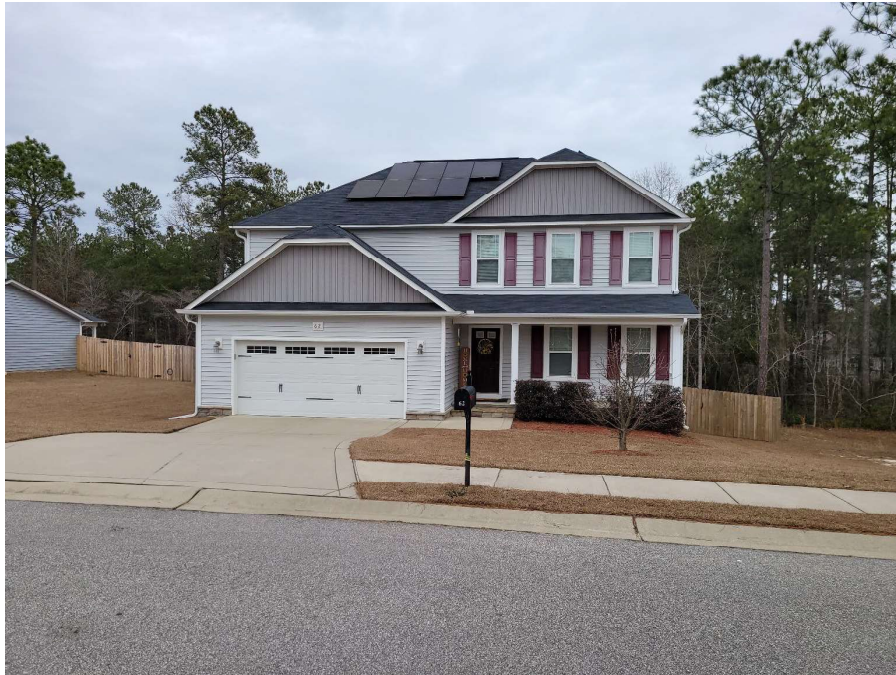
*Picture 1 – 62 Angel Oak Drive  
Bunnlevel, NC*

At your request, on February 3, 2022 we performed a review of the structural plan proposed by *Tarheel Basement Systems* for the foundation stabilization work at the Bunnlevel residence noted above. The structure is a conventionally framed, detached, single family residence with raised first floor framing over a pier/girder foundation system with perimeter masonry foundation walls (*see picture 1*).

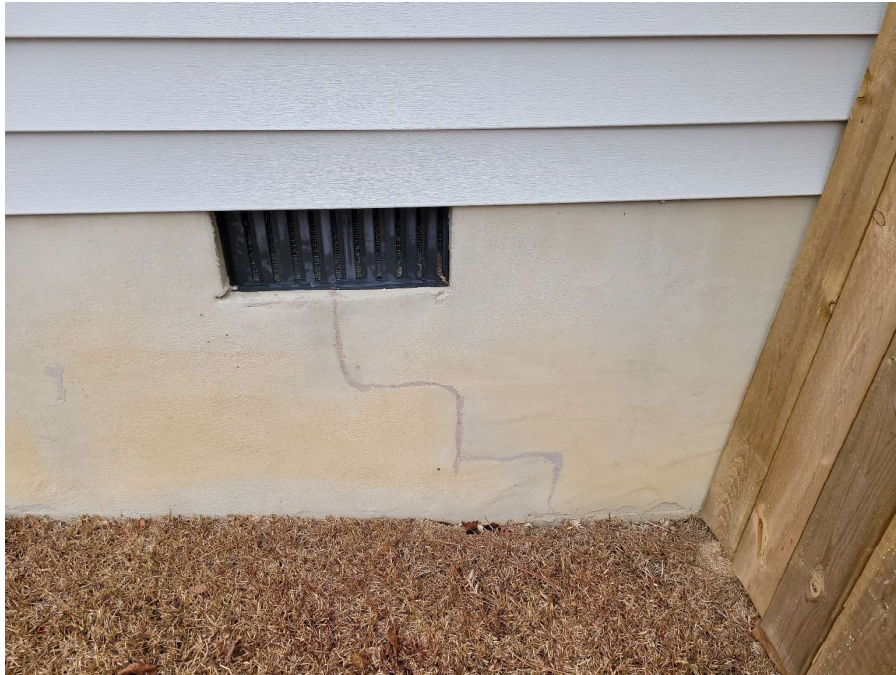
- Minor cracks were noted in the parging on the left, right, and back sides of the home (*see pictures 2-3 for examples*).
  - Measurement by laser level from the bottom of the floor joists indicated that the that the back-right corner of the home was down as much as approximately 1” relative to back-left corner of the home.
  - Additional measurement by laser level from the top of the foundation wall indicated that the foundation wall along the back of the home was level within ¼”.
    - Closer examination of the floor joists revealed that floor joists and the rim band to the right of the fireplace bump out were out of contact with the knee wall top plates due to the knee wall being shorter on the right side of the fireplace bump out compared to the knee wall on the left side of the fireplace bump out (*see pictures 4-5 for examples*).

*Picture 3 – Example of parging cracks*

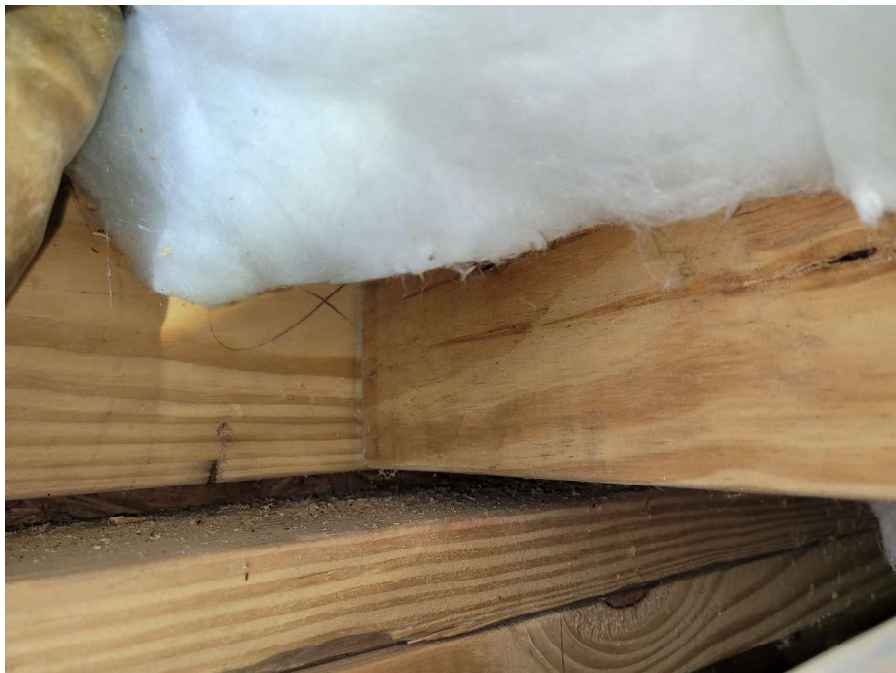
*Picture 4 – Floor joists and rim band out of contact with knee wall top plates*

- To prevent future movement of the floor system, joists and the rim band along the back of the home should be shimmed using tight fit shim material to the tops of the knee wall top plates.
- To prevent future settlement of the back and right portions of the home, the proposed series of (12) galvanized steel helical piers or push piers may be installed.
  - Helical piers should be installed to a torque capable of developing 20 kips of axial load, or to refusal. Push piers should be driven until engagement of the structure with lift indicating adequate depth/frictional resistance along the shafts of the piers
  - The contractor should locate and avoid utilities prior to work

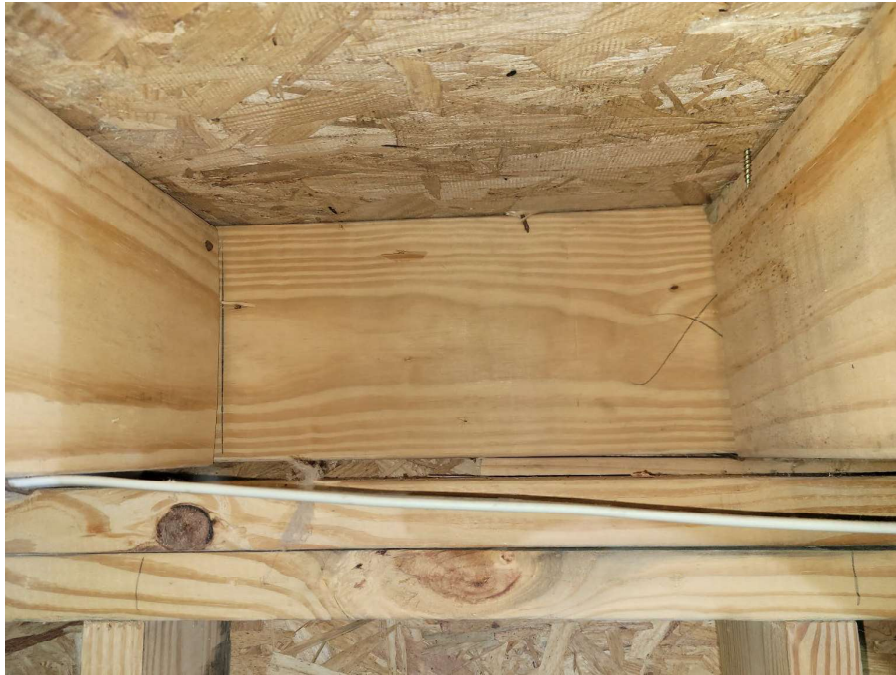
*Picture 5 – Floor joists and rim band out of contact with knee wall top plates*
