ENCS 2202-052
 1062 OLD STAGE RD S
 ERWIN N.C.
 28359

**SOIL/SITE EVALUATION
 for ON-SITE WASTEWATER SYSTEM**

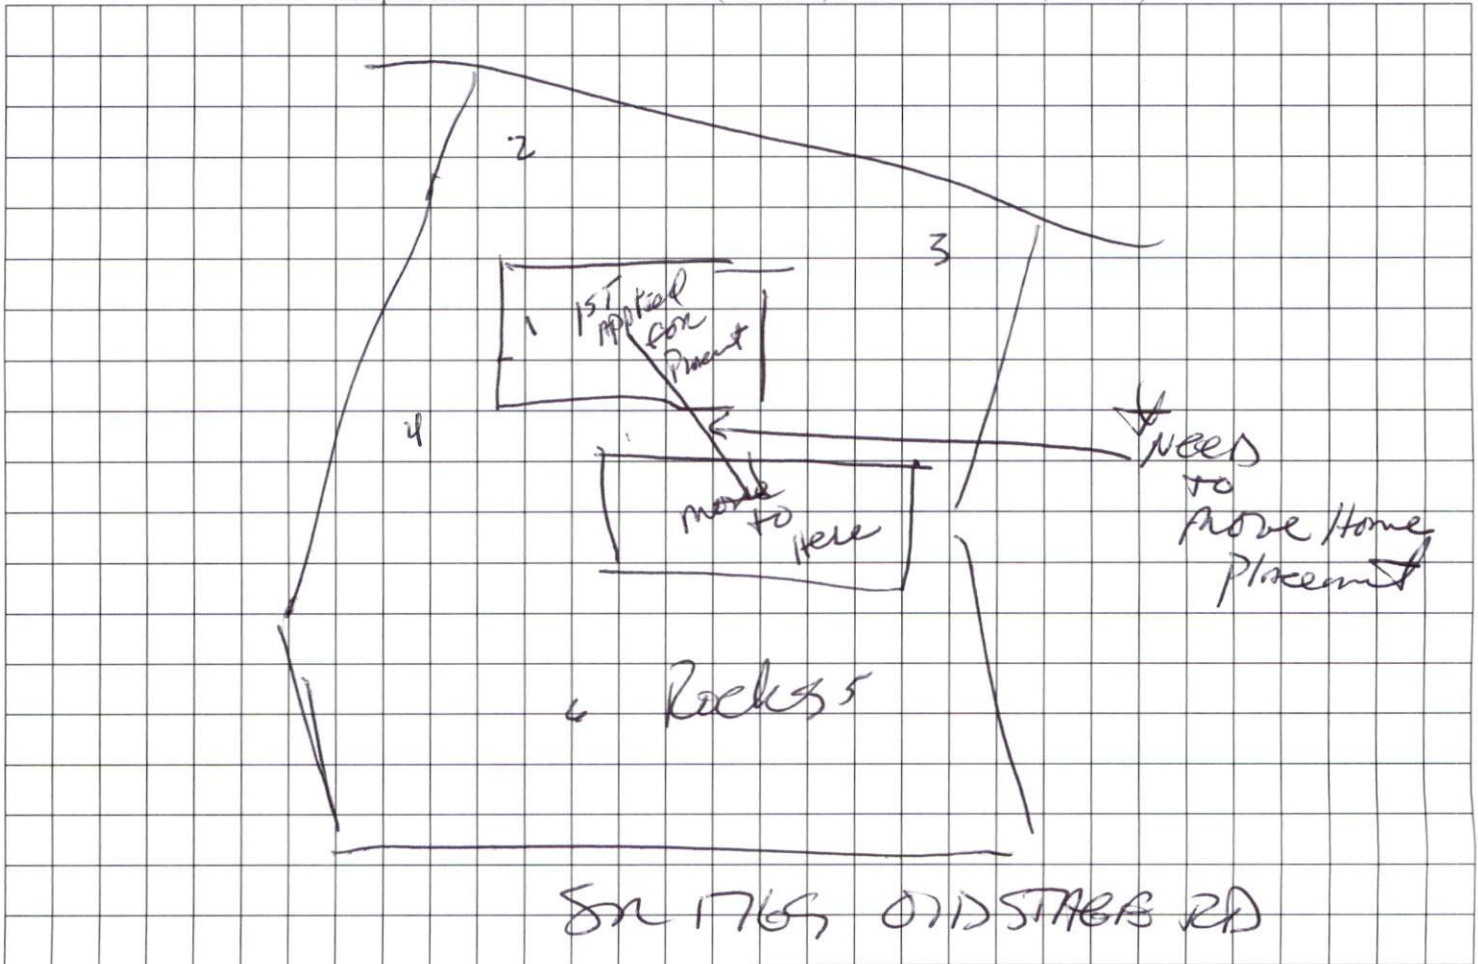
Show profile locations and other site features (dimensions, references or benchmark, and North)

Met owners and discussed moving Home toward on 1769 to give more room for system + repair
