Cody Johnston, PE
Stonewall Structural Engineering, PLLC
4800 Falls of Neuse Rd. #120
Raleigh, NC 27609
(919)407-8663

Re: Structural Observation — 50 North Ida Street, Coats, NC 27521

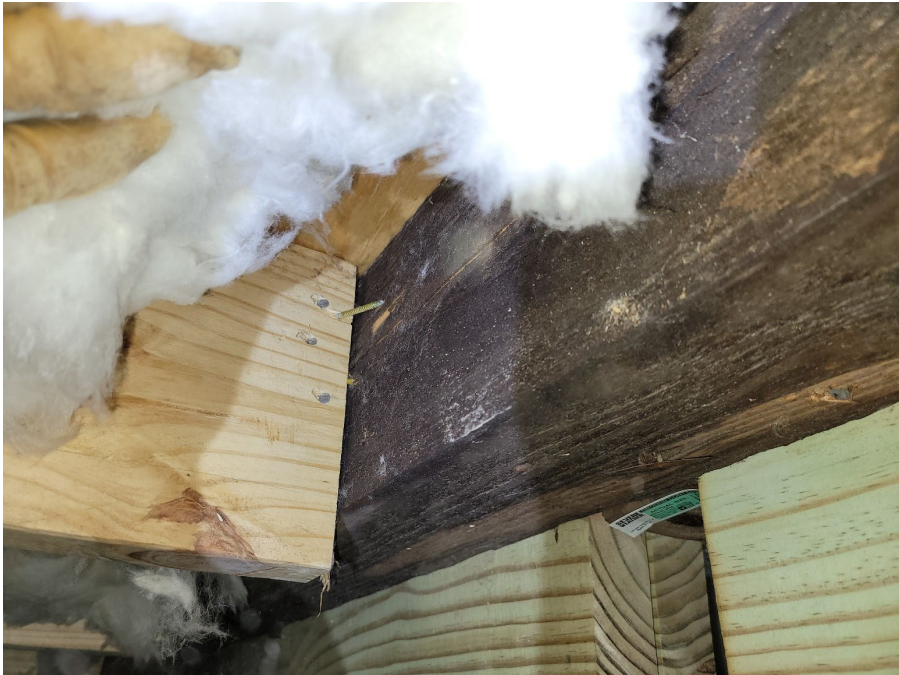
- New floor joists with left/right orientation were noted at the back-right corner of the home. These floor joists were inadequately fastened to the face of the existing girder (*see pictures 2 for example*).
- The back right portion of the perimeter foundation was noted to have been replaced with a new CMU foundation wall. The perimeter rim band and joists were out of contact over the new foundation wall (*see picture 3 for example*).
- Various new 6x6 girders were noted to have been installed throughout the home. The new 6x6 girders were supported by haphazardly constructed wooden supports and CMU piers (*see pictures 4-6 for examples*).
 - Probing of soils beneath the piers indicated that they did not have footing (*see picture 7 for example*).

Picture 2 – New floor joist inadequately fastened to existing girder

- The above-noted inadequately fastened joists should be secured to the side of the existing girder using Simpson face hangers.
- Install a new treated 2x #2 Southern Yellow Pine (SYP) sill plate along the right foundation wall where the rim band is out of contact. The new sill plate should be fastened to the foundation wall with Simpson “Universal Retrofit Foundation Plates” (or other approved anchor bolt alternative) at 6’ on center max spacing and 12” from sill plate ends and breaks with at least (2) foundation plates installed per sill plate segment.
- Remove the haphazardly constructed CMU piers and wood posts and support the 6x6 girders with new 8”x16” hollow CMU piers with 4” solid caps centered over 24”x24”x10” thick poured concrete footings set at least 12” into suitable bearing soils at the following spacings:

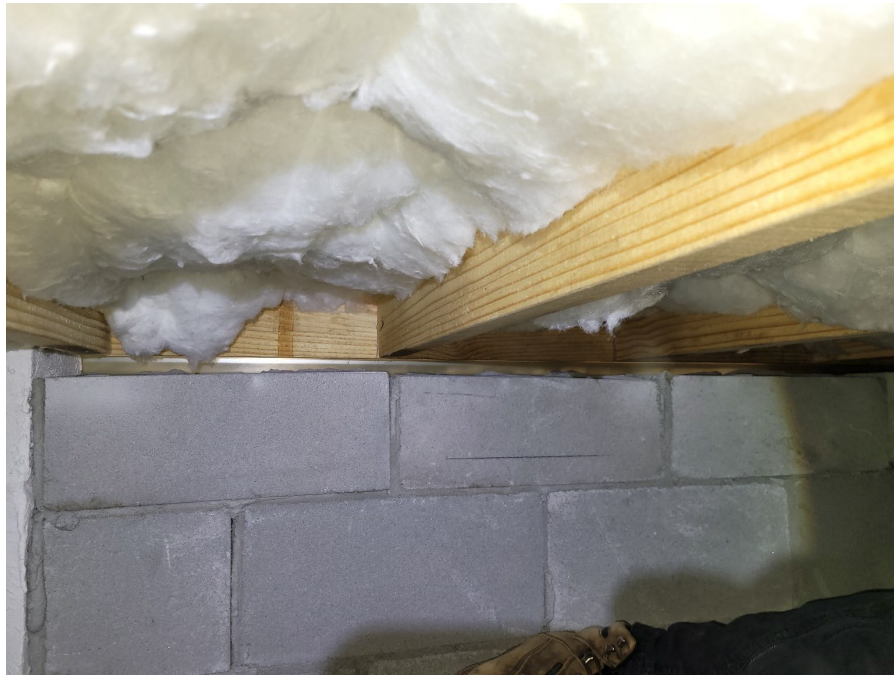
Picture 3 – New rim band out of contact over new foundation wall

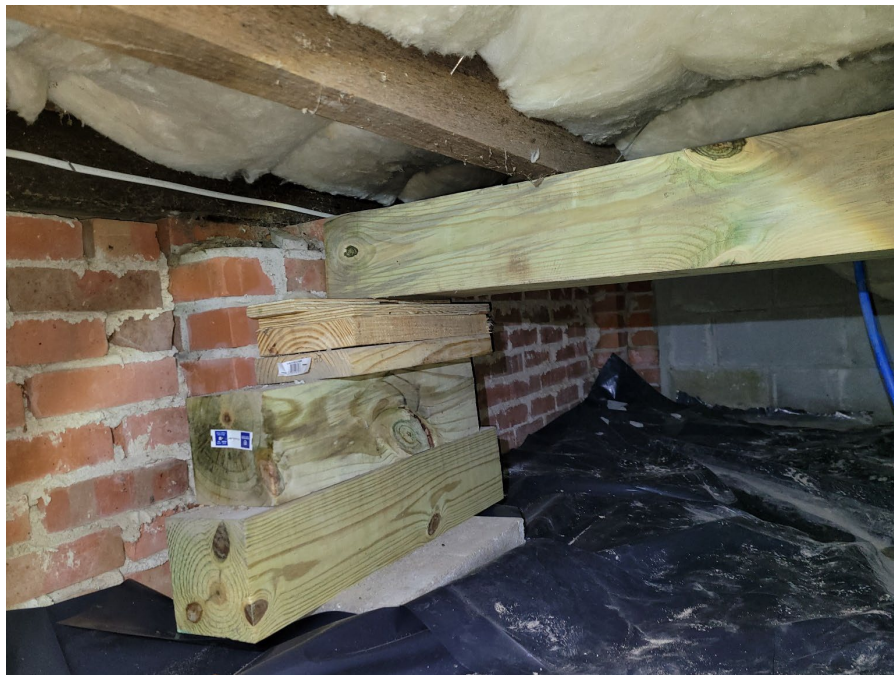
Picture 4 – Haphazardly constructed wooden support

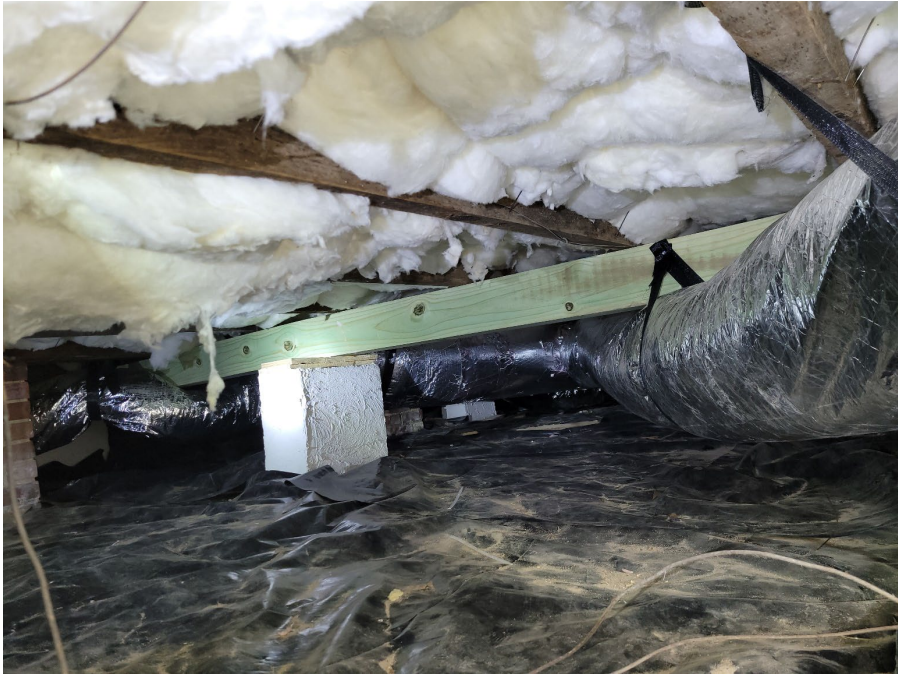
Picture 5 – New 6x6 girder supported by CMU pier

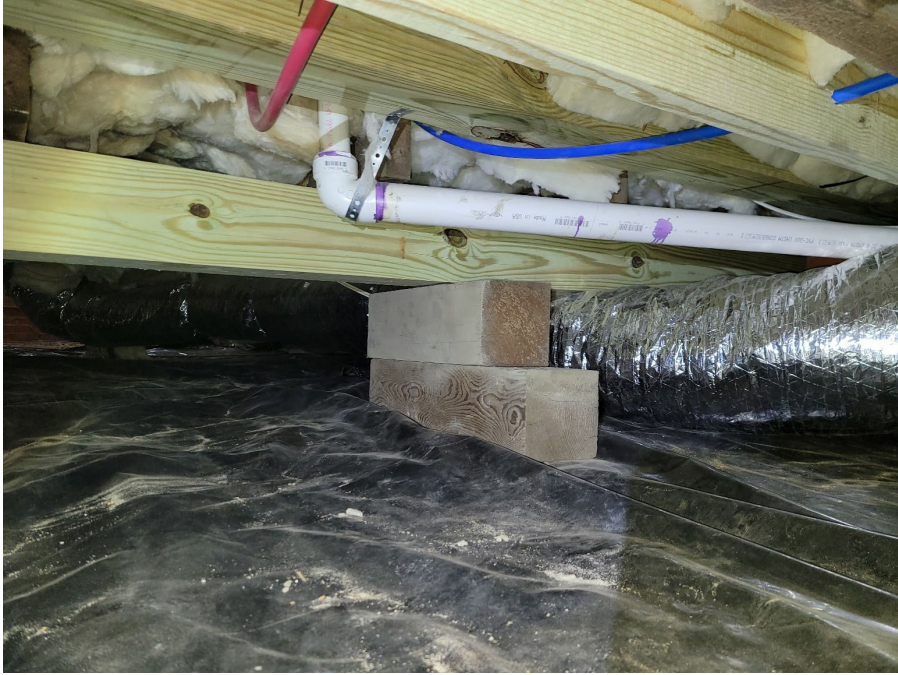
Picture 6 – Haphazardly constructed wooden support

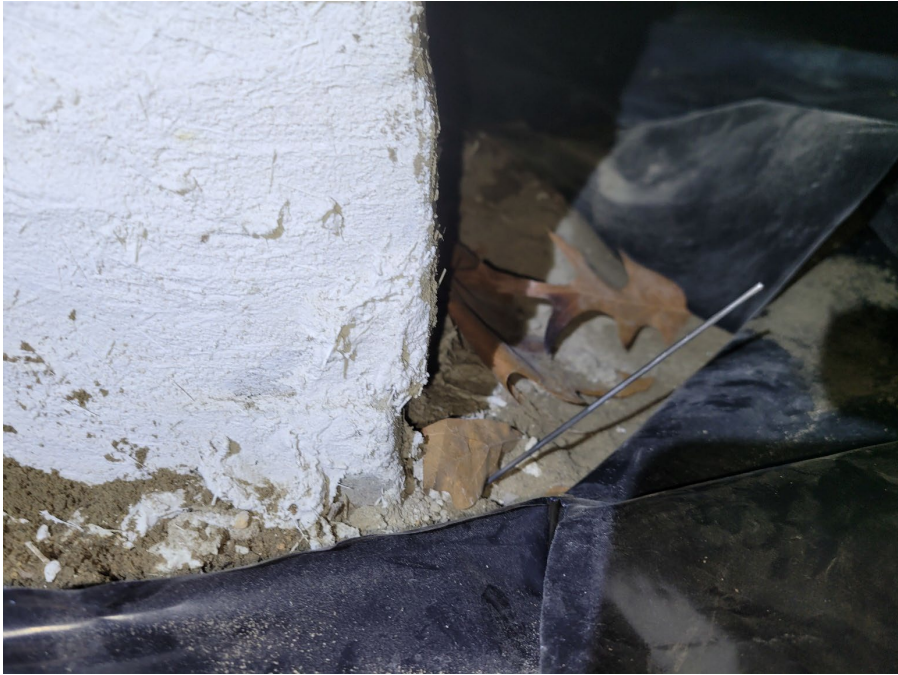
Picture 7 – New CMU pier with no footing

- Along the 6x6 girder with left/right orientation in the middle of the home, piers should be spaced no more than 4'-0" on center.
- Along all other 6x6 girder piers should be spaced no more than 5'-0" on center.
 - New piers should be shimmed with full width treated material to the bottom of the installed supplemental girders.
