PICTURE ADDENDUM

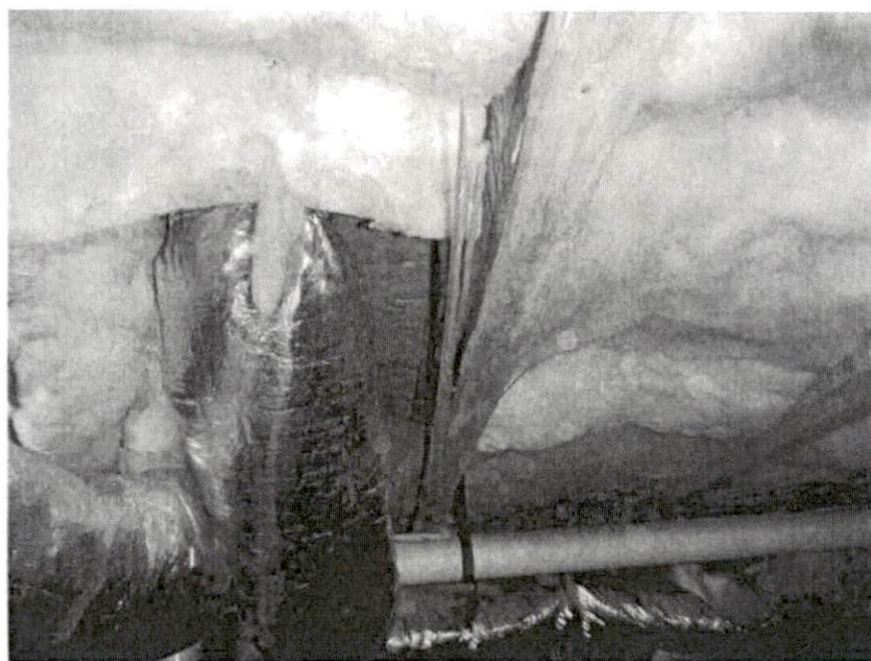
*Picture 2 – I-joint with damaged bottom chord*

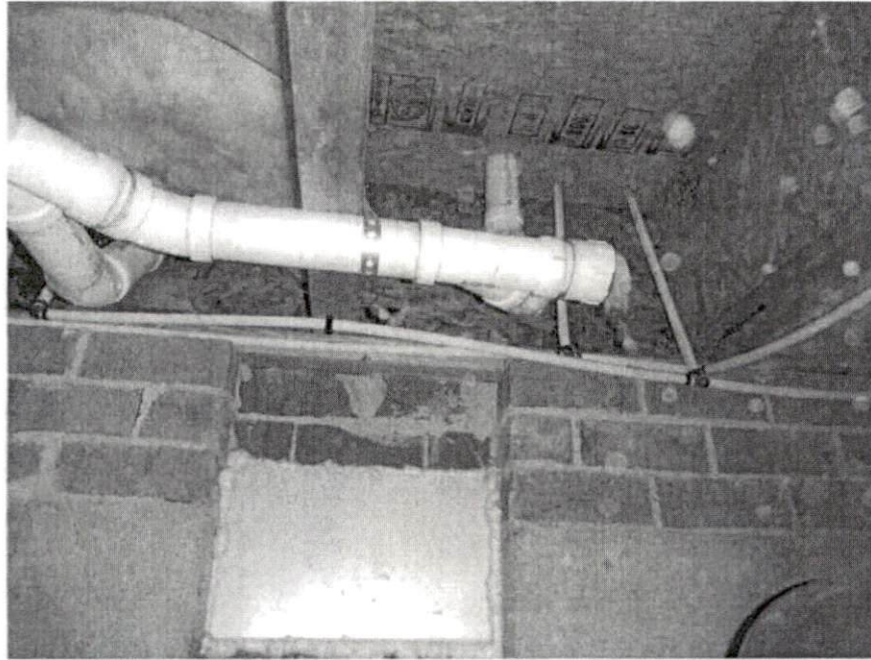
*Picture 3 – Joist supported on sill plate over vent opening*

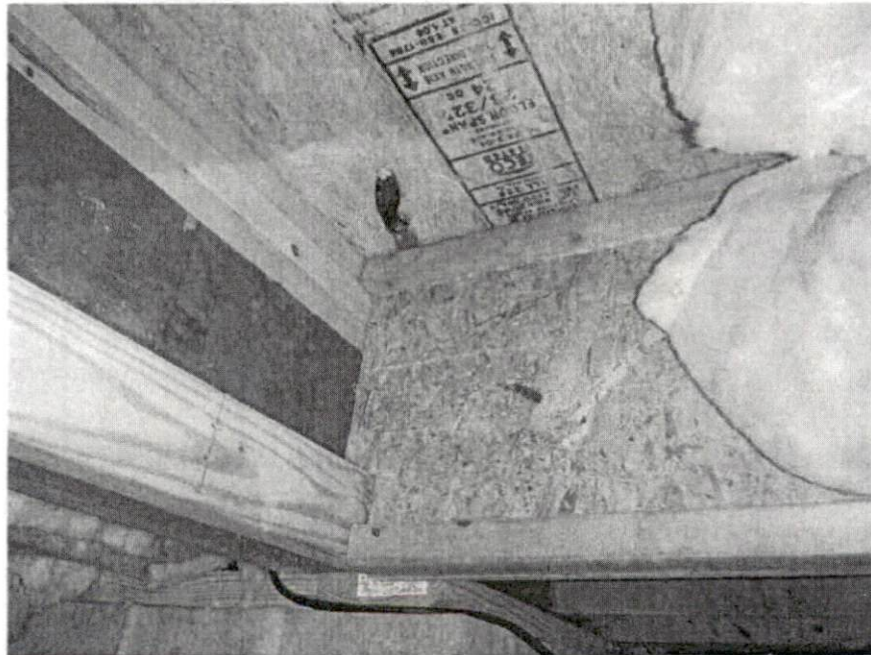
*Picture 4 – Example of notched and improperly supported i-joist at back foundation wall bump-out*

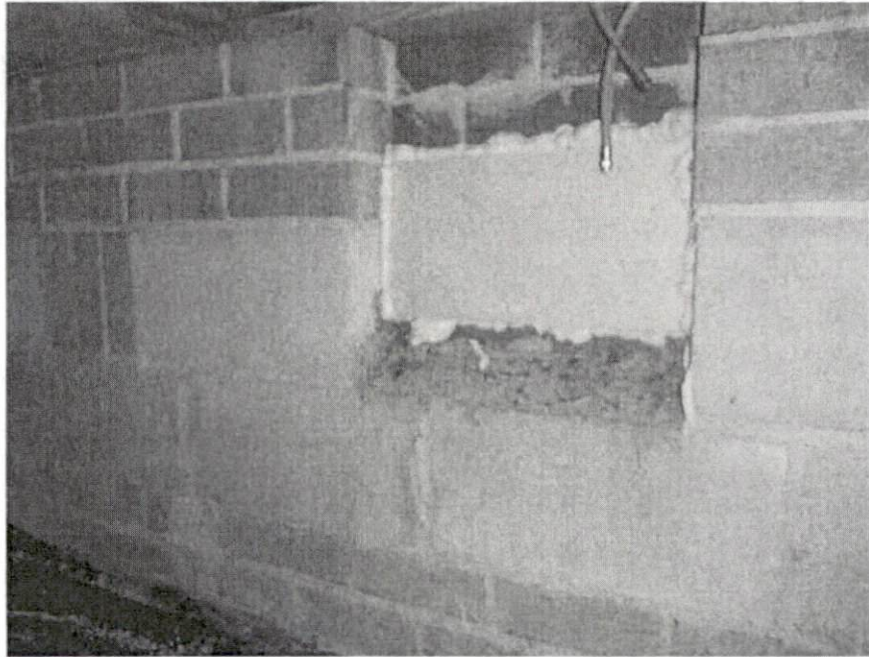
*Picture 5 – Example of sealed perimeter vent in partially closed crawlspace*

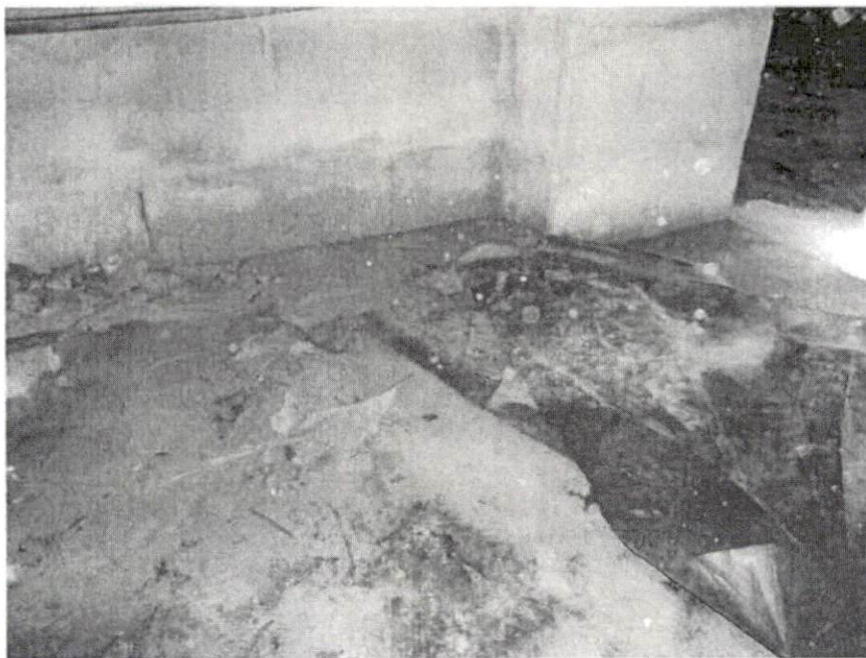
*Picture 6 – Standing water at back foundation wall*

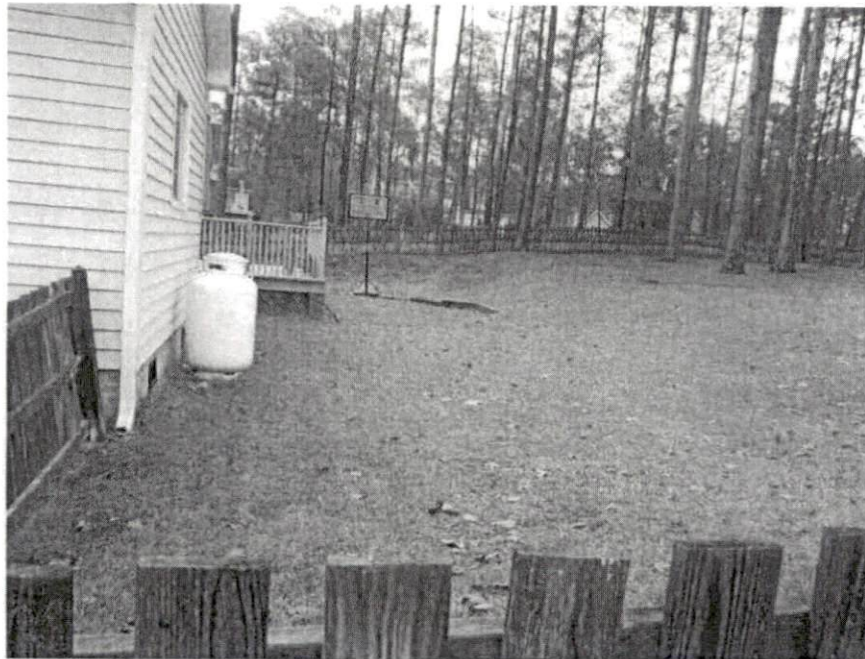
*Picture 7 – Inadequately sloped exterior grade at back of home*

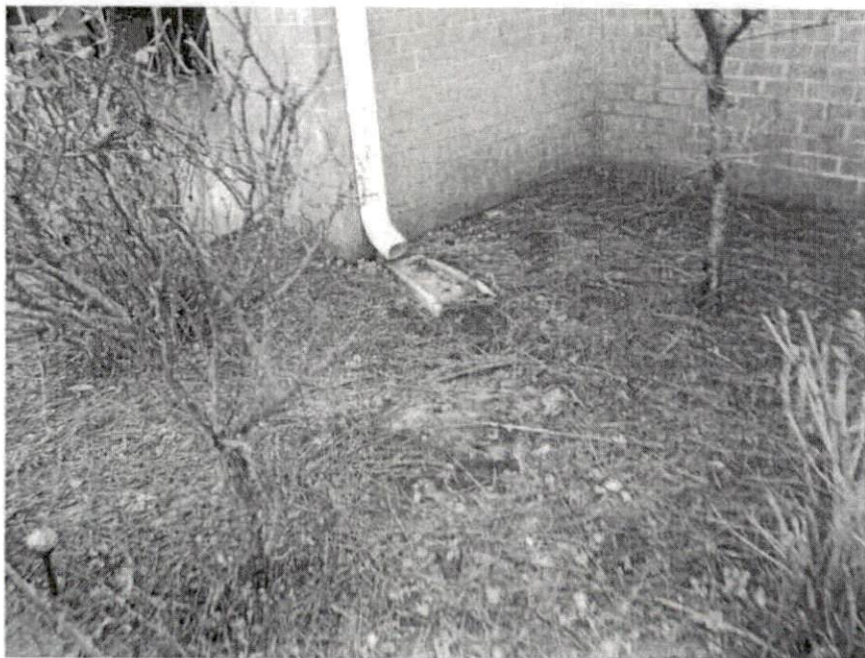
*Picture 8 – Example of roof gutter downspout installed for discharge at foundation*
