MDL Engineering Services

Date: March 8, 2023

Re: Soil Bearing & Compaction Evaluation
745 Creekview Lane
Linden, NC 28356
MDL Project No. SD201452

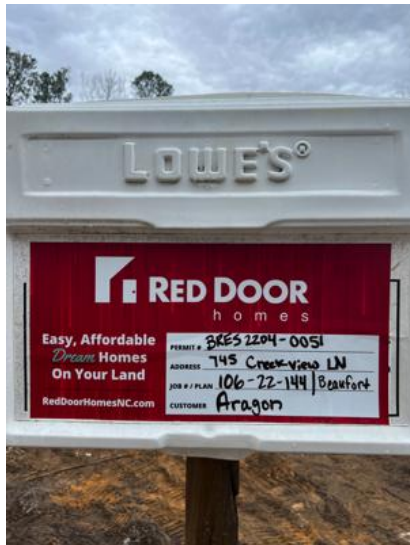
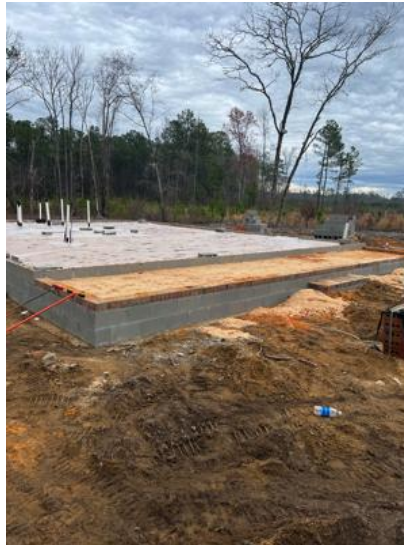
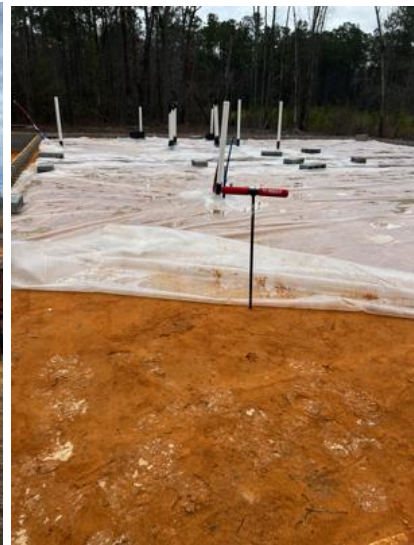
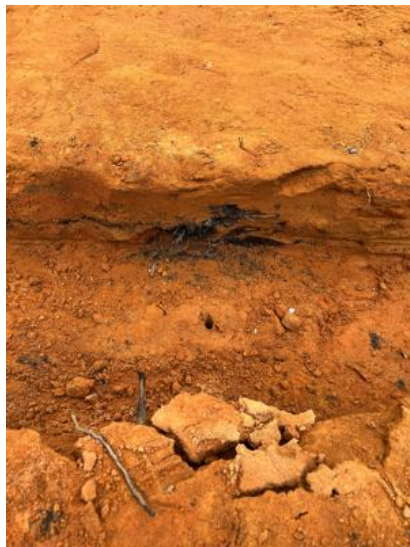
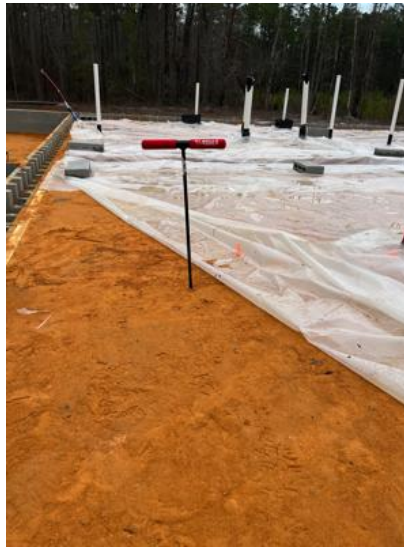
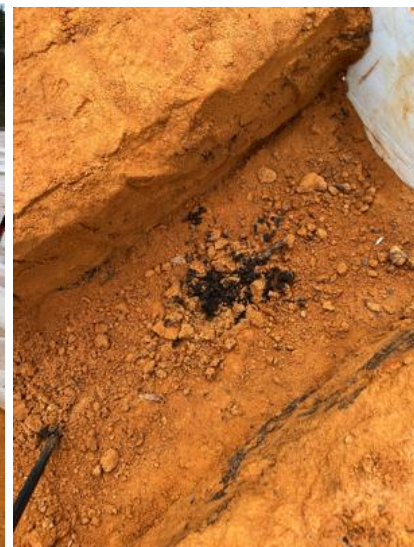
March 2, 2023

THE FILL WAS COMPACTED. TESTED THIS MATERIAL WAS NOT PROPERLY COMPACTED. IN ADDITION, THERE WERE MULTIPLE MOTHS THROUGHOUT. PRESENCE OF ORGANICS WERE CONFIRMED. MATERIAL NEEDS TO BE REMOVED & REPLACED.

The material inside the field of the home, the lug footings and the front porch were visually evaluated by the engineer, probed with a 1/2" rod and/or use of a DCP technique to correlate surface soil conditions with bearing capacity. The initial evaluation showed that the sandy material was not properly compacted, and the presence of organic materials were found throughout.

(OR REPLACE WITH WASHED SAND OR STRUCTURAL FILL (SUCH AS 57 STONE). FILL SHOULD BE COMPACTED TO 95%.

This material needed to be removed, sifted to eliminate the organic material and be replaced 6" layer at a time, with compaction performed in between each 6" layer.

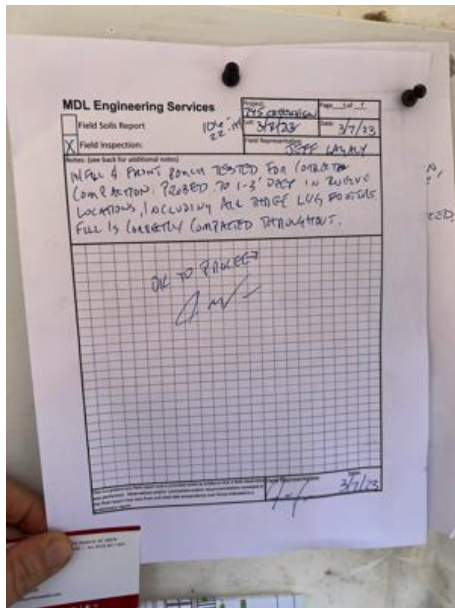
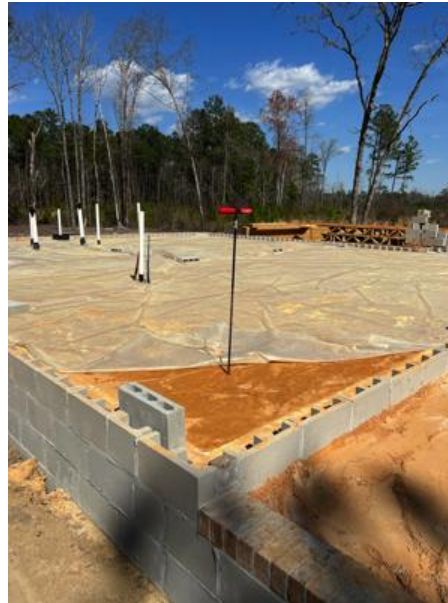
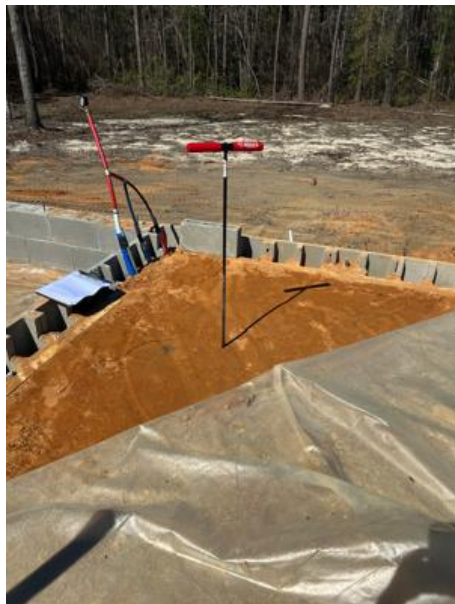
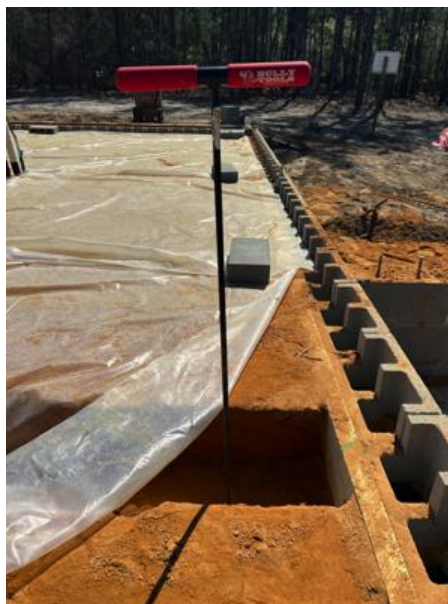
March 7, 2023

MDL Engineering was contacted on March 6, 2023 to re-test for compaction. The material was again probed with a 1/2" rod and/or use of a DCP technique to correlate surface soil conditions with bearing capacity. This test was performed in six different locations in the field and in multiple locations in every lug footing. The material passed the compaction in every spot. In addition, there was no visible sign of organic materials present this time.

The footing soils meet the requirements of the site drawings and the 2018 edition of the North Carolina Residential Building Code and are good to pour.
