The purpose of this investigation is to determine root cause of the settlement and deflection issues for the home at 230 Whit Court Angier, NC. and to recommend any necessary remediation procedures or modifications to mitigate future concerns.

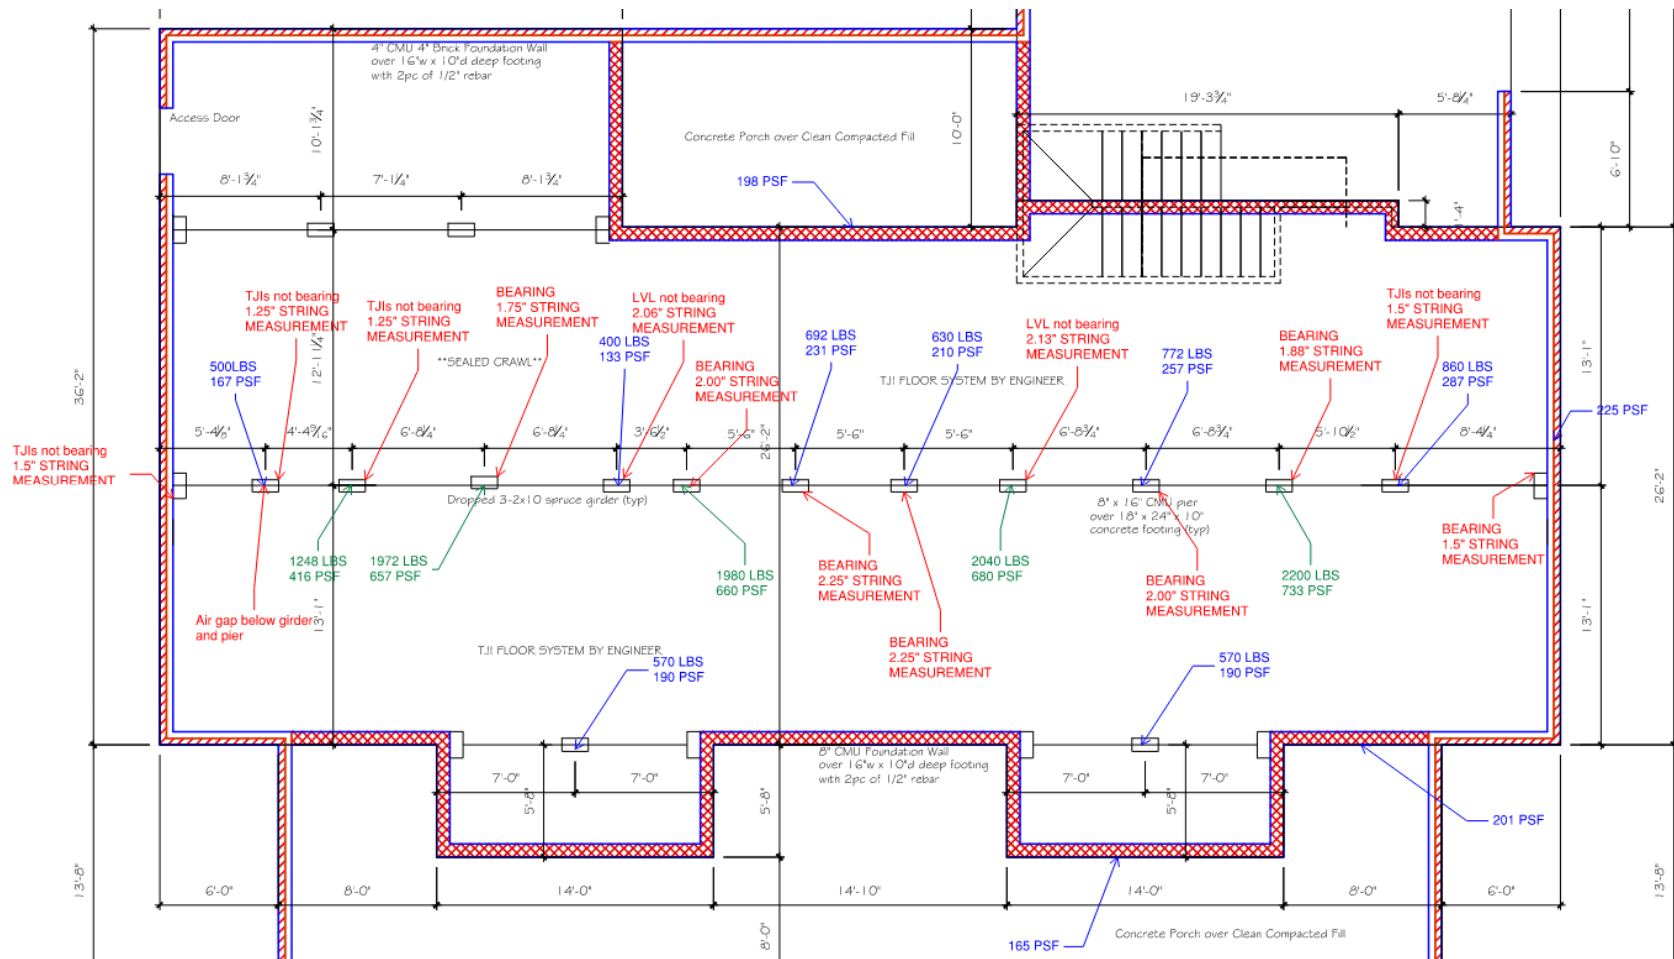
Figure 1

Initial inspection on December 17<sup>th</sup>, 2021, (See Figure 1)

- Significant settlement and deflection of the main girder under the home was observed. A string line was placed under the home and measurements were taken throughout indicating that the interior piers had settled from their original location.
  - Deflections/Settlements peaked under the hallway and at the transition to the kitchen, each was approximately ¾"
- Moisture measurements were taken on various elements and each fell within an acceptable range with the average being 6.8%.
- There were several piers where the LVLs spanning from front to back of the home were suspended above the piers.

Structural Analysis (See Figure 1)

- A load analysis was performed to determine the load path of the framing and to determine if the foundations were adequately sized.
- The analysis was performed with an assumed 10psf load and partition loading was omitted for simplicity.
- Footings and piers were found to be within code allowable ranges, however areas on concentrated load were identified.

Second inspection on April 22<sup>nd</sup>, 2022, (See Figure 1)

- Additional interior cosmetic issues were noted by the homeowner.
- A second round of measurements were taken on the string line and no significant changes were noted.
- Moisture readings were taken and averaged 6.7%.

Notes: Measurements and other observations shown in RED.  
 Balanced foundation loading locations shown in BLUE.  
 Locations of concentrated load indicated in GREEN.

Initial indications from the first inspection and from the load path analysis indicated that the settlements and deflections were likely due to a combination of various factors and could not be directly attributed to any one single root cause. Rather a combination of greater than normal deflection of the structure, unequal settlement of the internal piers potential shrinkage of the framing members likely all contributed to the overall problem of greater than normal settlement of the home. The load path analysis aligned with the locations that were seeing additional settlements, indicating the most reasonable solution would be to provide additional support to limit both the concentrated loading on internal piers and to mitigate compounding deflections of the structural framing.

Note that while additional cosmetic concerns have risen on the interior of the home during the 4 month observational window, the measurement data that was taken indicated that no additional settlement had occurred. Moisture readings taken during that time also indicated the dehumidifier in the crawl space is adequately controlling the moisture content and thus no additional material shrinkage would be expected.

To mitigate additional settlement issues and to minimize the existing deflection issues it is recommended to jack the main girder back into its original level condition and replace the existing shims with incompressible shims that would not deform or shrink over time. Jacking should be done slowly (no more than  $\frac{1}{4}$ " for any single movement is recommended), frequent checks and observations of the surrounding structure should be made throughout the process to ensure no negative impacts to the structure or interior of the home.
