The purpose of this investigation is to determine root cause of the settlement and deflection issues for the home at 230 Whit Court Angier, NC. and to recommend any necessary remediation procedures or modifications to mitigate future concerns.

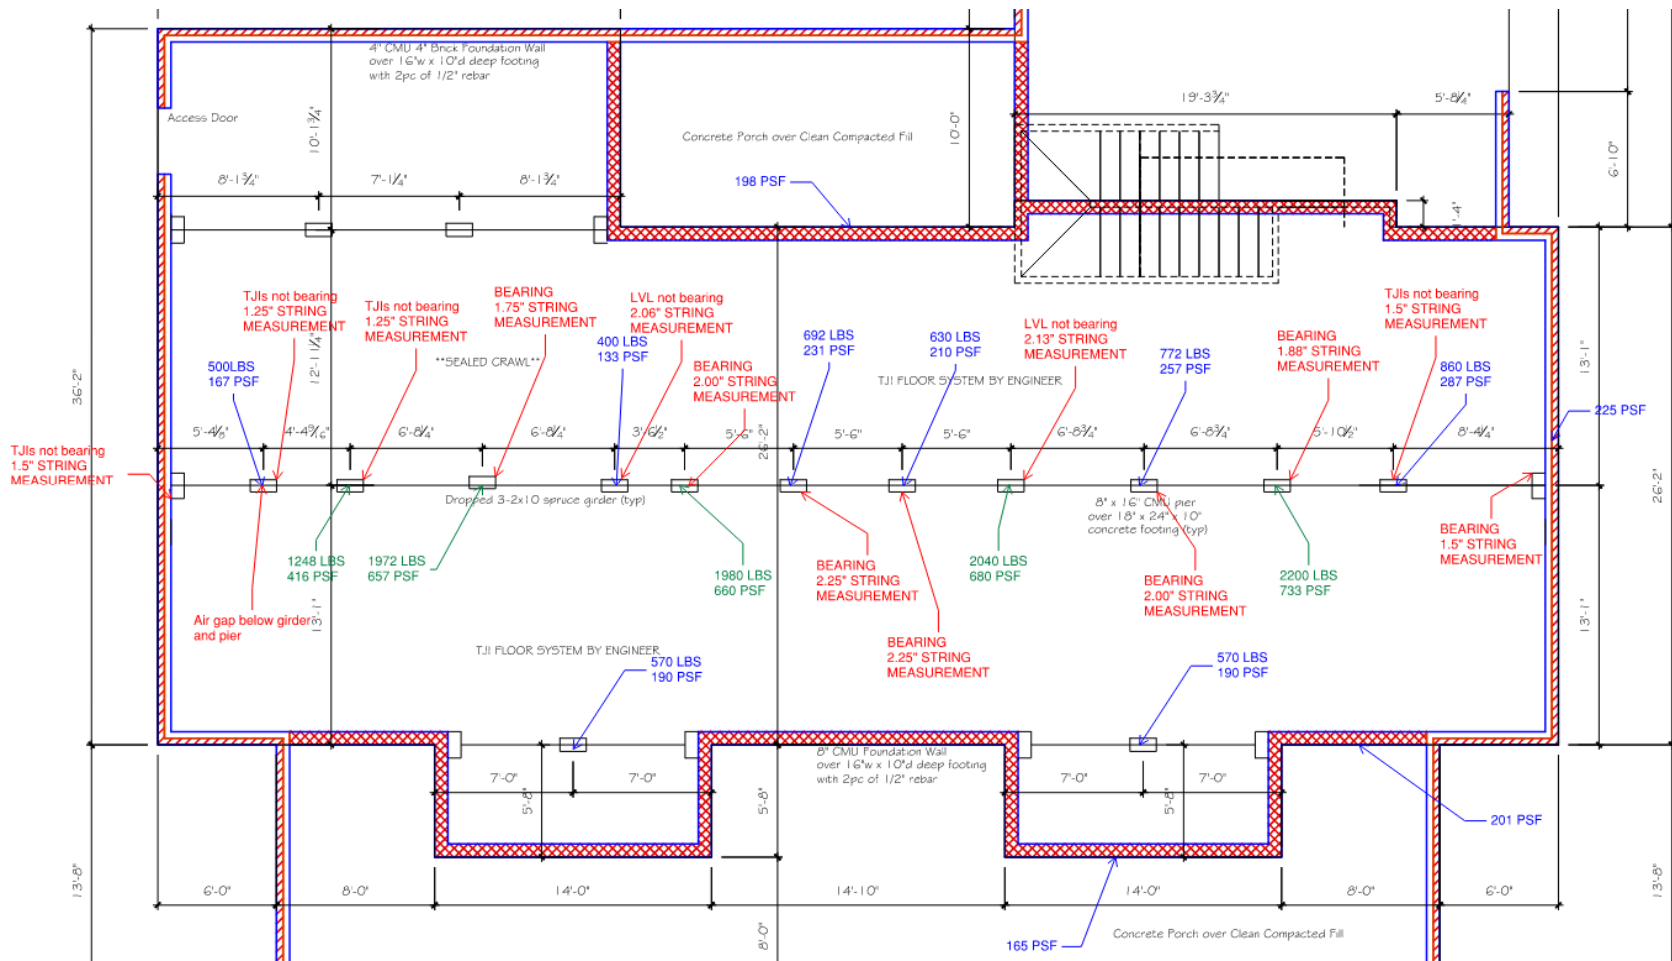
Figure 1

Initial inspection on December 17th, 2021, (See Figure 1)

- Significant settlement and deflection of the main girder under the home was observed. A string line was placed under the home and measurements were taken throughout indicating that the interior piers had settled from their original location.
 - Deflections/Settlements peaked under the hallway and at the transition to the kitchen, each was approximately $\frac{3}{4}$ "
- Moisture measurements were taken on various elements and each fell within an acceptable range with the average being 6.8%.
- There were several piers where the LVLs spanning from front to back of the home were suspended above the piers.

Structural Analysis (See Figure 1)

- A load analysis was performed to determine the load path of the framing and to determine if the foundations were adequately sized.
- The analysis was performed with an assumed 10psf load and partition loading was omitted for simplicity.
- Footings and piers were found to be within code allowable ranges, however areas on concentrated load were identified.

Second inspection on April 22nd, 2022, (See Figure 1)

- Additional interior cosmetic issues were noted by the homeowner.
- A second round of measurements were taken on the string line and no significant changes were noted.
- Moisture readings were taken and averaged 6.7%.

Initial indications from the first inspection and from the load path analysis indicated that the settlements and deflections were likely due to a combination of various factors and could not be directly attributed to any one single root cause. Rather a combination of greater than normal deflection of the structure, unequal settlement of the internal piers potential shrinkage of the framing members likely all contributed to the overall problem of greater than normal settlement of the home. The load path analysis aligned with the locations that were seeing additional settlements, indicating the most reasonable solution would be to provide additional support to limit both the concentrated loading on internal piers and to mitigate compounding deflections of the structural framing.

Note that while additional cosmetic concerns have risen on the interior of the home during the 4 month observational window, the measurement data that was taken indicated that no additional settlement had occurred. Moisture readings taken during that time also indicated the dehumidifier in the crawl space is adequately controlling the moisture content and thus no additional material shrinkage would be expected.

To mitigate additional settlement issues and to minimize the existing deflection issues it is recommended to jack the main girder back into its original level condition and replace the existing shims with incompressible shims that would not deform or shrink over time. Jacking should be done slowly (no more than $\frac{1}{4}$ " for any single movement is recommended), frequent checks and observations of the surrounding structure should be made throughout the process to ensure no negative impacts to the structure or interior of the home.
