W. Harrison Welch, PE
Stonewall Structural Engineering, PLLC
4800 Falls of Neuse Rd. #120
Raleigh, NC 27609
(919)407-8663

Re: Structural Observation — 489 Lenoir Drive, Spring Lake, NC 28390

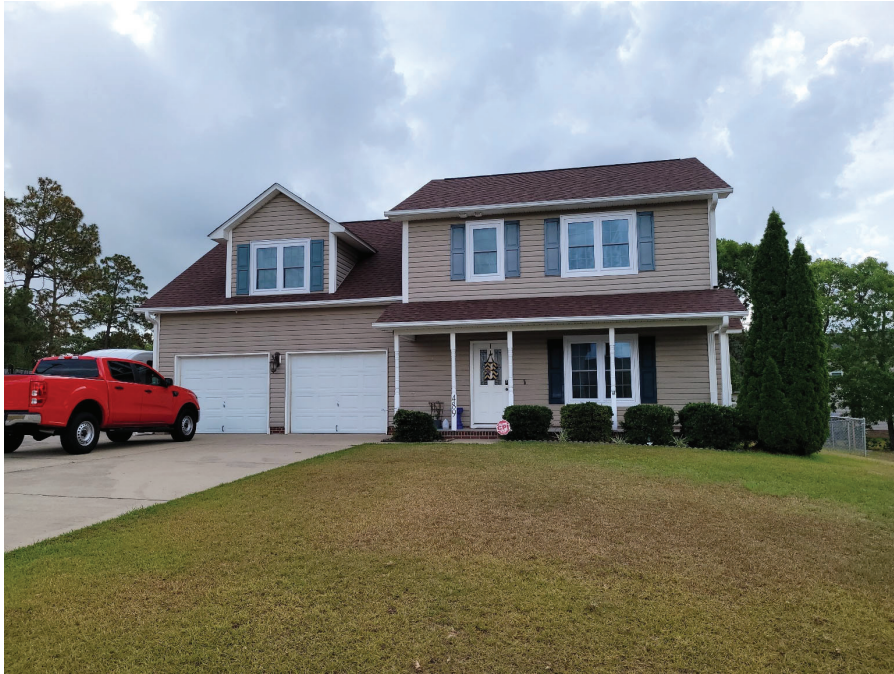
Picture 1 – 489 Lenoir Drive, Spring Lake, NC

At your request, on July 1, 2022, we performed a review of the structural plan proposed by *Tarheel Basement Systems* for the foundation stabilization work at the Spring Lake residence noted above. The structure is a conventionally framed, detached, single family residence with a slab-on-fill foundation system (*see picture 1*).

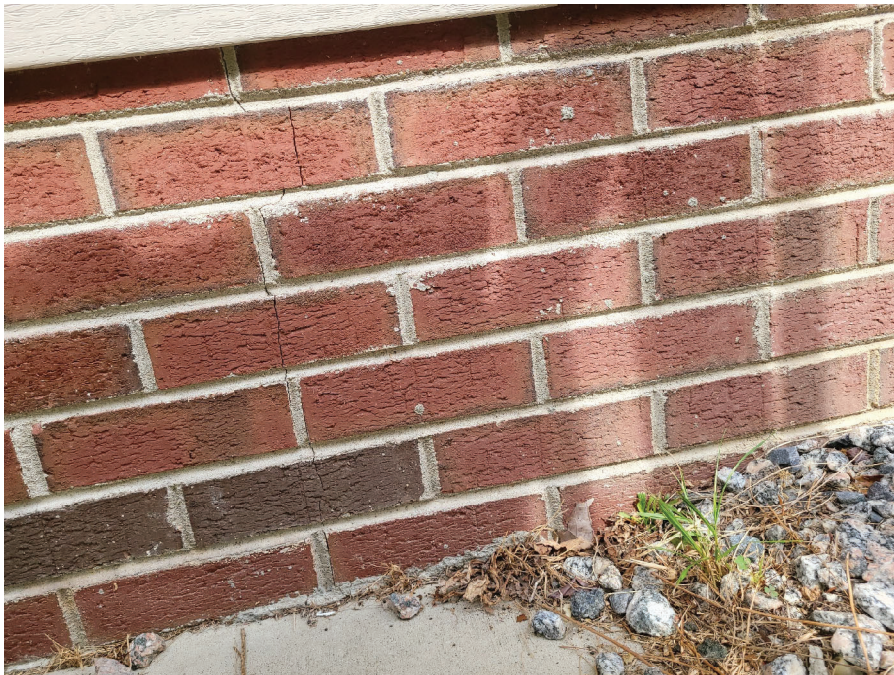
- Minor perimeter foundation cracks were noted on the back of the house, to the left of the back steps (*see picture 2 for example*).
 - Measurement by laser level indicated that the back-right corner of the main portion of the home was down as much as approximately $\frac{1}{4}$ " relative to the crack on the back of the home.
 - Roof gutter downspouts were noted to be installed for discharge at the foundation (*see picture 3 for example*).

Picture 2 – Foundation crack

- Install a series of (3) galvanized steel push piers to stabilize the structure against additional differential settlement.
 - Push piers should be driven until engagement of the structure with lift indicating adequate depth/frictional resistance along the shafts of the piers.

- Install piers at approximately 6' on center and at the approximate locations shown in the attached repair schematic.
- Provide drainage improvements around the perimeter of the structure such that rainwater runoff is adequately diverted from the perimeter of the home. Drainage improvements are intended to help avoid the need for extensive foundation repair/stabilization work in the future.

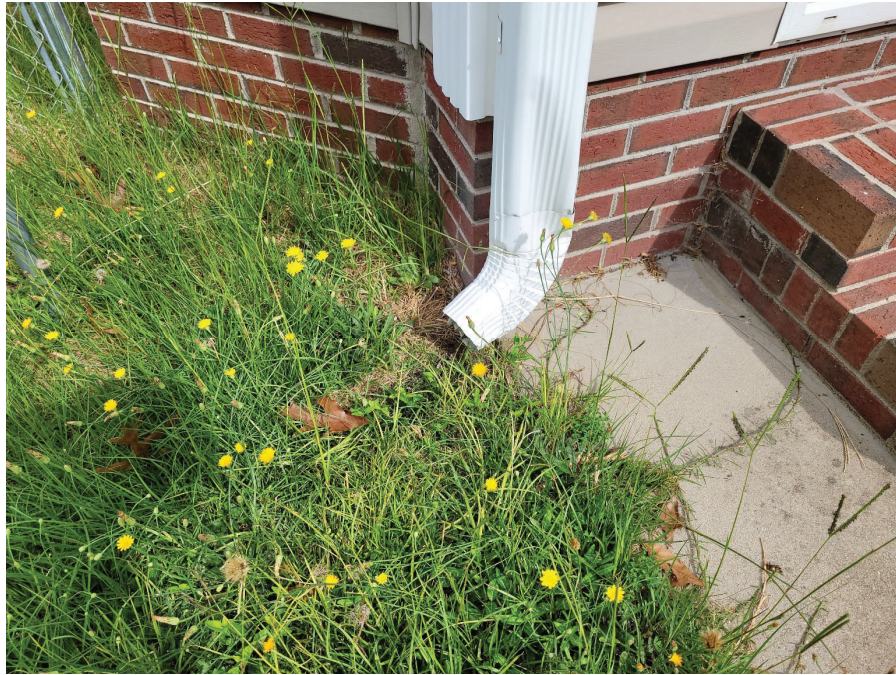
Picture 3 – Roof gutter downspouts installed for discharge at the foundation

- Current building standards require 6" of fall within the first 10' from a structure or use of drains and swales. A system of exterior perimeter "French" drains and/or catch basins installed at low points in the grade may be necessary to achieve adequate drainage. Any low spots in the grade adjacent to the home should be filled for positive drainage away from the structure.
- Extend roof gutter downspouts and any HVAC condensation drains for discharge at least 5' from the perimeter of the structure onto soils adequately graded away from the home.

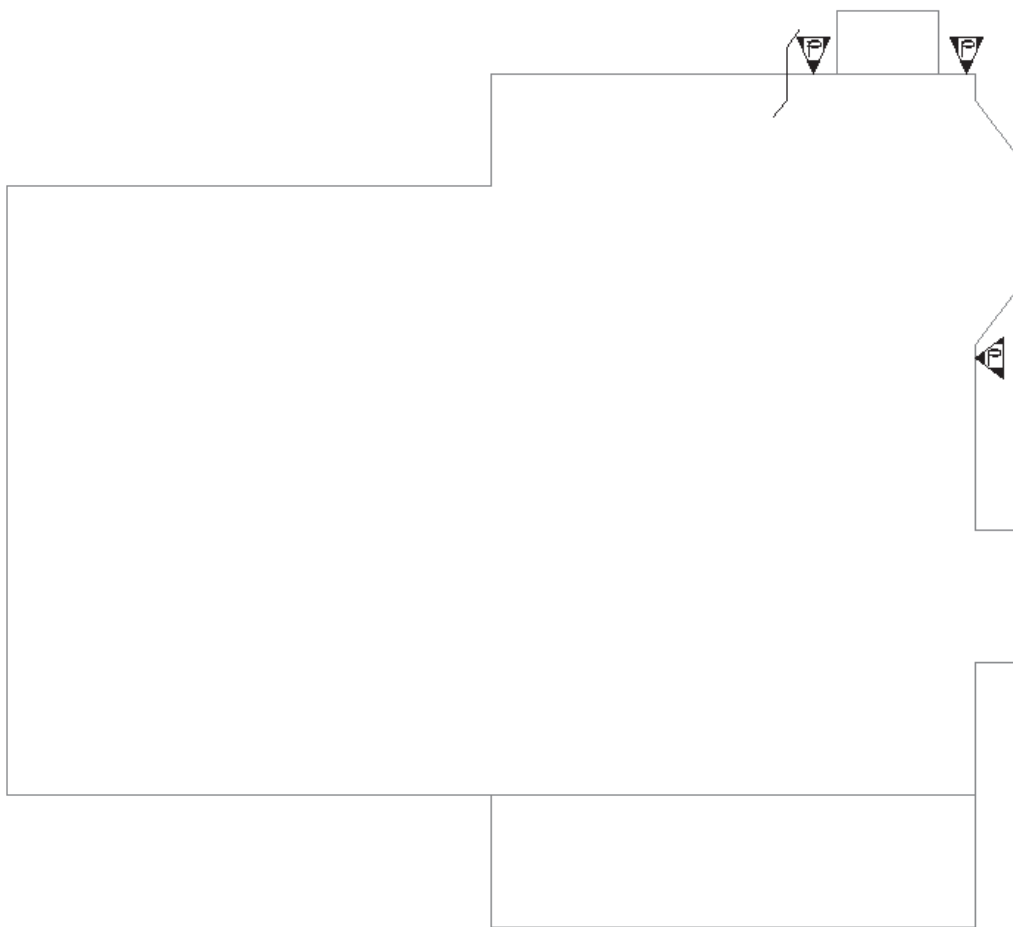
SCHEMATIC ADDENDUM

▼ APPROXIMATE PUSH PIER LOCATIONS

— APPROXIMATE LOCATION OF CRACK

We recommend the following work be performed by a qualified general contractor (*see repair schematic*):

- The contractor should locate and avoid utilities prior to work.
 - Where the foundation wall is less than 4' tall, avoid installing piers beneath windows or doors. **Piers should not be installed on the bay window at the back right of the home.**
