SFA Design Group, LLC

April 18, 2022

RE: Existing Condition Report
Bennett Residence
4105 Red Hill Church Rd
Coats, NC 27521

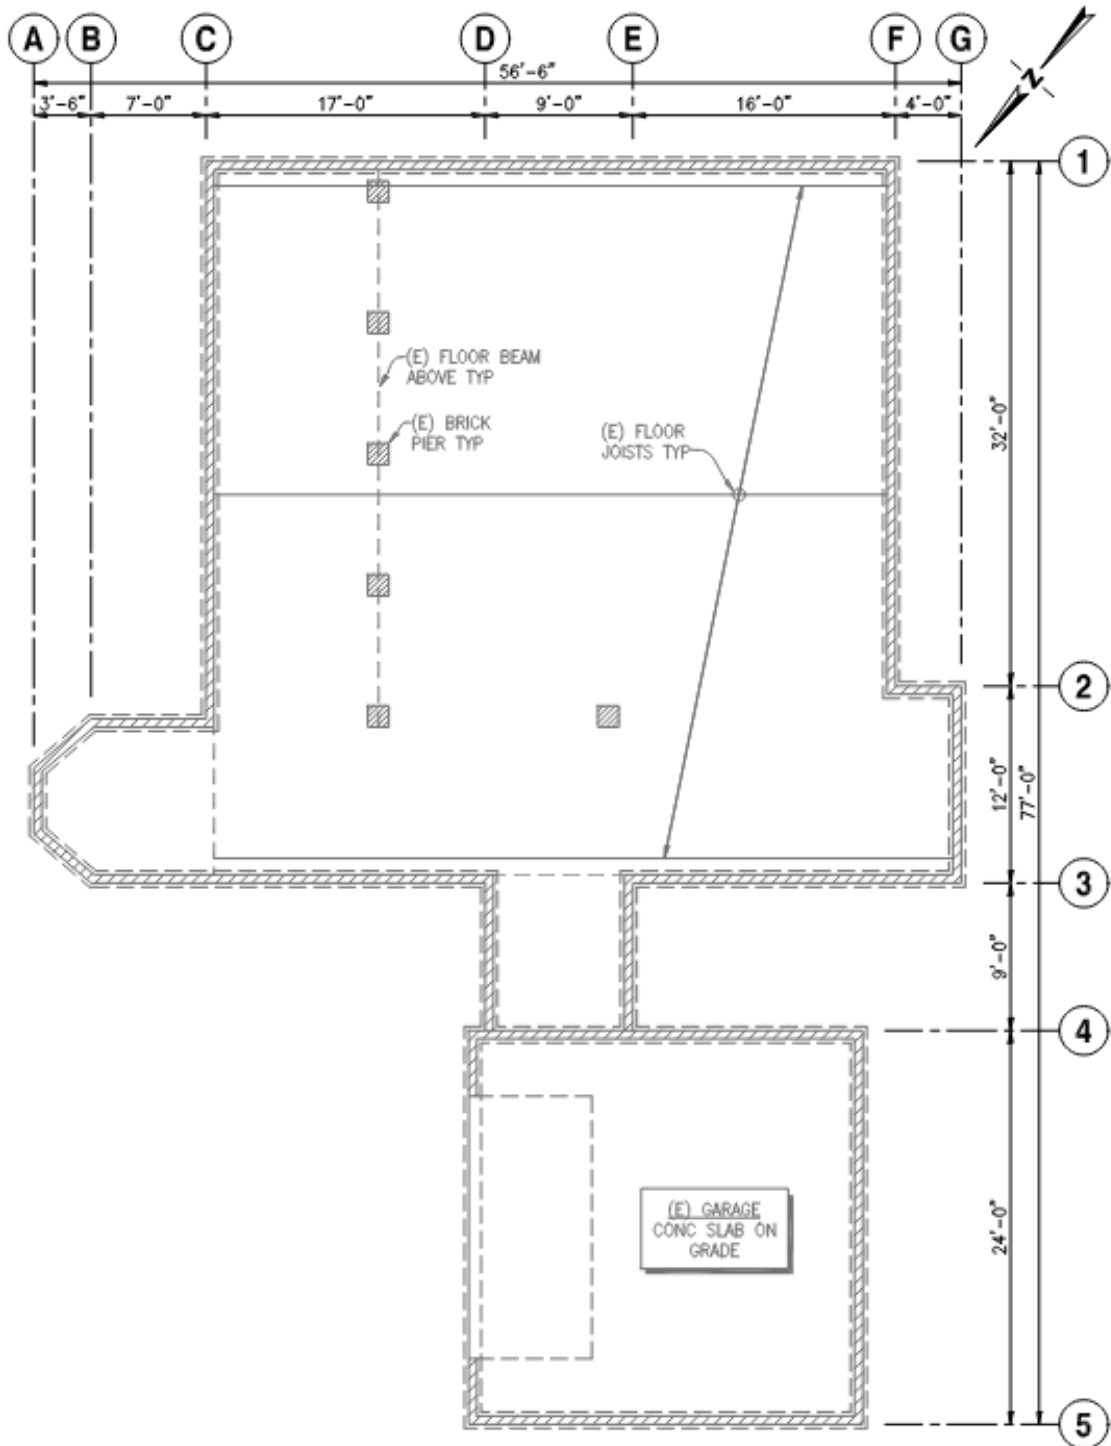
FOUNDATION LAYOUT

A visual inspection of the property found most of the CMU, brick and concrete foundation to be in average condition, with certain areas showing signs of differential settlement (Figure-C).

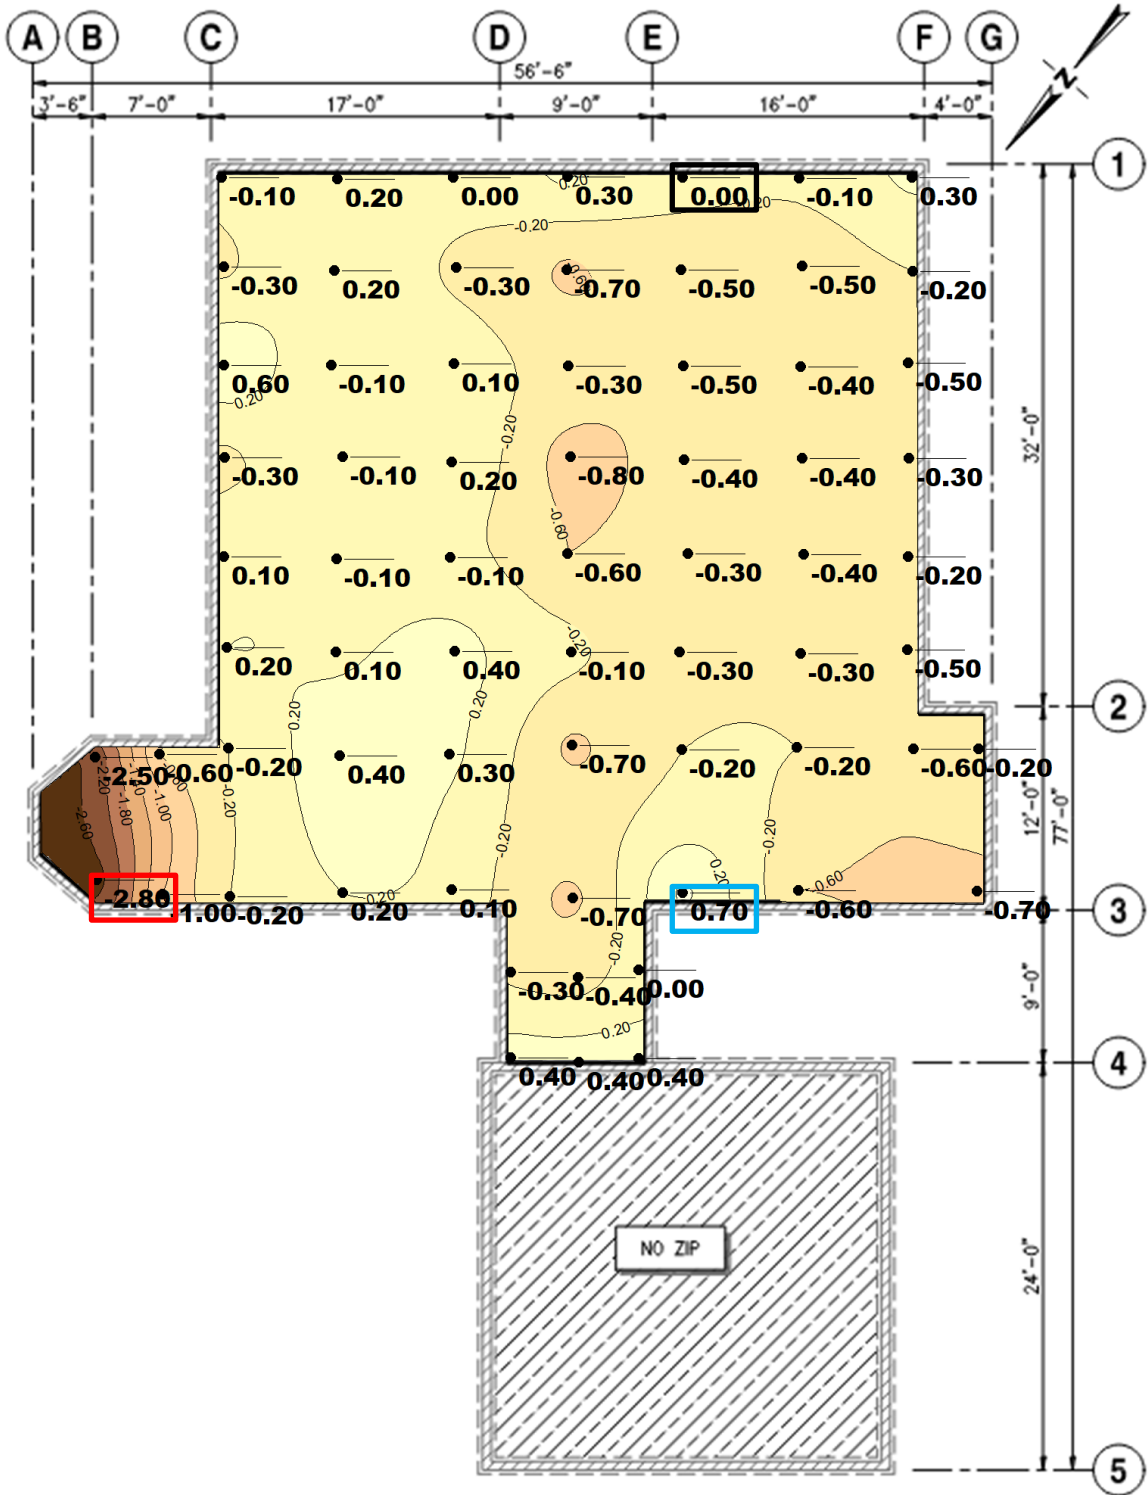
ZIP LEVEL MEASUREMENTS AND 2D TOPOGRAPHIC MAP	Project Number: RBC22-046

A Zip Level Survey was performed on the interior of the subject property, using the front door as the bench mark or starting point; designated as "0.0" on the floor plan (Figure-D). Measurements of the floor elevation were made in tenths of an inch. The high point was +0.7" and the low point was -2.8". The maximum difference in the floor readings was 3.5". As can be seen on the topographic map, the most significant settlement is indicated by dark brown contours surrounding the area (Figure-D & E).

Starting Point: 0.0
 Highest Point: +0.7"
 Lowest Point: -2.8"
