Re: Structural Observation — 134 Pear Tree Lane, Fuquay-Varina, NC 27526

At your request, on May 25, 2022 we performed a visual structural observation of deteriorated framing in the addition, sloping floors, and damaged beams at the Fuquay-Varina residence noted above. The structure is a double wide manufactured home over a pier/curtain wall with interior masonry piers. An addition has been constructed on the right side of the home that has raised 1st floor framing over a pier/curtain wall foundation system (*see picture 1*).

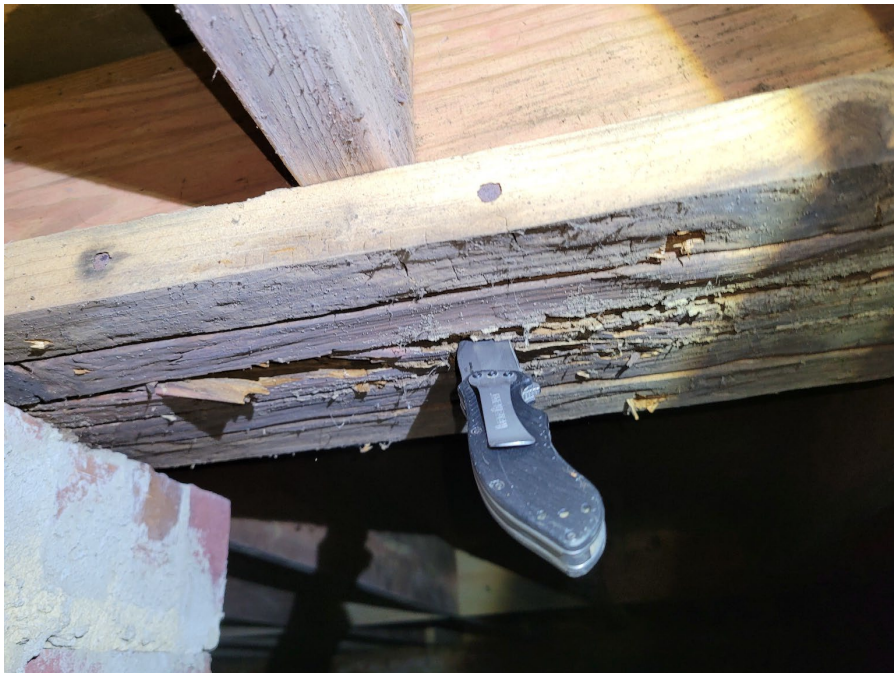
- Thorough probing of the 1st floor framing in the addition revealed that the following members were deteriorated beyond the salvageable limits (*see pictures 2-5 for examples*).
 - Both spans of the girder.
 - All floor joists in the front bay of the addition.
 - The 4th through 6th floor joists in the back joist bay from the left wall of the addition. Additionally, the floor sheathing above these joists.
 - The members were noted to have been haphazardly repaired (*see picture 6 for example*).

- The above-noted deteriorated floor framing has been the result of a combination of potential wood destroying insect (WDI) activity and rot due to prolonged exposure to moisture in the crawlspace.

Picture 2 – Example of deteriorated girder

- Remove the above-noted significantly deteriorated portions of the girders and replace using full depth treated (3)2x8 #2 Southern Yellow Pine (SYP) material with continuous span between existing and proposed masonry girder support piers.

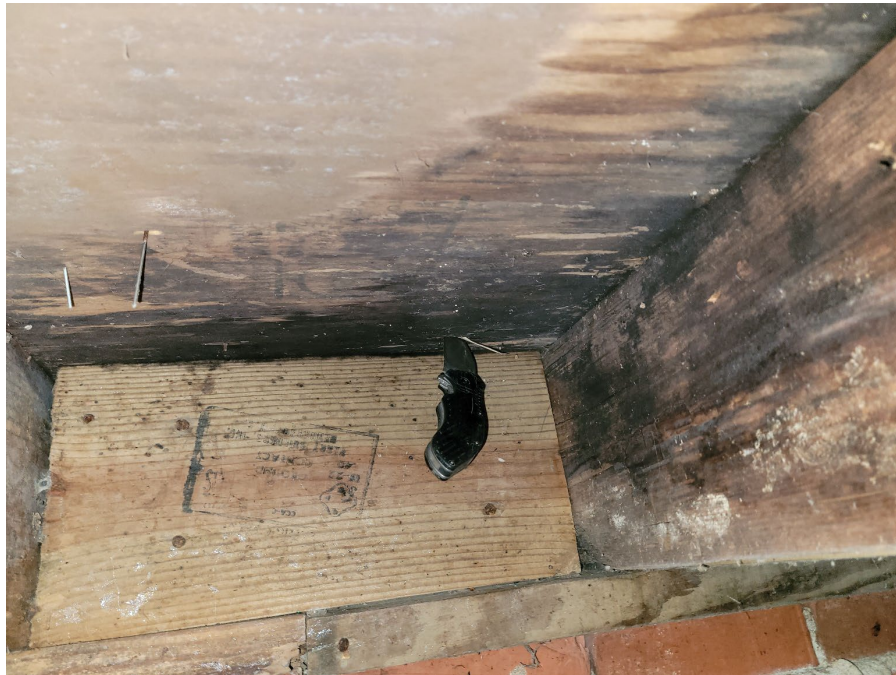
Picture 3 – Example of deteriorated sheathing

- New floor joists should be notched as necessary and fastened to the new girder and rim beam using Simpson double face hangars.
- Clean and reinforce the above-noted deteriorated and haphazardly repaired sheathing using tight fit ¾" plywood with edge support by 2x4s securely fastened to parallel joists (*see attached detail addendum*).

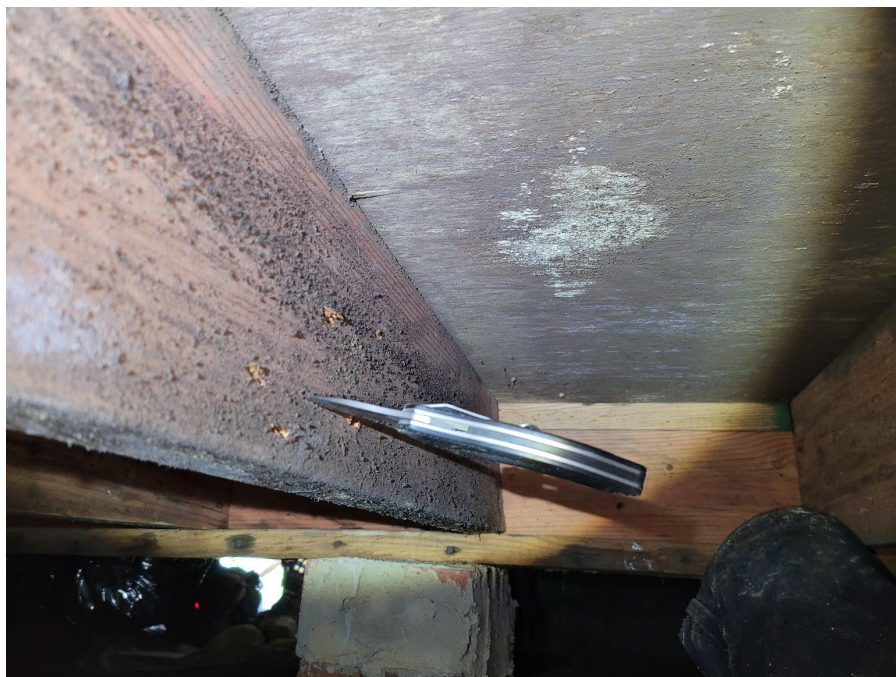
Picture 4 – Example of deteriorated floor joist

- Reinforce all joists in the addition with an additional ply of 2x10 #2 SYP, fastened to the side of the existing joists using (3)10d common nails at each end and at 12" on center staggered top and bottom along the lengths of the joists. Sistered material should span continuously between end supports.

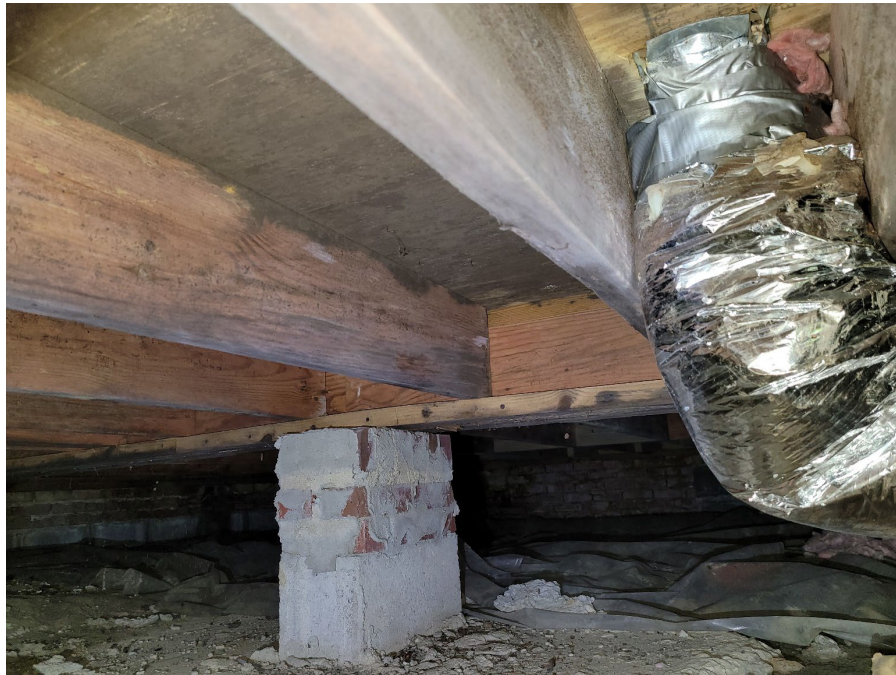
Picture 5 – Example of deteriorated floor joist

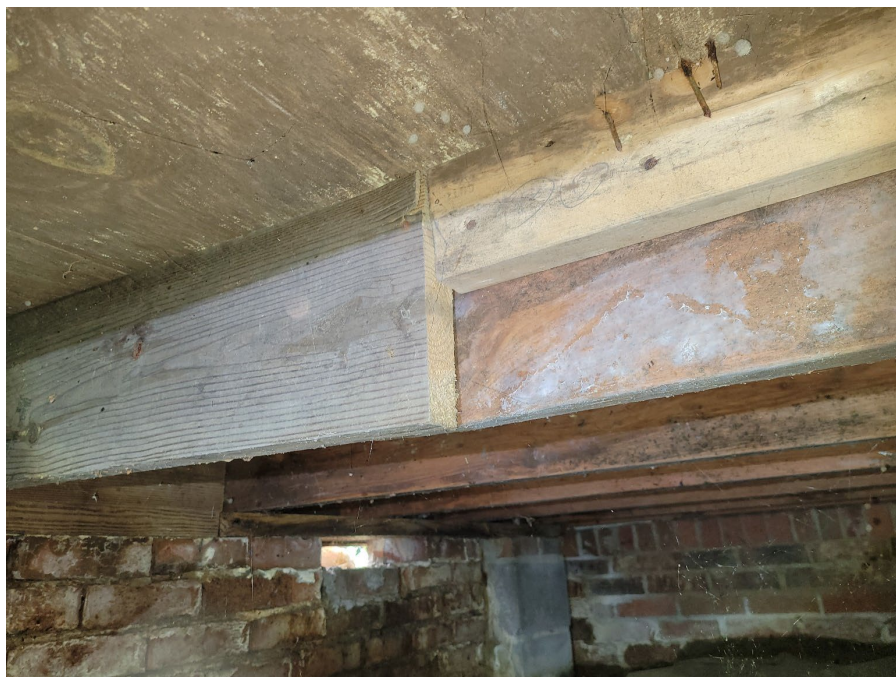
Picture 6 – Example of haphazardly reinforced floor joist

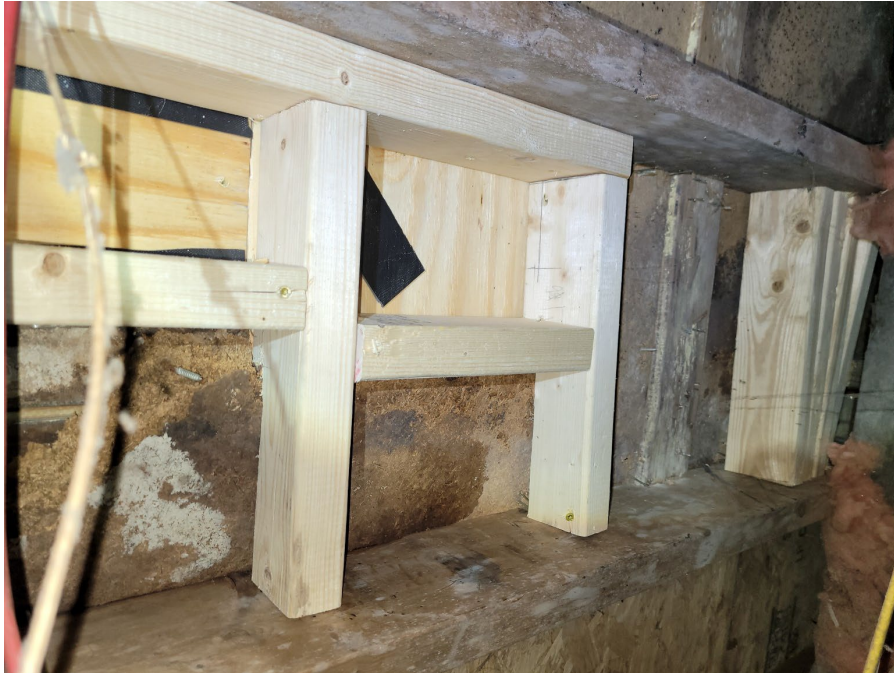
- Uneven floors and “soft” spots were noted at various locations throughout the manufactured home, especially along the marriage line.
 - Investigation of the crawlspace revealed that sections of sub-floor in the manufactured home had been haphazardly replaced (*see pictures 7-8 for examples*).
 - Crawlspace soils were noted to be damp, and the vapor barrier was in poor condition (*see picture 9 for example*).
- The middle and right portions of the manufactured home were not accessible due to low clearance and the presence of ductwork (*see picture 10 for example*).

- The above-noted uneven floors been the result of a combination of differential settlement of interior masonry piers due to inadequate management of moisture in the crawlspace and previous repairs made to the floor sheathing.

Picture 7 – Example of haphazardly replaced sheathing

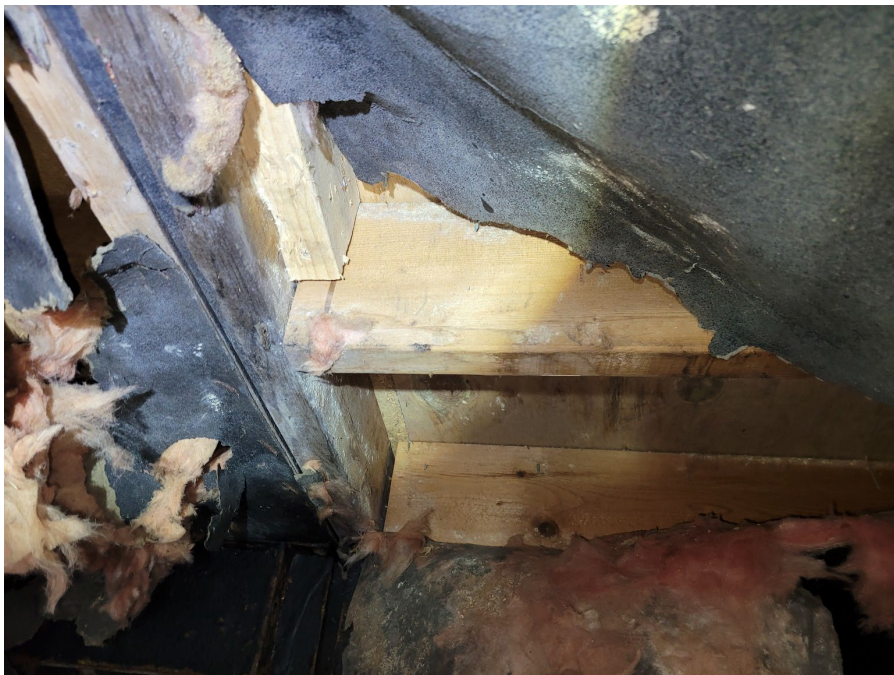
Picture 8 – Example of haphazardly replaced floor sheathing

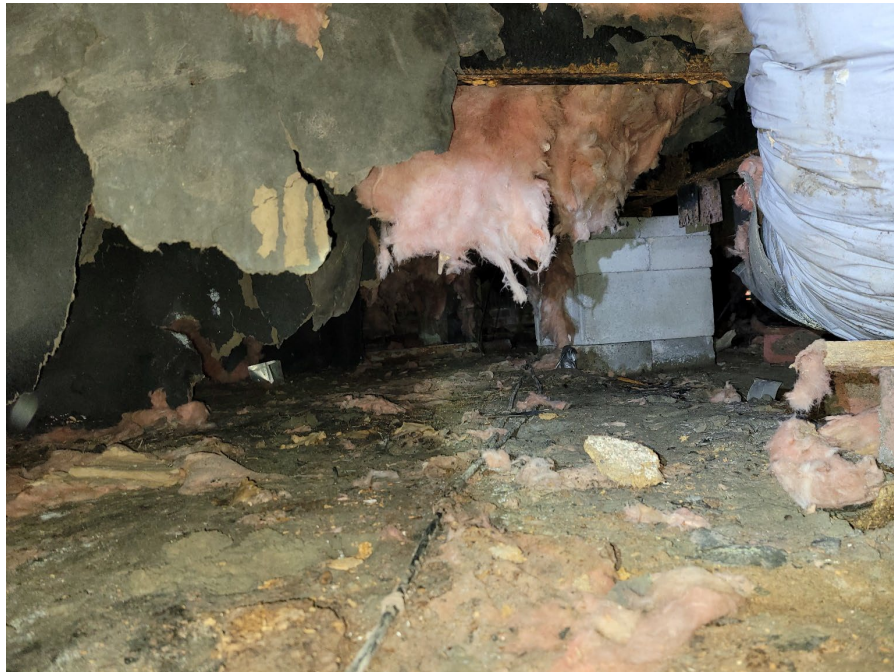
Picture 9 – Example of damp soils with poor vapor barrier coverage

- Improve vapor retarder coverage such that the entire crawlspace floor is covered and edges are sealed around the bases of masonry piers.
 - Vapor retarder improvements are recommended as an attempt to better manage moisture levels in crawlspace soils to help mitigate the effects of further settling of interior masonry piers. However, while this is typically the most cost effective solution for the given circumstances, this method is not always successful and interior pier(s) may continue to settle over time which could necessitate removal and replacement of affected piers with new piers installed over footings which extend down to firmer soils located deeper in the ground.

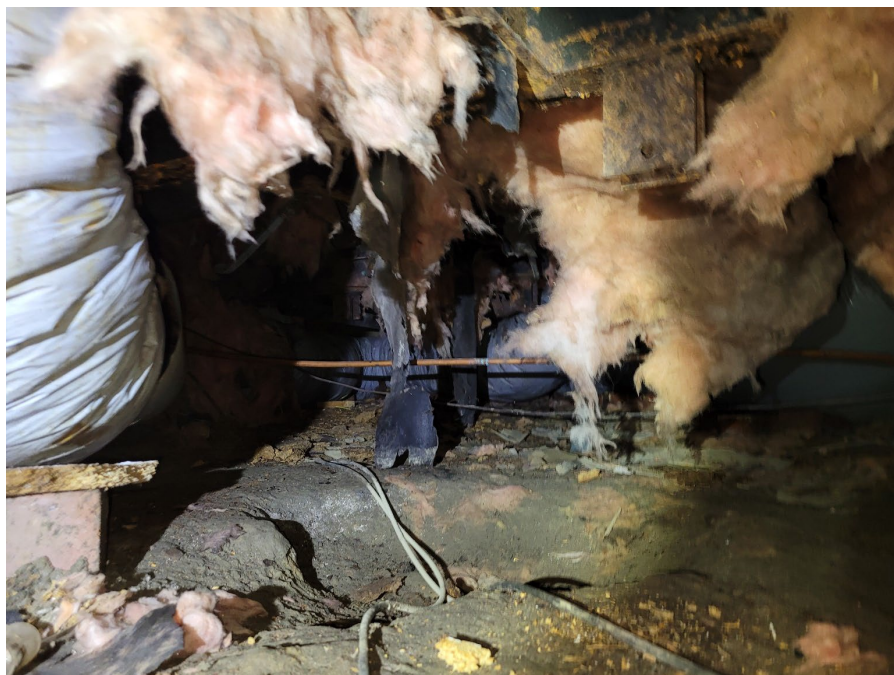
- Removal of ductwork and the underfloor insulation would be required to fully inspect the sub-floor of the manufactured portion of the home to diagnose the extent of the previous sub-floor repairs.

Picture 10 – Example of limited access due to clearance and ductwork

- Modern building standards require at least 18" of clearance from top of crawlspace soils to the undersides of joists, and at least 12" of clearance from top of crawlspace soils to the undersides of girders. We recommend removal of soils from the crawlspace as is necessary to achieve minimum clearances to help prevent significant deterioration of wood framing members due to rot. Care should be taken not to undermine foundation elements by removal of soils from the crawlspace.

- Once soils have been excavated, the floor system at the currently inaccessible portions of the crawlspace should be observed and analyzed.
 - If excavation is not to be performed, any new framing material should be treated #2 SYP in areas where minimum clearances are not met.

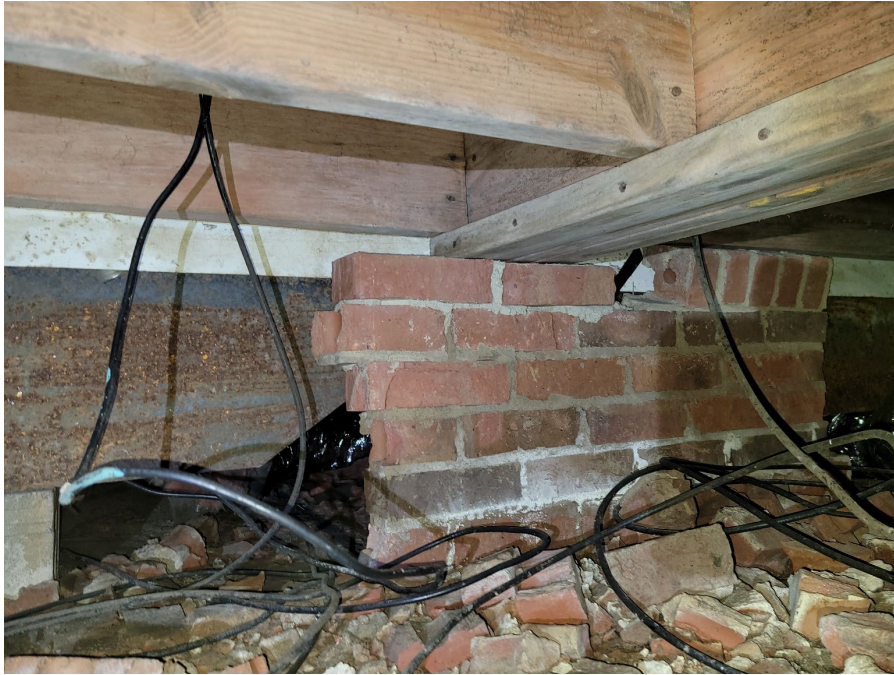
- The left end of the girder in the addition was bearing on the non-structural curtain wall of the original manufactured home (*see picture 11*).

Picture 11– Example of girder end bearing on the curtain wall

- The girder should be supported with piers at the left end, and at mid span of both existing spans. The new piers should be constructed per the detail at the end of this report and should be centered over 24"x24"x10" thick poured concrete footings.
