Reference: Engineering Services
447 Deanne Lane
Coats, NC 27521
TE&D Project No.: 1901-020458_A

- 1) Structural assessment of the first-floor framing within the crawlspace.

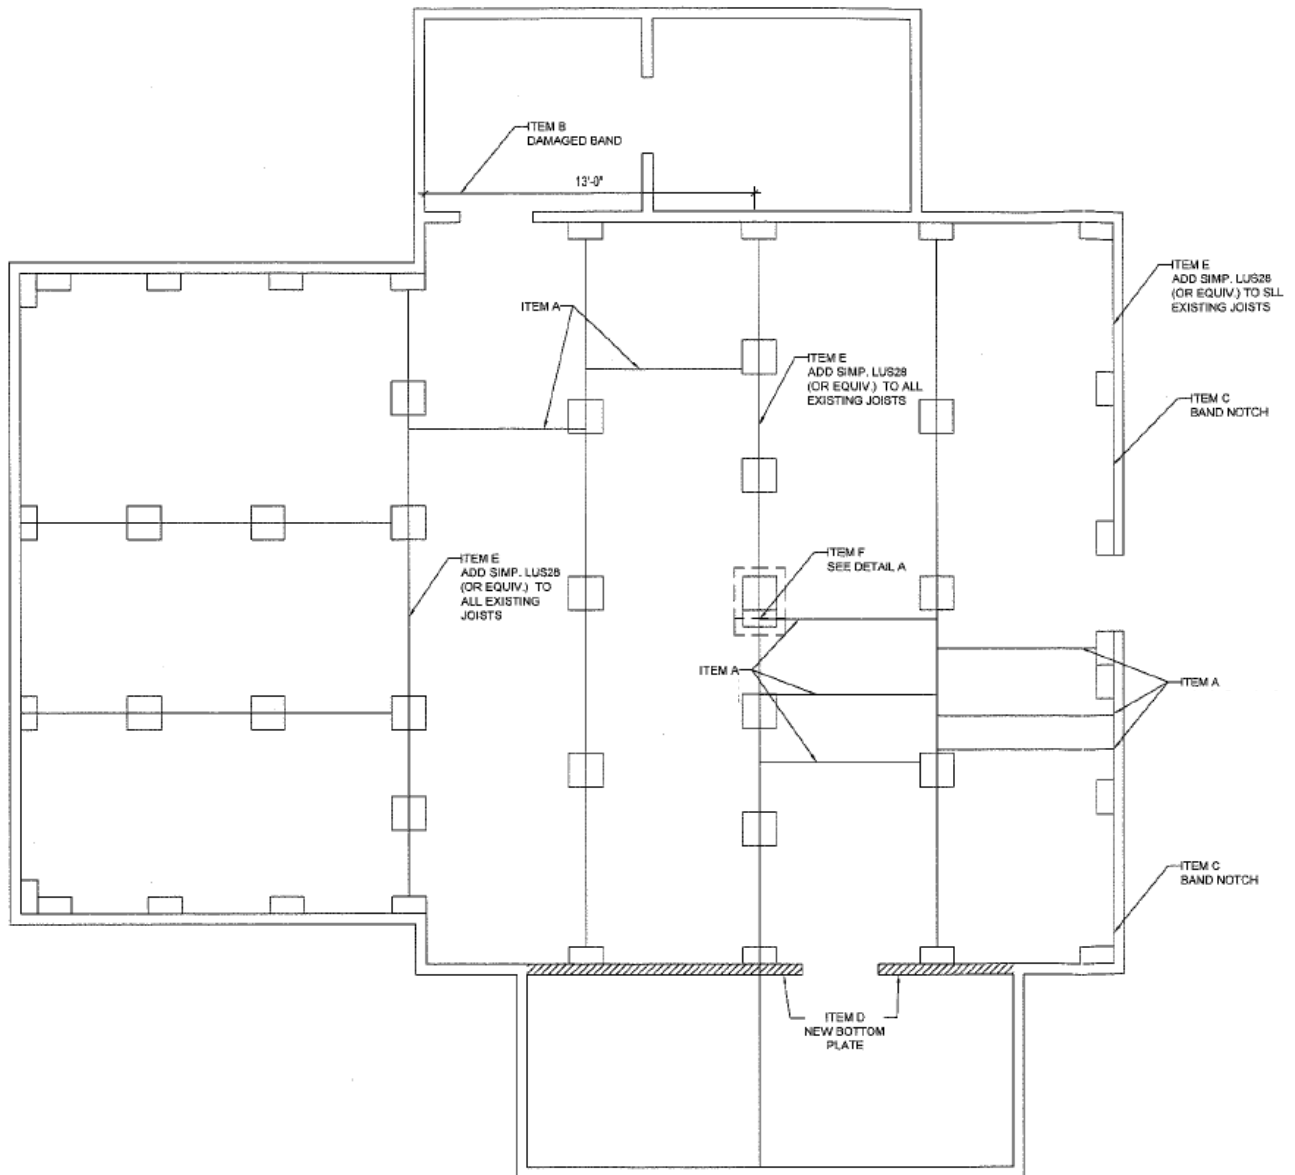
- A) Eight (8) 2 x 8 joists were observed to have been previously damaged by wood destroying insects. New, treated 2 x 8 joists are to be "sistered" to all damaged joists with (2) rows of 10D nails at 16" o.c. New joists are to have full bearing at each end. (see plan for joist locations)

- F) An unsupported splice was observed in the second girder from the right. A new 8 x 16 CMU block pier is to be installed below the splice. The new pier is to have full bearing on a new, minimum 12" x 20" x 10" poured concrete footing. (see plan for location and detail A for installation)
