Reference: Engineering Services
447 Deanne Lane
Coats, NC 27521
TE&D Project No.: 1901-020458_A

- 1) Structural assessment of the first-floor framing within the crawlspace.

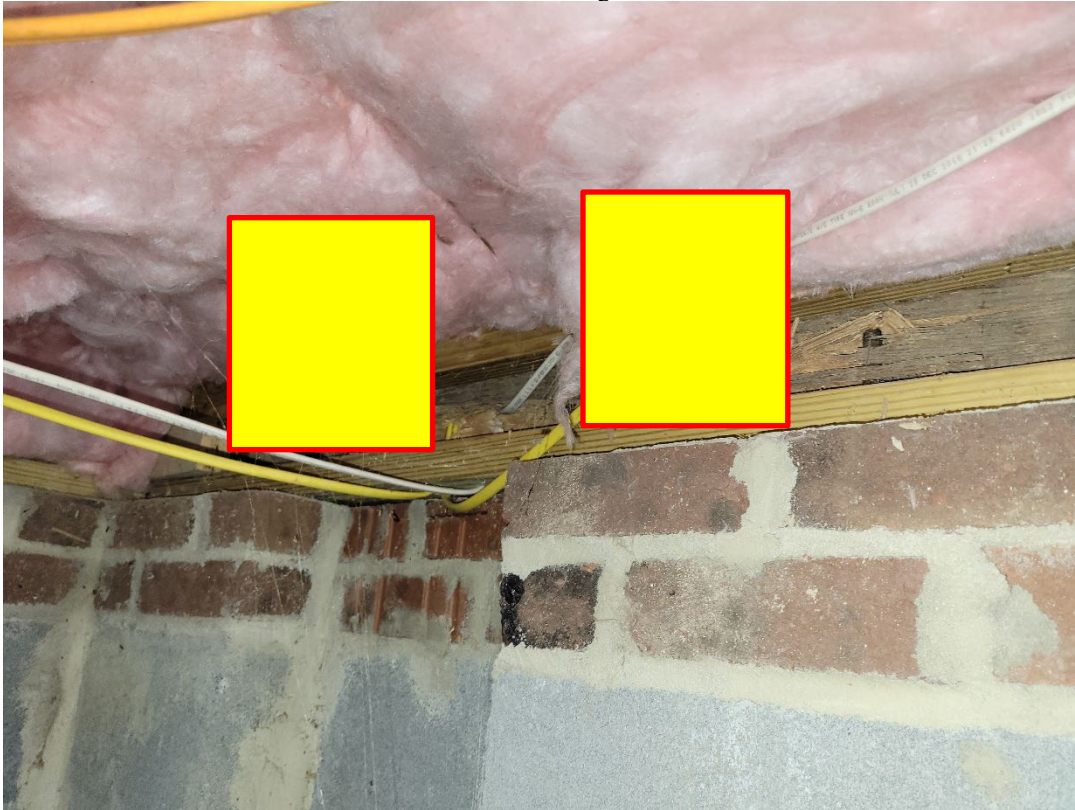
Item #1B:
Install 2 x 10 Blocking at 16" o.c.

- B) Approximately 13'-0" of the 2 x 8 band at the rear of the house was observed to be damaged. Based on our observations and analysis, the band is to be reinforced with 2 x 10 blocking installed vertically at 16" o.c. Blocking is to be secured to the exterior deck band with 5/8" diameter through bolts. A (2) 2 x 8 header is to be installed over the crawlspace opening.

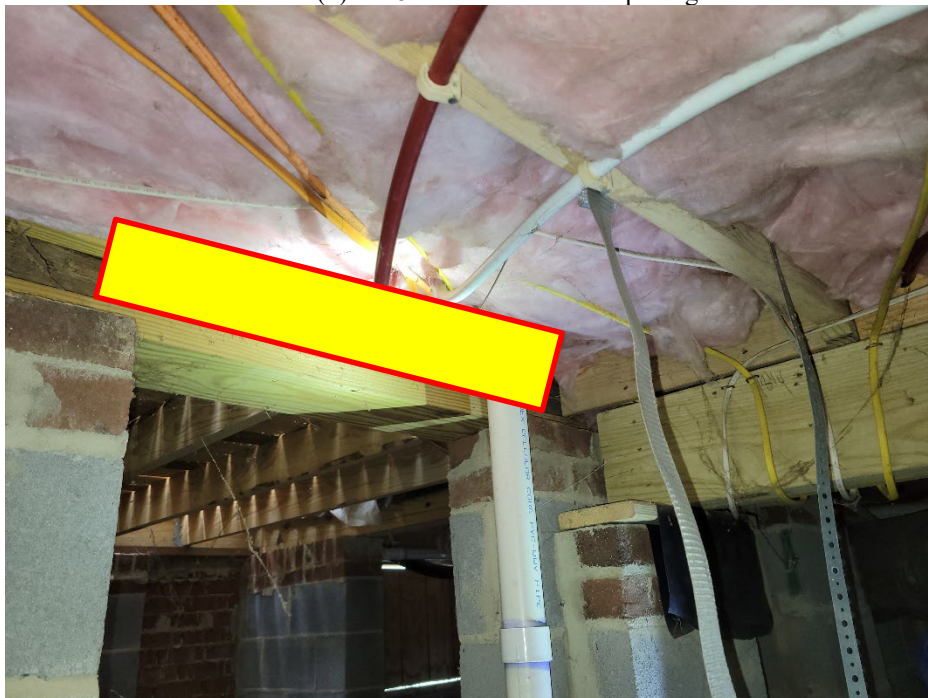
Install (2) 2 x 8 header over crawl opening

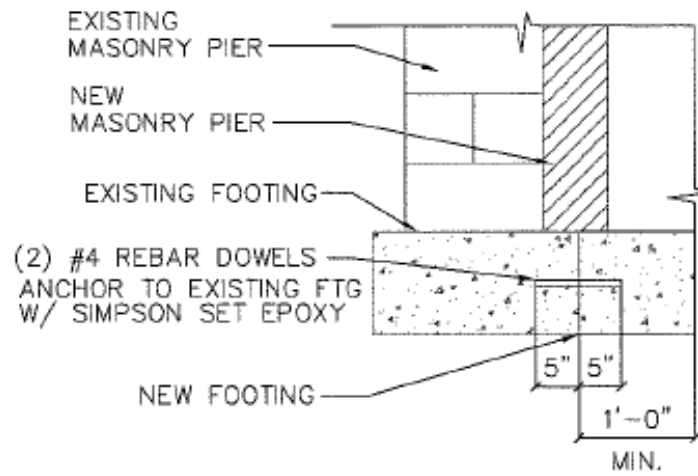
DETAIL "A"

- F) An unsupported splice was observed in the second girder from the right. A new 8 x 16 CMU block pier is to be installed below the splice. The new pier is to have full bearing on a new, minimum 12" x 20" x 10" poured concrete footing. (see plan for location and detail A for installation)
