Reference: Engineering Services  
905 Cool Springs Rd.  
Lillington, NC 27546  
TE&D Project No.: 2301-020053

As requested, a representative of Tyndall Engineering & Design, PA (TE&D) was on-site to observe the following item(s):

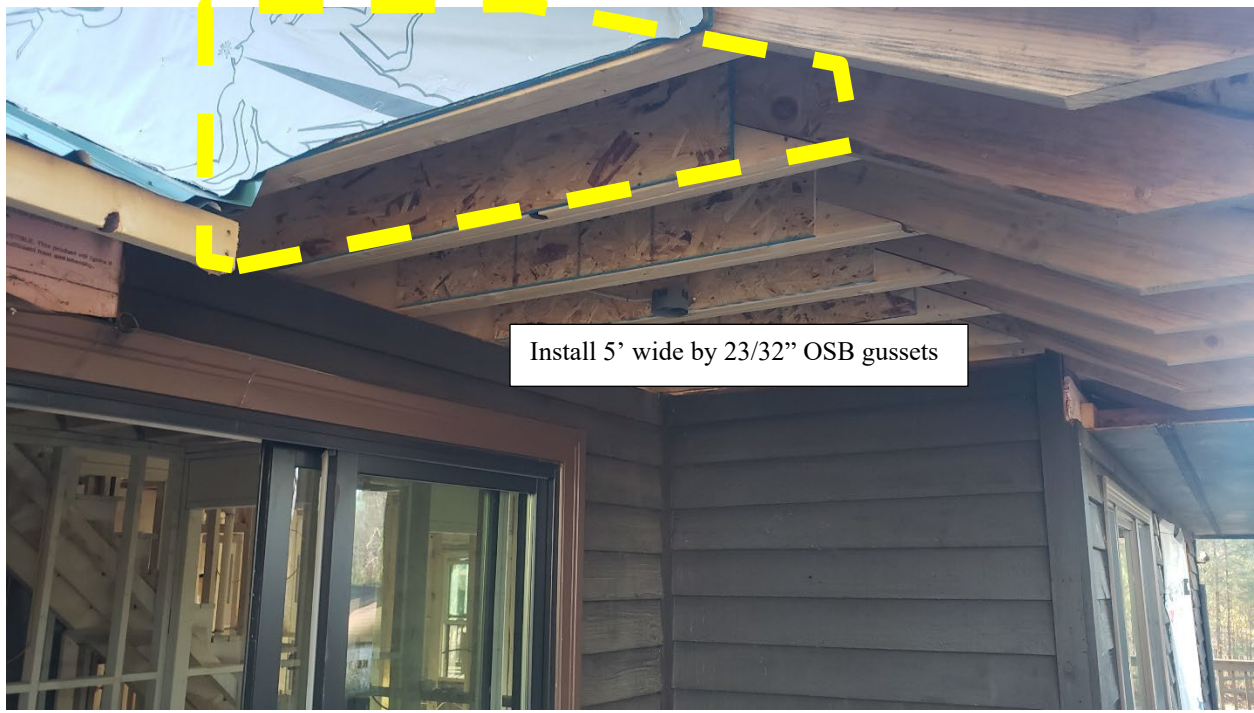
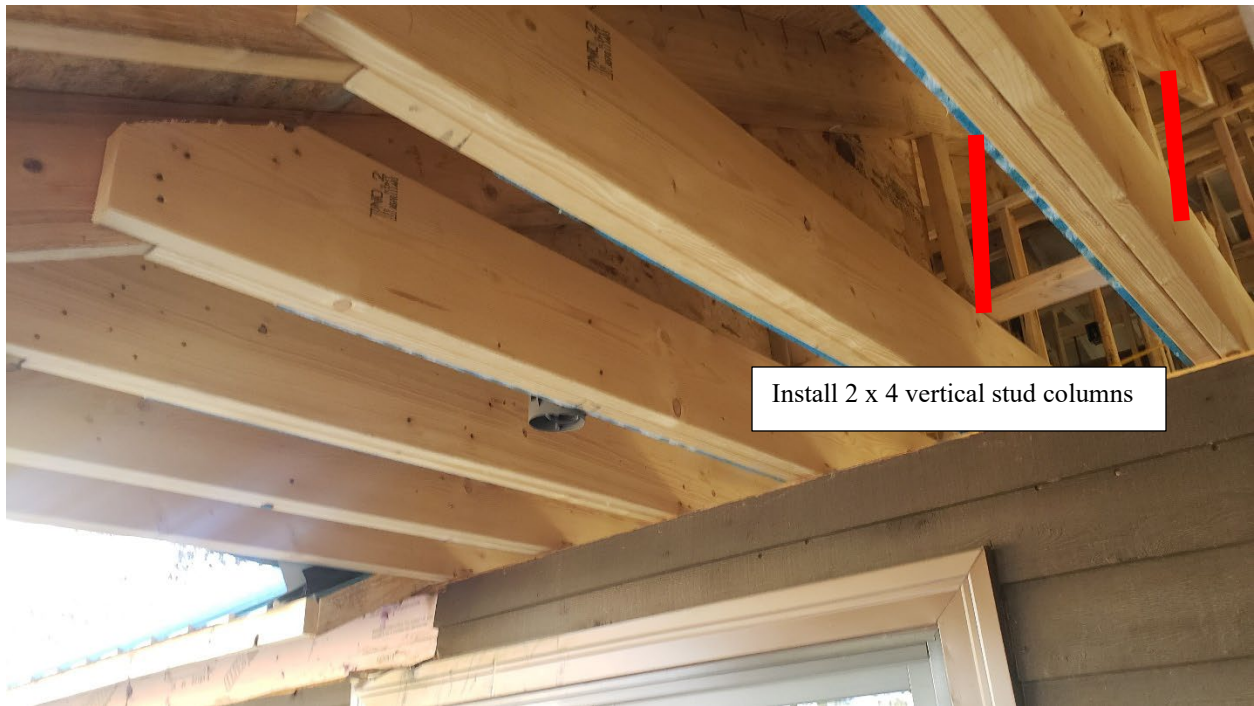
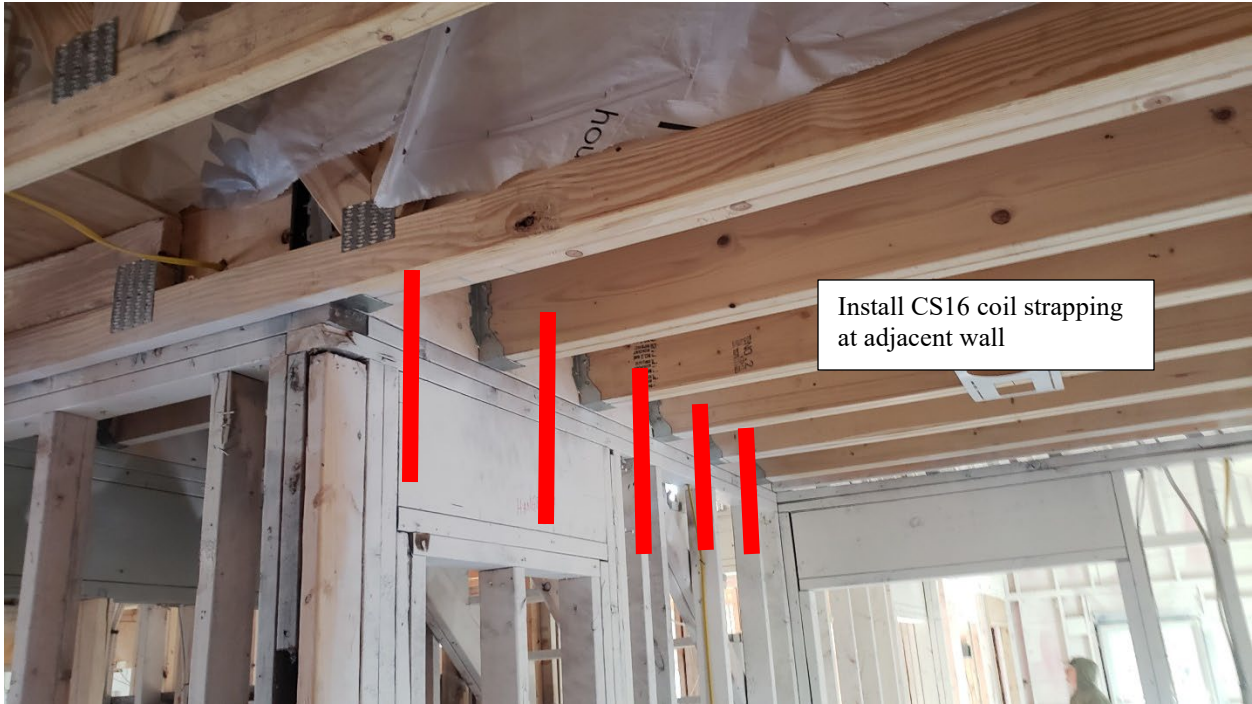
### Cantilevered Roof Framing

- 1) We understand the roof framing cantilevers 5'-0" over the rear exterior door. The roof was framed with 2 x 8 rafters at 16" o.c. spanning 15'-0". The ceiling was framed with (2) 2 x 10 joists at 16" o.c. spanning a maximum 10'-0" and cantilevered 5'-0". Based on our observations and analysis, the following modifications are to be made:

- A) The 2 x 8 rafters are to be reinforced with collar ties at 16" o.c.
  - B) New 2 x 4 vertical studs are to be installed tightly between the 2 x 8 rafters and the (2) 2 x 10 ceiling joists. The new studs are to be installed at 16" o.c. (i.e., every rafter/ceiling joist)

- C) New 5'-0" wide by 23/32" OSB gusset plates are to be installed to the cantilevered roof framing. The new gusset plates are to be secured to the rafters, ceiling joists, and wall studs (installed in item 1.B.) with (2) rows of 8D nails at 4" o.c.

- D) The (2) 2 x 10 joists are to be secured together with (3) rows of 10D nails at 16" o.c.
  - E) The wall 10'-0" adjacent to the rear exterior is to be reinforced with Simpson CS16 coil straps (or equivalent) installed per the manufacturer's specification. New coil straps are to be installed at 16" o.c. (i.e., every stud) to prevent uplift from the cantilevered ceiling joists. See attached photo at the top of page 4.

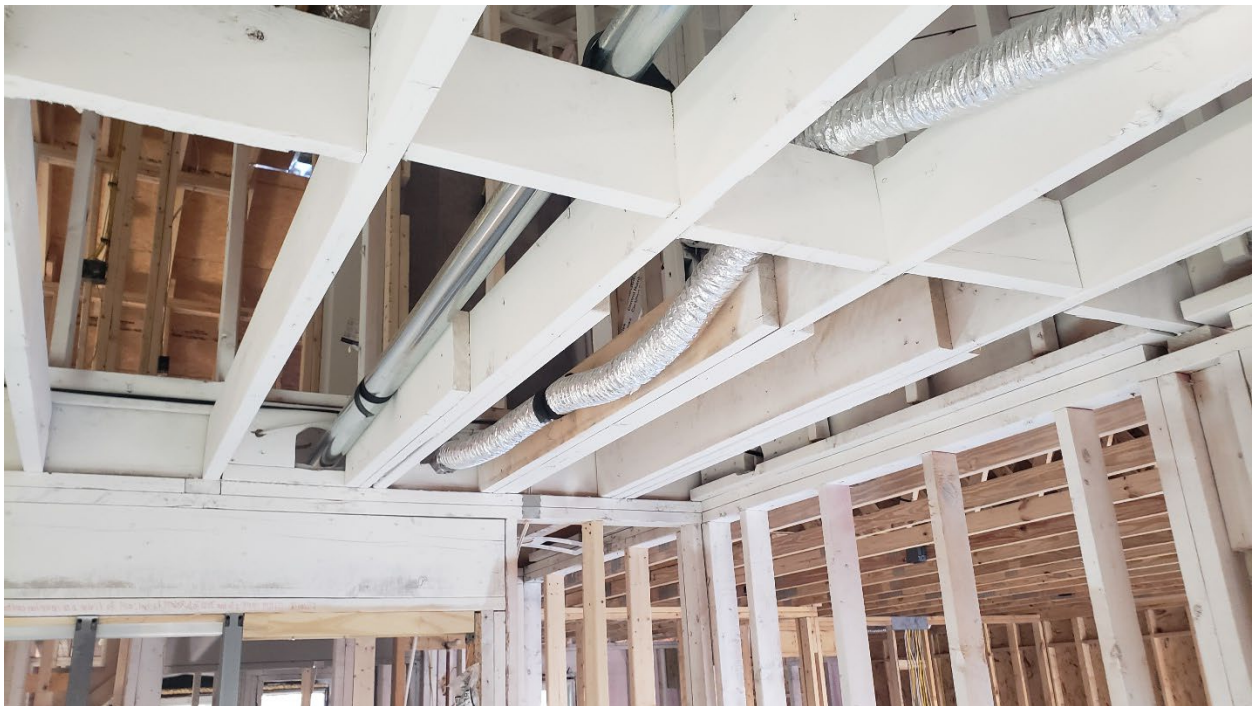
**“Scabbed” Ceiling Joists**

- 2) (3) notched 2 x 8 ceiling joists spanning 13'-10" over the front bedroom were reinforced with 3'-0" long and 5'-0" long "scabs". The existing joists and scabs are suitable and are to be fastened with (2) rows of 10D nails at 4" o.c.

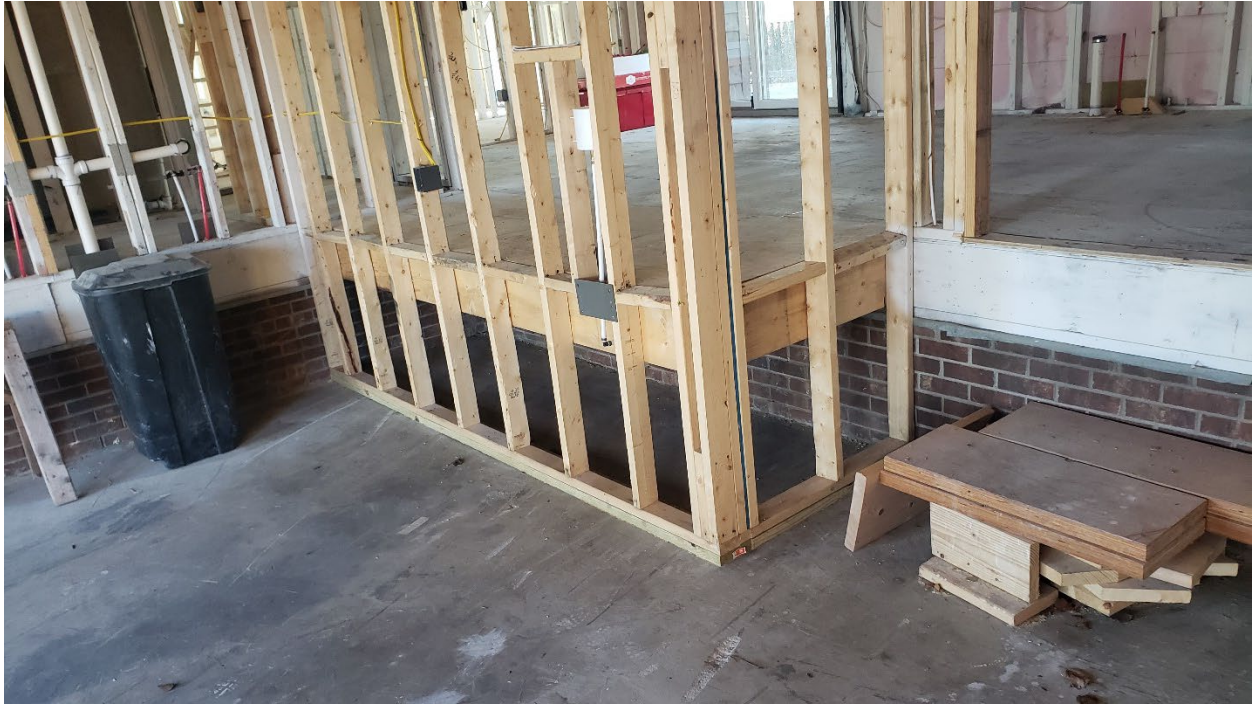
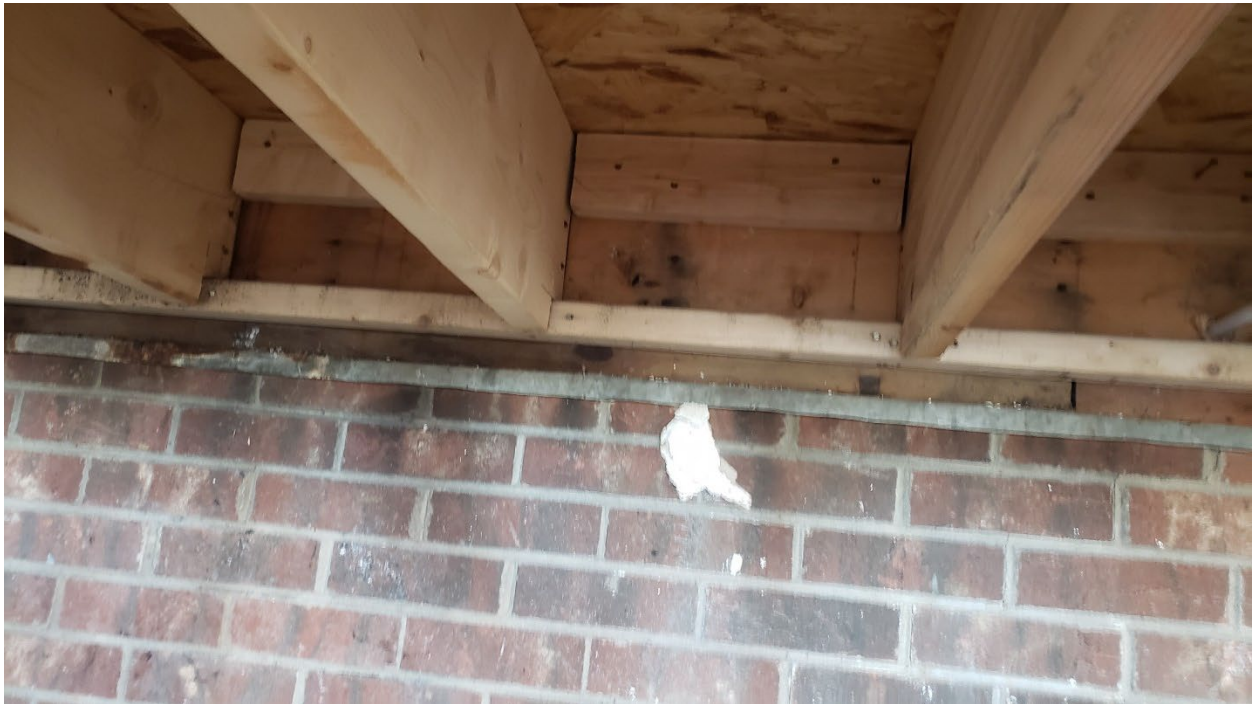
### **Kitchen Addition within the Garage**

- 3) A 3'-0" x 10'-0" addition to the kitchen was installed within the garage. The floor of the addition was framed with 2 x 10 joists at 16" o.c. spanning 3'-0" front to rear with full bearing at the garage foundation wall and at a (1) 2 x 10 band. Based on our observations and analysis, the (1) 2 x 10 band is not adequately supported and is to be secured to the wall framing with (3) rows of 10D nails at 16" o.c. (i.e., every stud). Additionally, the ledgers are to be secured to the bands with (4) 10D nails per joist.

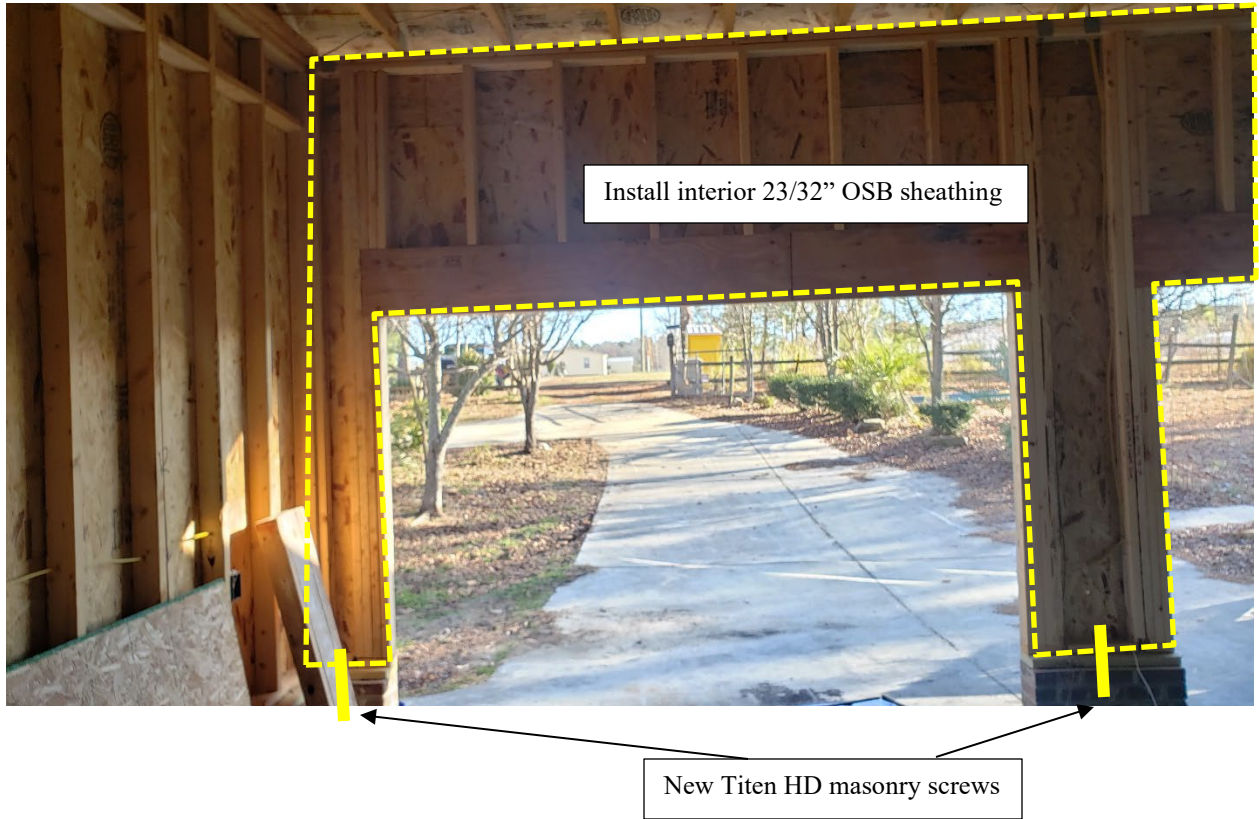
### Garage Door without Portal Framing

- 4) We understand that the (2) 9'-0" wide garage doors were not framed using the portal framing method. Based on our observations and analysis, the following modifications are to be made:

- A) New 1/2" x 8" Simpson Titen HD masonry screws are to be installed per the manufacturer's specifications at each end of the garage doors and between the garage doors. (1) screw is to be installed per location.

- B) New 23/32" OSB sheathing is to be installed to the interior of the front garage wall. The sheathing is to be secured to all framing members with (1) row of 10D nails at 4" o.c. Sheathing is to be installed in full sheets and is to be cut tightly around openings.
