**APPLICATION ID:**  
APP-05552

**INSPECTION RECORD ID:**  
INSP-0005702

## ASBESTOS REPORT

**RE: Asbestos Inspection**

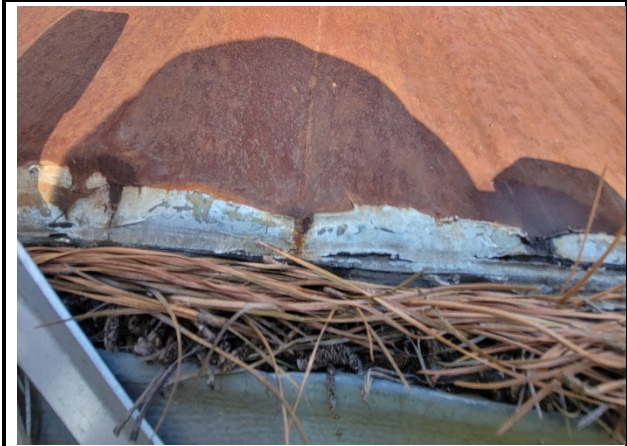
Of the suspected asbestos containing materials collected, none were found by analytical analysis to be regulated asbestos materials (>1% by weight).

Roof Sealant

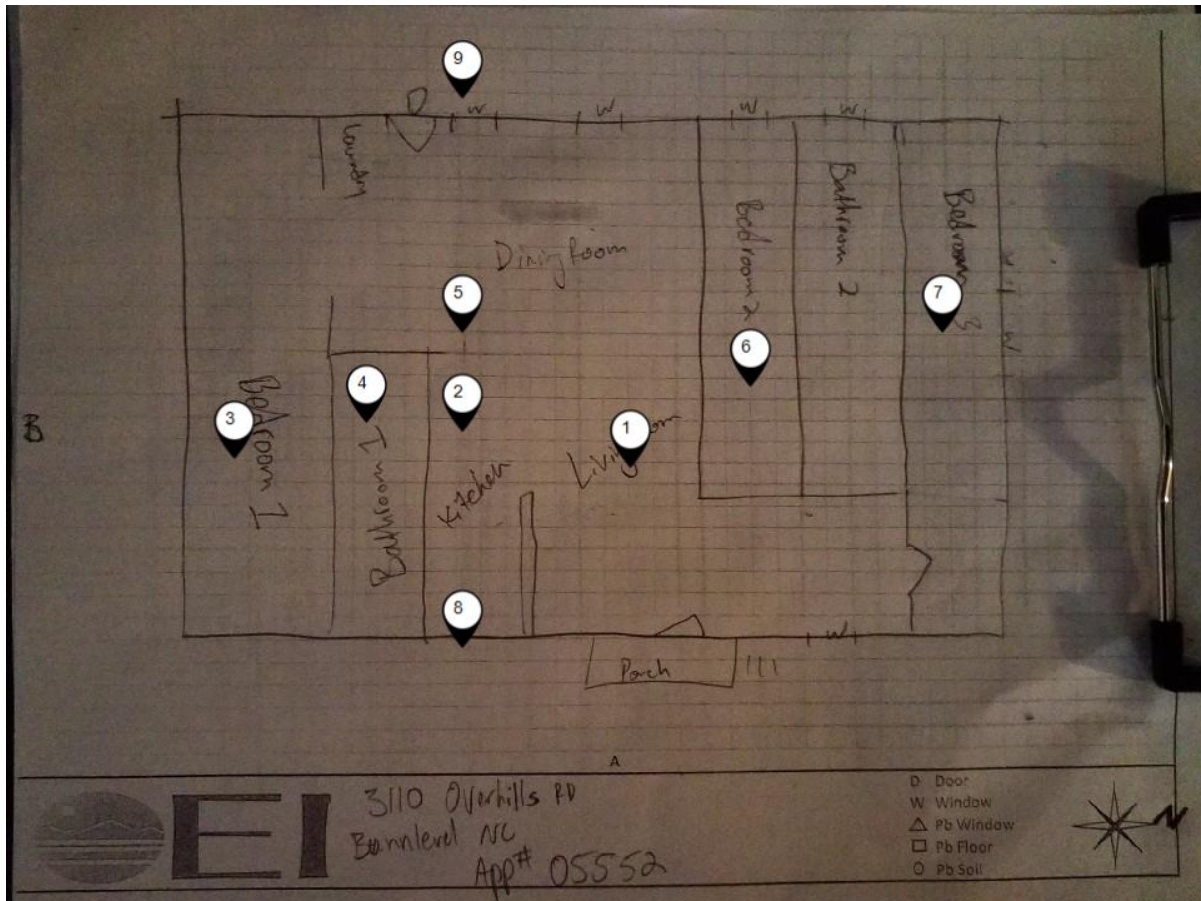
All Sample Locations for Main floor

Map ID	Sample ID	Section Name	Space Name	Material	Lab Result	Analytical Result
1	001A	Main floor	Living Room	001 - Textured Ceiling Material (Popcorn)	Tested Negative by Lab (No Asbestos Detected)	N/A
2	001B	Main floor	Kitchen	001 - Textured Ceiling Material (Popcorn)	Tested Negative by Lab (No Asbestos Detected)	N/A
3	001C	Main floor	Bedroom 1	001 - Textured Ceiling Material (Popcorn)	Tested Negative by Lab (No Asbestos Detected)	N/A
4	002A	Main floor	Bathroom 1	002 - Brown Linoleum	Tested Negative by Lab (No Asbestos Detected)	N/A
5	002B	Main floor	Kitchen	002 - Brown Linoleum	Tested Negative by Lab (No Asbestos Detected)	N/A
6	003A	Main floor	Bedroom 3	003 - Gypsum Wallboard	Tested Negative by Lab (No Asbestos Detected)	N/A
7	003B	Main floor	Bedroom 2	003 - Gypsum Wallboard	Tested Negative by Lab (No Asbestos Detected)	N/A
8	004A	Main floor	Side A	004 - Caulk, Window	Tested Negative by Lab (No Asbestos Detected)	N/A

9	004B	Main floor	Side C	004 - Caulk, Window	Tested Negative by Lab (No Asbestos Detected)	N/A

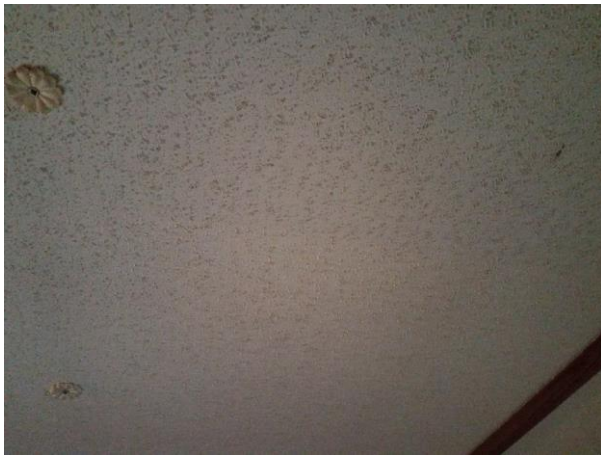
001A, 001 - Textured Ceiling Material (Popcorn), Living Room, Main floor

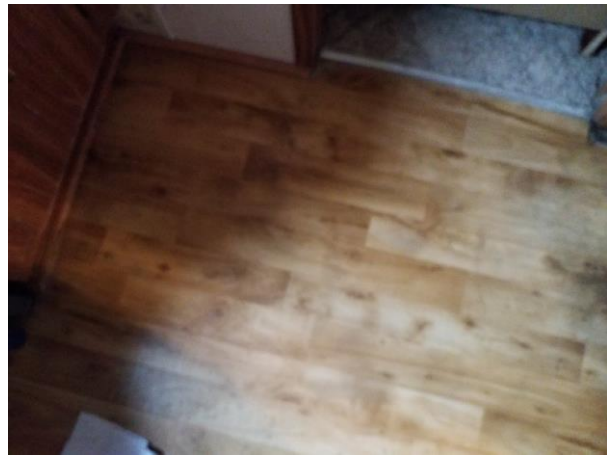
002A, 002 - Brown Linoleum, Bathroom 1, Main floor

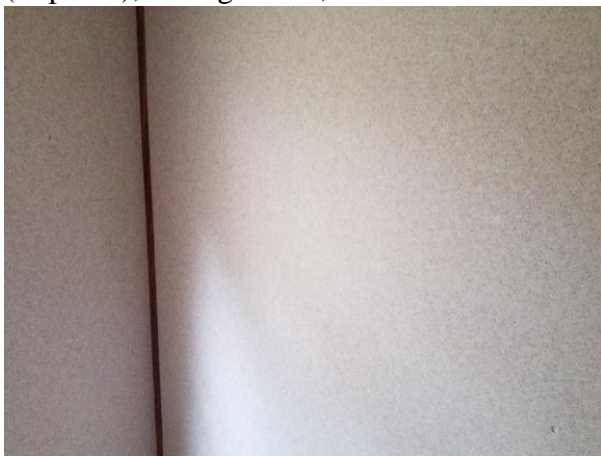
003A, 003 - Gypsum Wallboard, Bedroom 3, Main floor

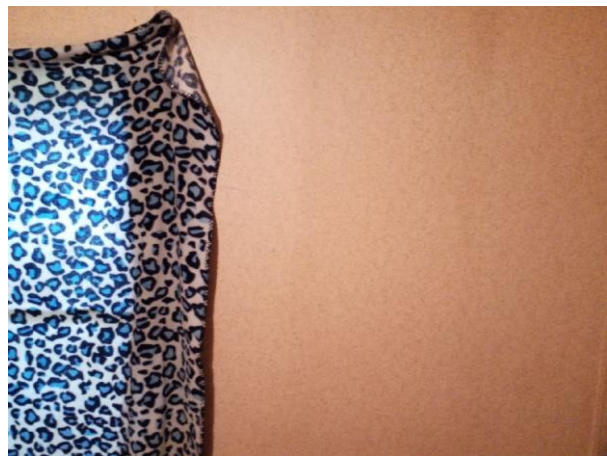
003B, 003 - Gypsum Wallboard, Bedroom 2, Main floor

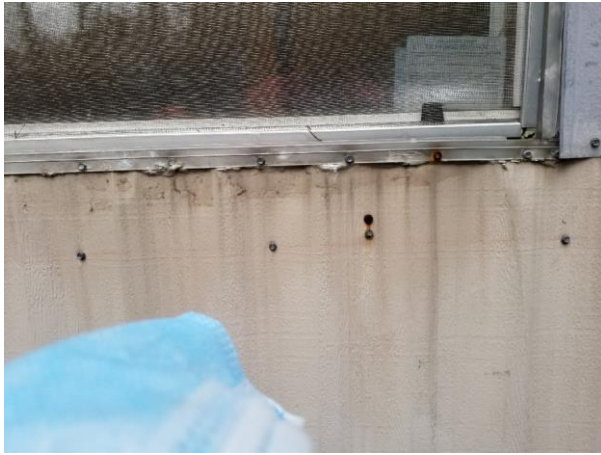
004A, 004 - Caulk, Window, Side A, Main floor
