BUILDING Lofted Barn, Painted

## Time of Sale Septic Inspection

Date: 09/08/20

Street # 198 Street Name Fletcher Tutor Rd

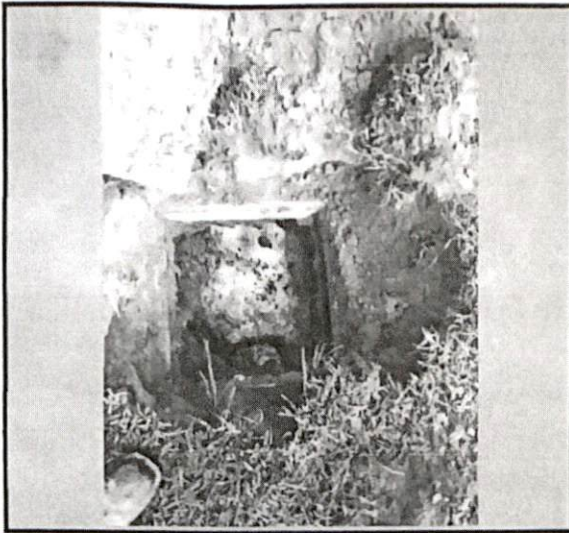
Inlet side of tank.

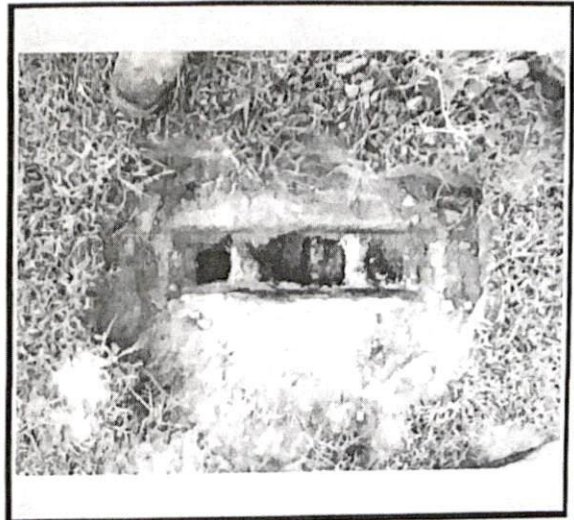
Outlet side of tank.

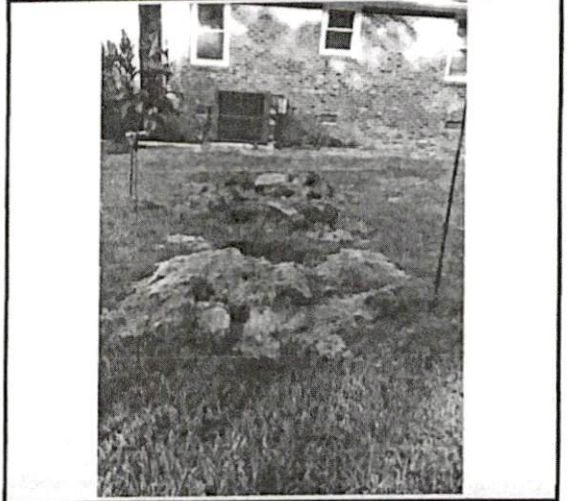
Tank location in relation to house.
