David Brantley & Sons, Inc
37 Pine Ridge Rd
Zebulon, NC 27597
252-478-3721
Brantleyoffice@gmail.com

Time of Sale Septic Inspection

Street # **198**

Street Name **Fletcher Tutor Rd**

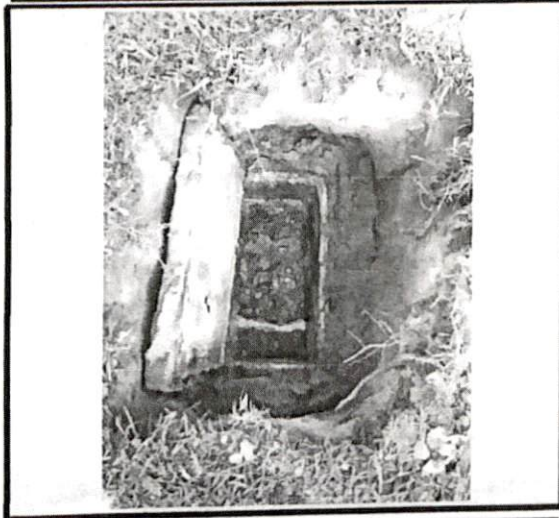
Comments: **Septic tank needs to be pumped out.
Tank is located in back of home right off of air unit.
Distribution box was uncovered and has a lot of sludge in it and needs to be cleaned out.
Drain field consist of 1 line that is 6' wide and marked with blue flags.
No surfacing of effluent at drain field was present during inspection.**

Distribution box showing sludge inside and needs to be cleaned out.

done 9/8/2020
