Reference: Engineering Services  
1014 Piney Grove Rawls Rd.  
Knightdale, NC 27545  
TE&D Project No.: 2201-010322\_E

As requested by the client, a representative of Tyndall Engineering & Design, PA (TE&D) was on-site to inspect and observe the following:

Reference: Engineering Services  
1014 Piney Grove Rawls Rd.  
Knightdale, NC 27545  
TE&D Project No.: 2201-010322\_C-R

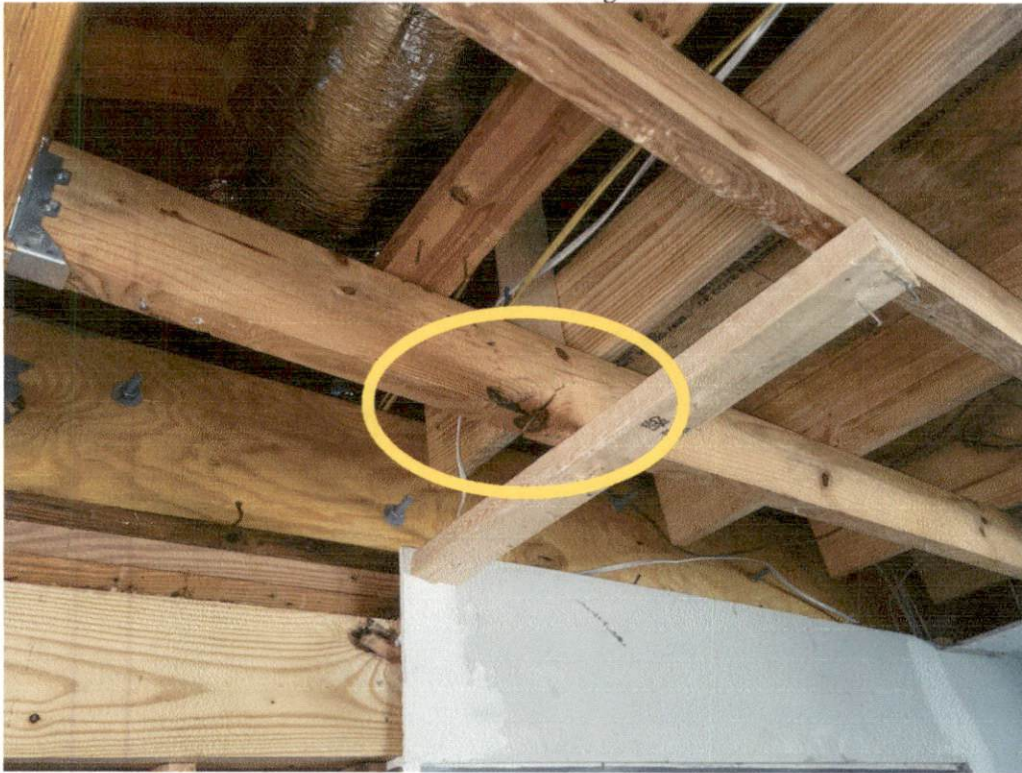
**Item 1: Cracked Ceiling Joist**

- 1) We observed a crack in a 2 x 6 ceiling joist spanning front to back over the living room. Based on our observations and analysis, a new 2 x 6 joist is to be "sistered" to the cracked joist with (2) rows of 10D nails at 16" o.c. The new joist is to have full bearing at each end.

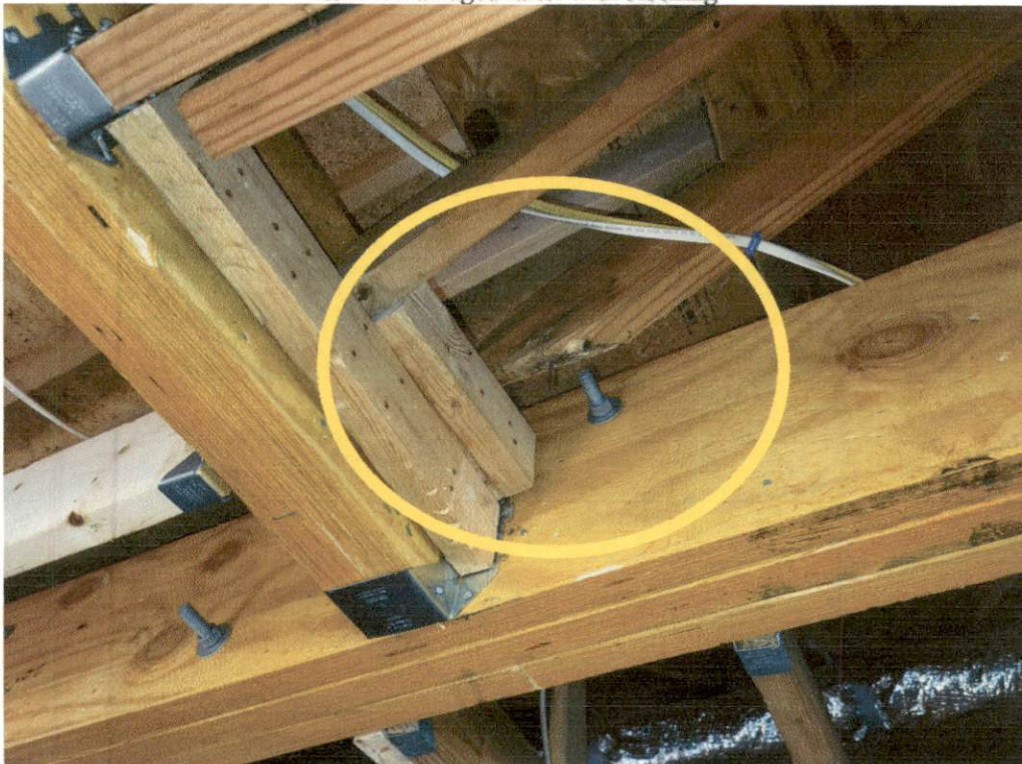
**Item 2: Damaged rafter with blocking**

- 2) We observed the damaged 2 x 6 rafter over the kitchen to be bearing on (2) 2 x 4 blocking installed to the side of the LVL beam. Based on our observations and analysis, this configuration is inadequate to support the anticipated loading conditions. A 2 x 6 x 4'-0" scab is to be fastened to the end of the damaged rafter with (2) rows of 10D nails at 8" o.c. The new rafter scab is to have full bearing at the LVL beam below.

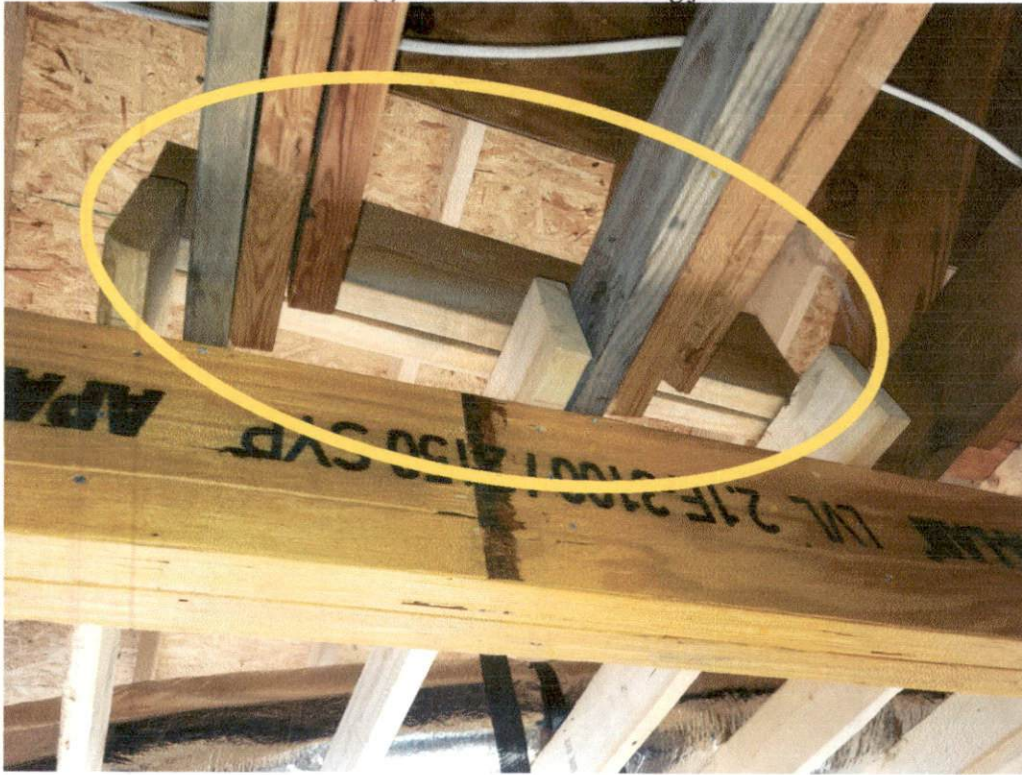
Item 3: (2) 2 x 10 installed on ceiling joists

- 3) We observed a (2) 2 x 10 to be stacked on top of the existing ceiling joists to allow bearing for the 2 x 6 rafters. Based on our observations and analysis, the existing configuration is inadequate to support the anticipated loading conditions and following modifications are to be made:

- A) The rafters are to be secured to the (2) 2 x 10 with Simpson L50 hangers (or equivalent) installed per the manufacturer's specifications.
  - B) The (2) 2 x 10 is to be secured to the ceiling joists below with Simpson H2.5A ties (or equivalent) installed per the manufacturer's specifications.

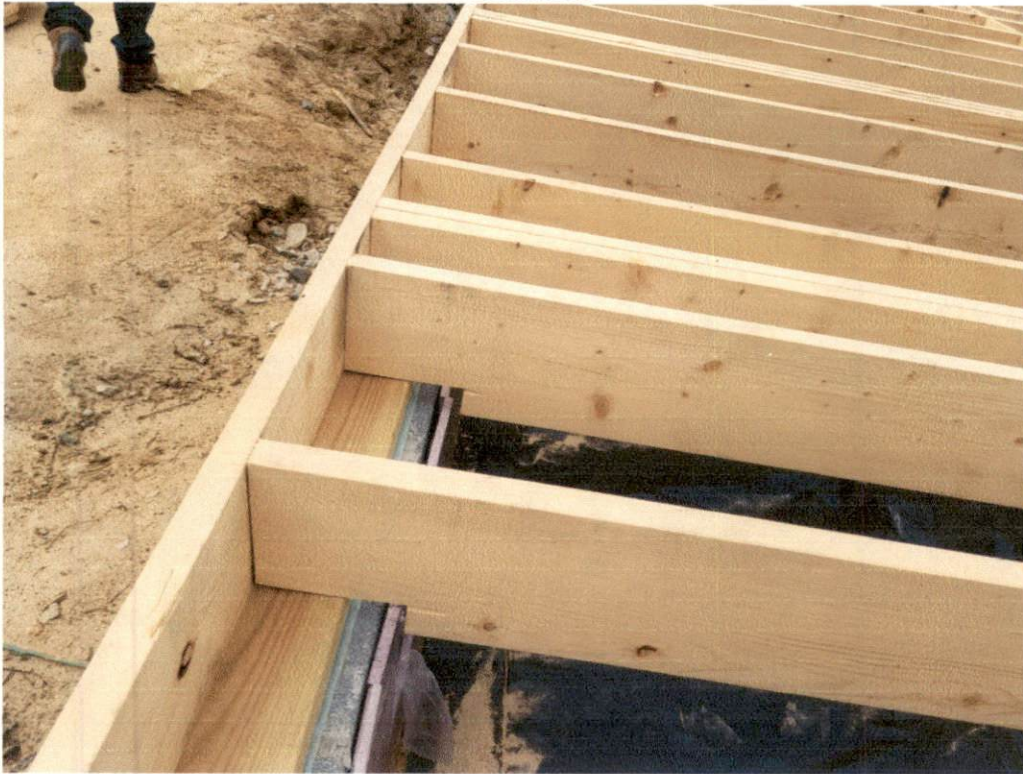
**Notched Joists:**

- 1) The new 2 x 10 floor joists were notched with 2" x 6-1/2" notches to allow for bearing at the new foundation wall.
- 2) New 2 x 10 joists were bearing directly on the existing hollow CMU foundation wall with no sill plate.

- 1) We understand the 2 x 10 floor joists below the rear addition are to be notched approximately 2" x 6-1/2" in order to be secured to the 2 x 8 band. Based on our observations and analysis, this configuration is adequate to support for the anticipated loading conditions.
- 2) We observed the new, treated 2 x 10 floor joists were installed bearing directly on the existing hollow CMU foundation wall. The existing floor joists were also observed to be treated. Based on our observations and analysis, the existing floor joist and foundation wall configuration is adequate to support the anticipated loading conditions. No modification is required.
