W. Harrison Welch, PE
Stonewall Structural Engineering, PLLC
4800 Falls of Neuse Rd. #120
Raleigh, NC 27609
(919)407-8663

Re: Structural Observation — 511 Stage Road, Spring Lake, NC 28390

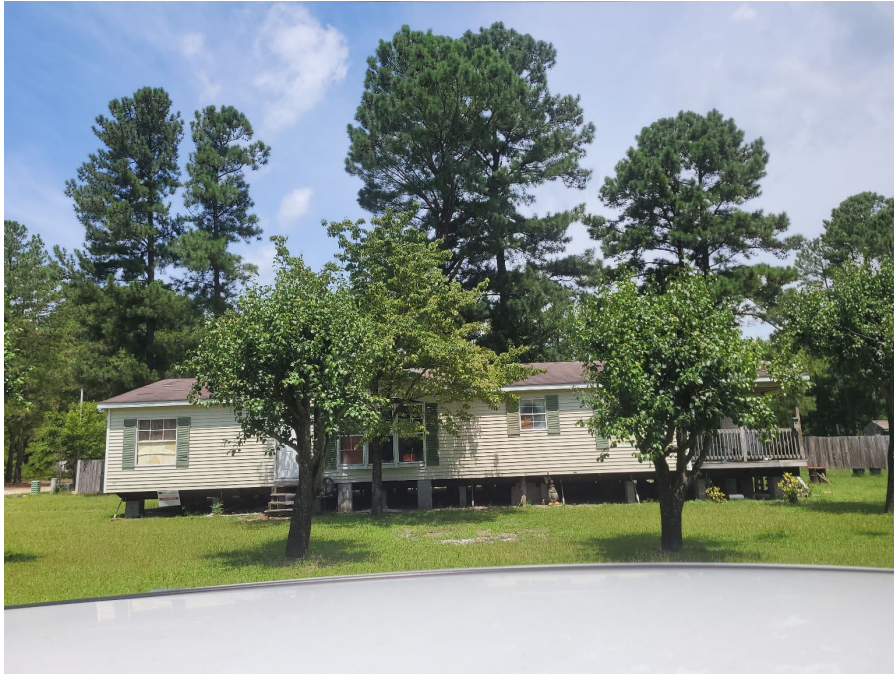
Picture 1 – 511 Stage Road, Spring Lake, NC 28390

At your request, on July 20, 2023 we performed a visual structural observation of fire damaged roof trusses at the 511 Stage Road residence noted above. The structure is a double wide manufactured home with interior masonry piers (*see picture 1*).

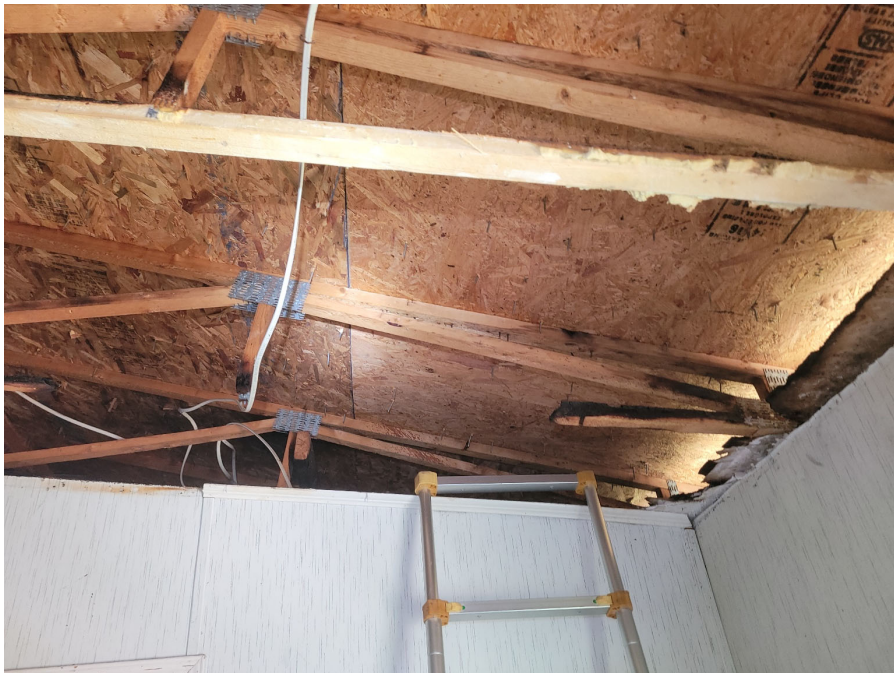
- In the back truss bay, the leftmost (5) roof trusses were damaged beyond the salvageable limits (*see pictures 2-4 for examples*).

Picture 2 – Example of fire damaged roof truss

- Remove and replaced the (5) rightmost roof trusses with new 2x8 rafters and 2x6 ceiling joists. New rafters and ceiling joists should be #2 Southern Yellow Pine material.
 - The ceiling joist should bear on the outside wall and marriage line of the home.
 - Fasten rafters to the wall top plate using Simpson H2.5A Hurricane Tie installed per manufacturer’s specifications.
 - Securely fasten rafters to ceiling joists at the exterior wall of the home.
 - Install a tight-fit 2x4 stub between the rafter and ceiling joist at the marriage line. Securely fasten the rafter and ceiling joist to the stub.
 - If the stub is installed to the side of the rafter/joist, the stub should be face nailed to the rafter/joist using (4) 10d common nails per connection.

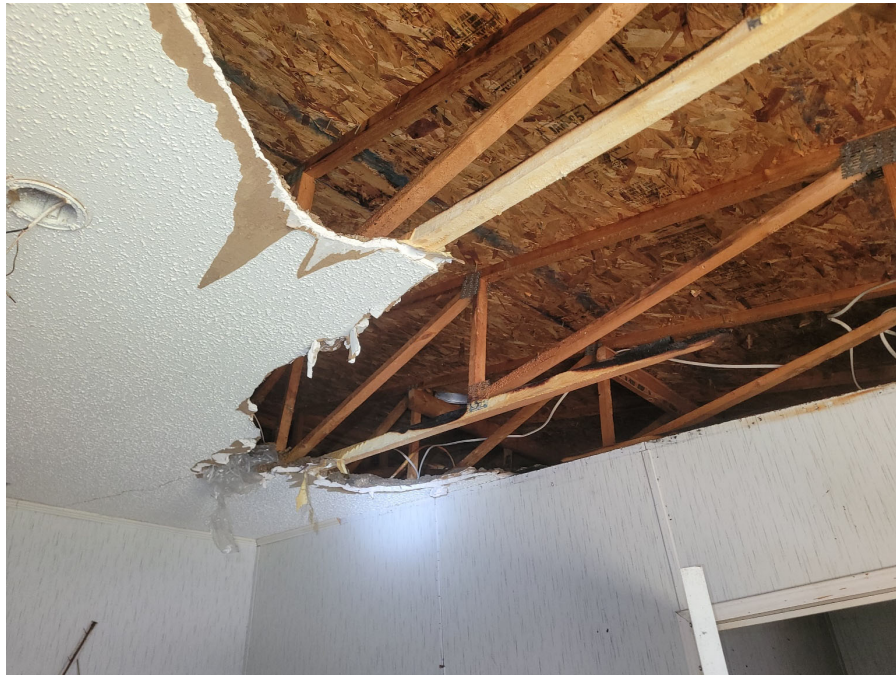
Picture 3 – Example of fire damaged roof truss

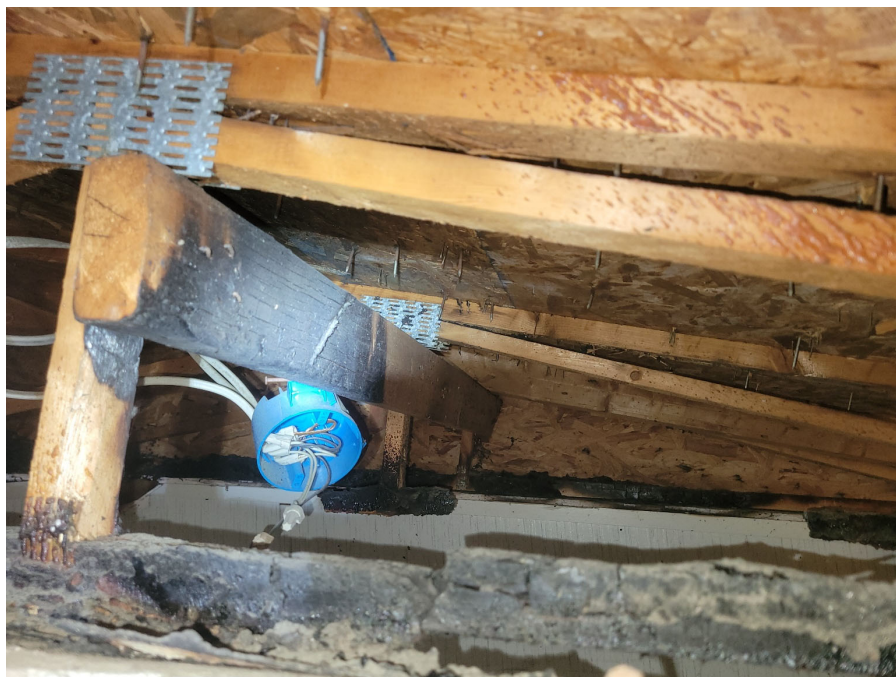
Picture 4 – Example of fire damaged roof truss
