SFA Design Group, LLC

February 15, 2023

RE: Existing Condition Report
Hopfauf Residence
303 Quail Hollow
Sanford, NC 27332

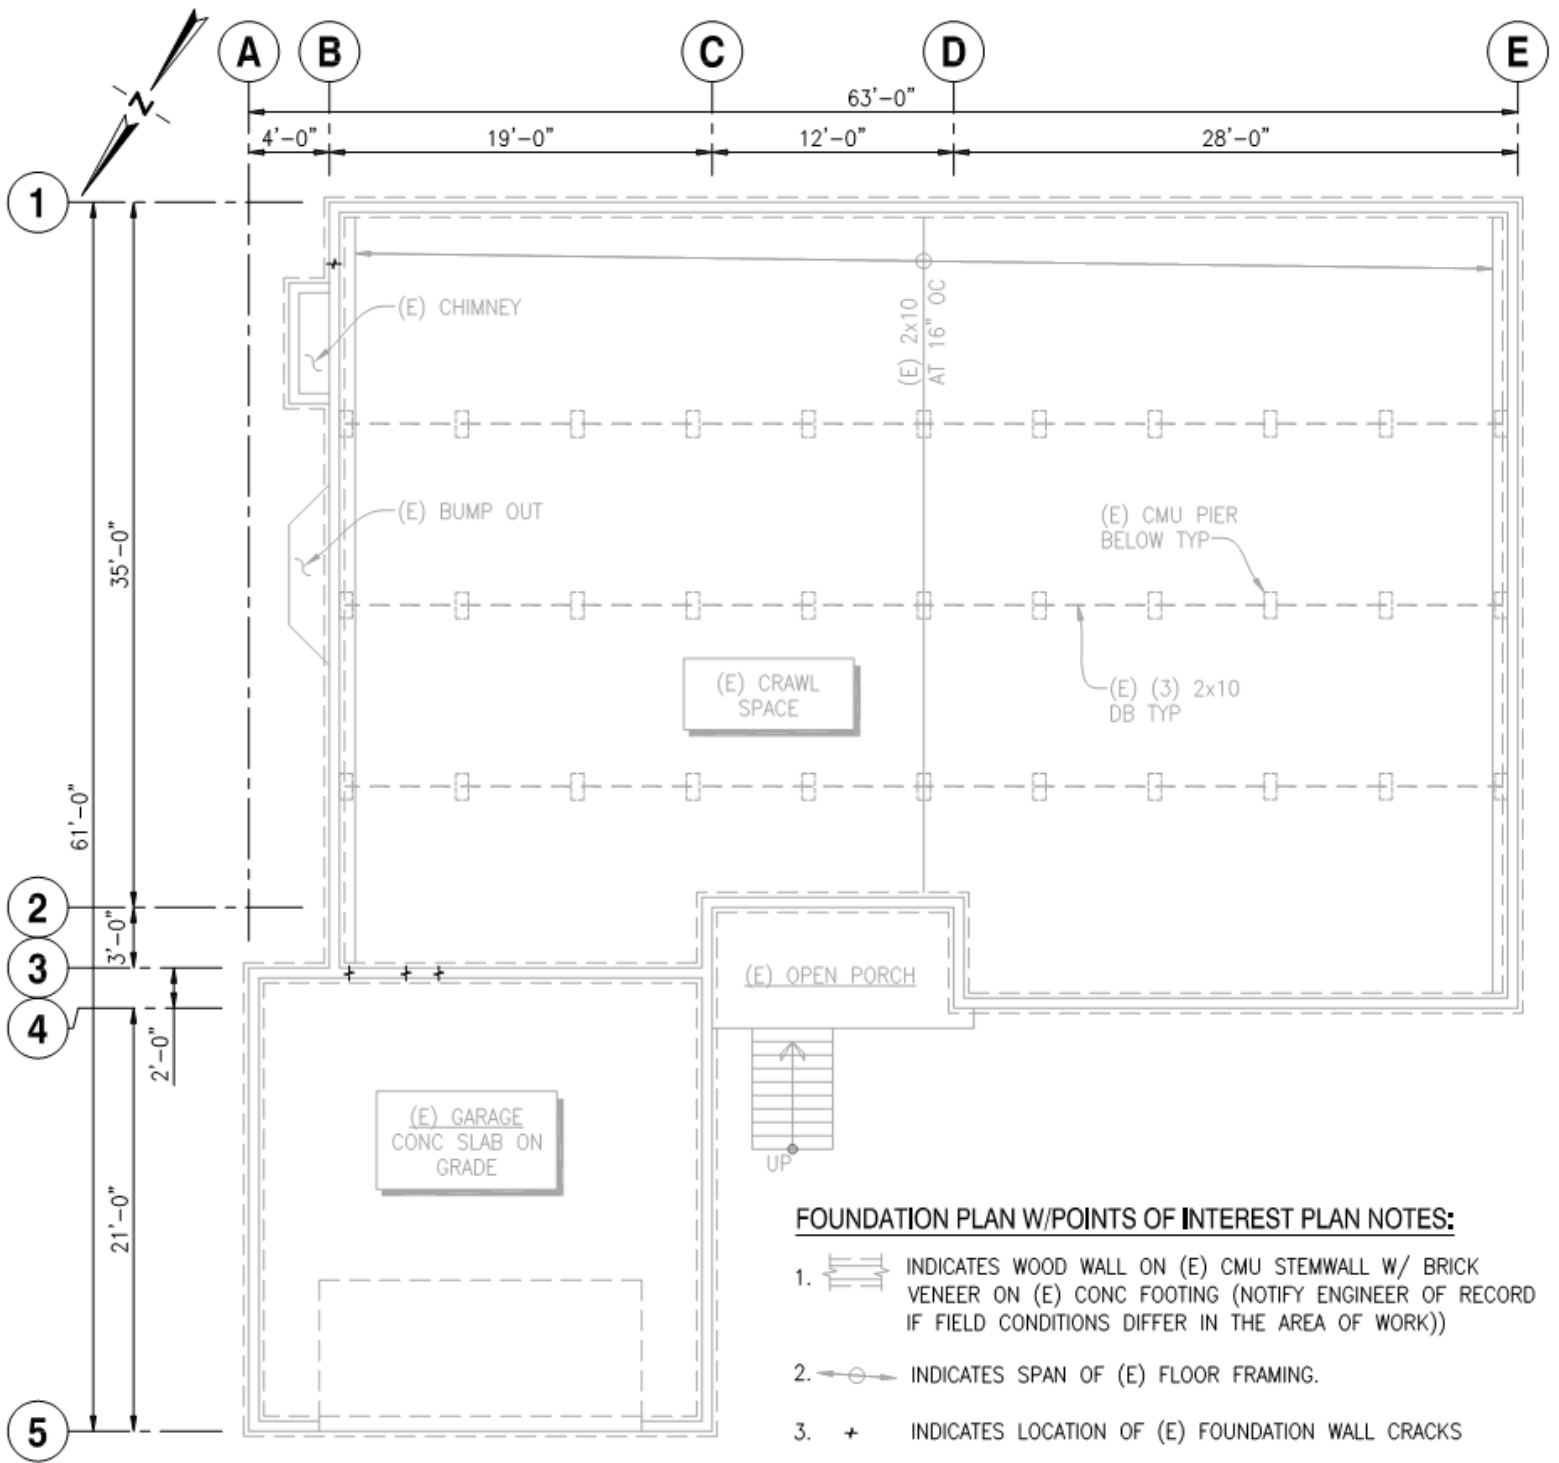
FOUNDATION LAYOUT

A visual inspection of the property found most of the CMU, brick and concrete foundation to be in average condition, with certain areas showing signs of differential settlement (Figure-C).

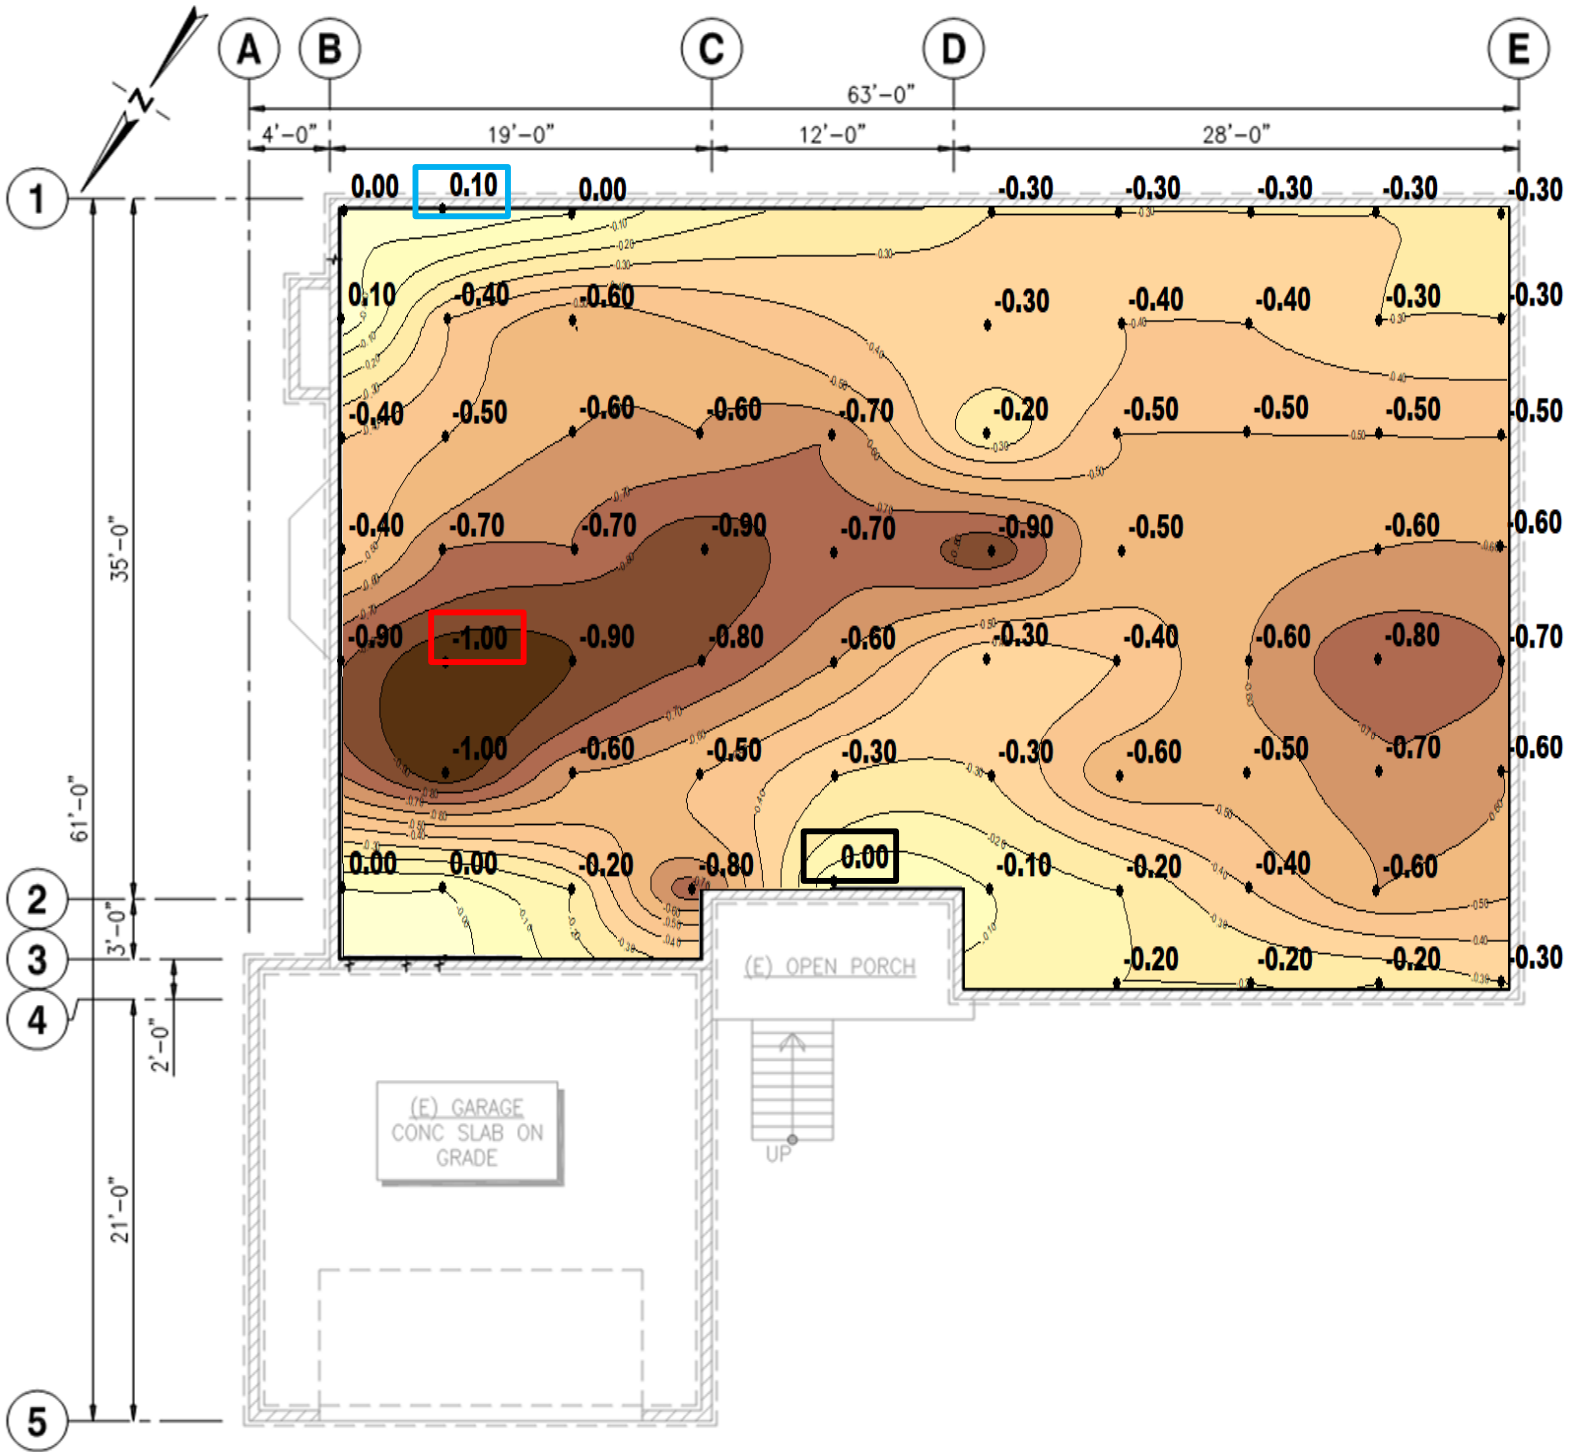
ZIP LEVEL MEASUREMENTS AND 2D TOPOGRAPHIC MAP	Project Number: RBC23-023
		FIGURE-D

A Zip Level Survey was performed on the interior of the subject property, using the front door as the bench mark or starting point; designated as "0.0" on the floor plan (Figure-D). Measurements of the floor elevation were made in tenths of an inch. The high point was +0.1" and the low point was -1.0". The maximum difference in the floor readings was 1.1". As can be seen on the topographic map, the most significant settlement is indicated by dark brown contours surrounding the area (Figure-D & E).

Starting Point: 0.0
 Highest Point: +0.1"
 Lowest Point: -1.0"

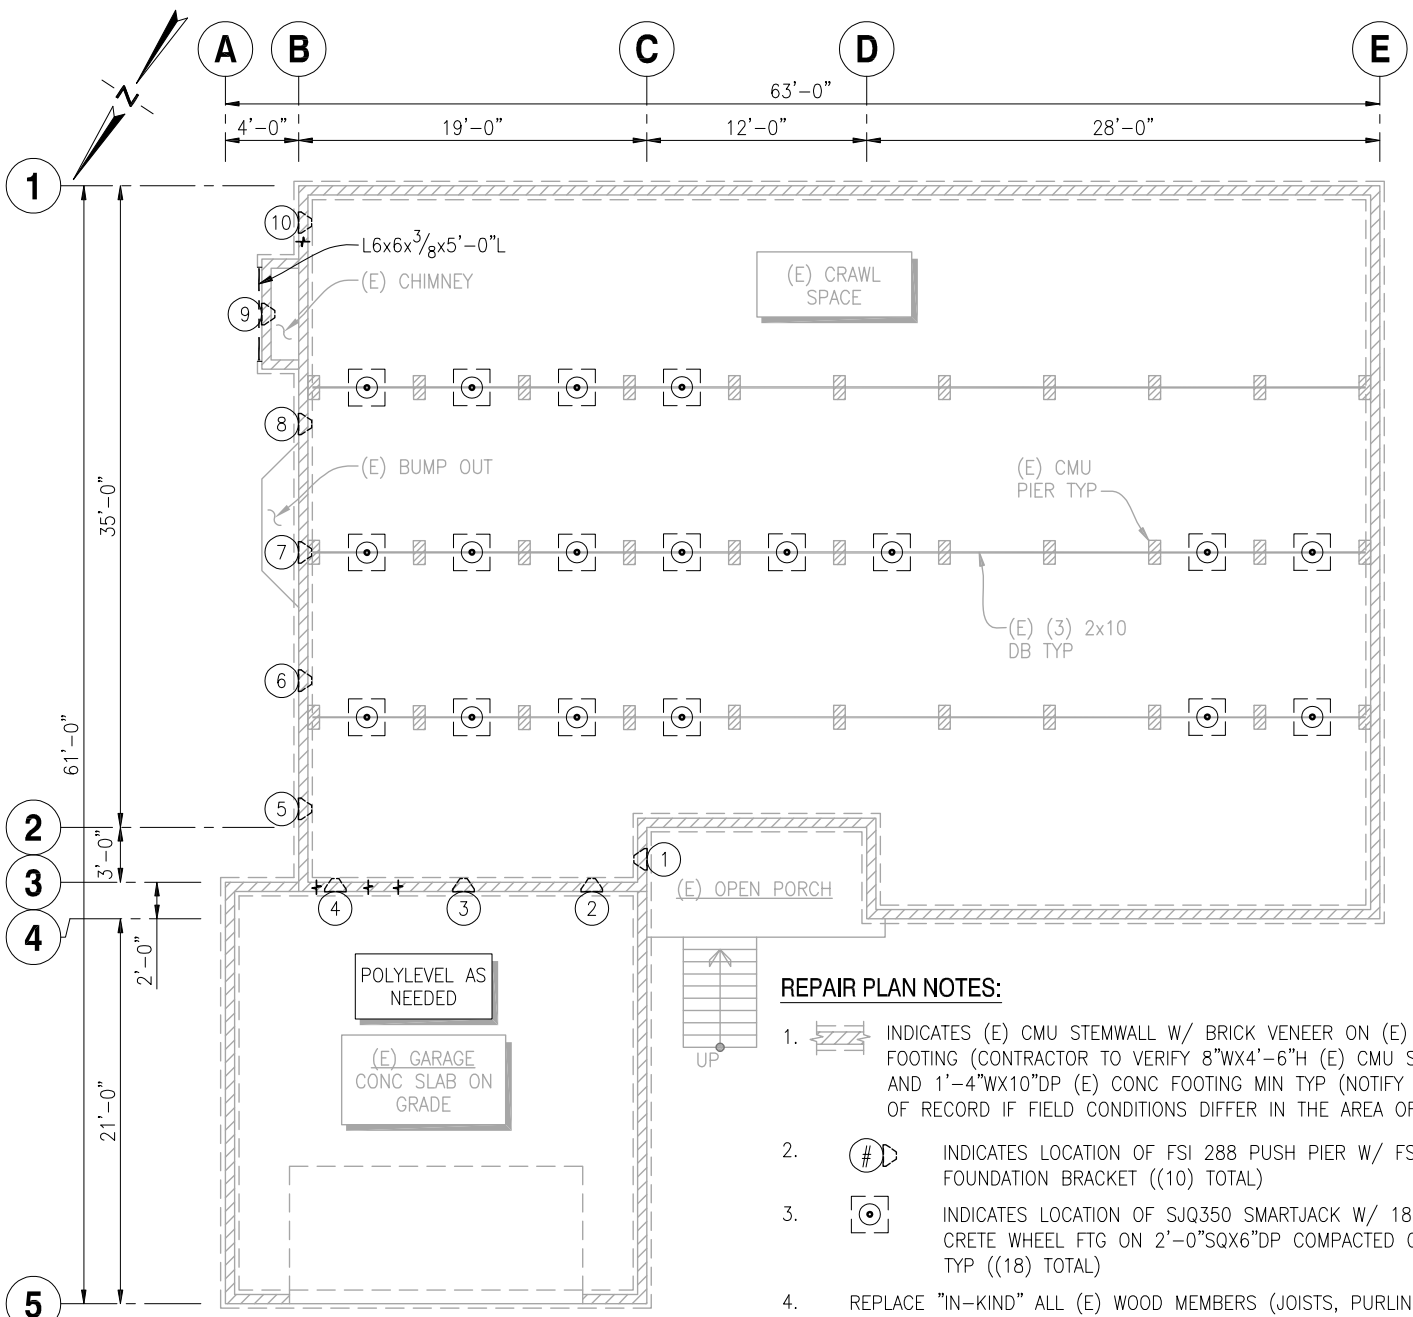
Based upon field observations, and evaluation of collected data, we find the property to be experiencing settlement, cracks, and general foundation stress in various areas. We have evaluated the repair plan (Figure G) proposed by the contractor for adverse affects on the performance of the structure relating to stabilization of the areas indicated, structural integrity, and life safety and find it to be viable. Based upon our findings, portions of the structure outside of the contractors recommended repair plan are experiencing differential settlements outside of the ½ in : 10 ft criteria. Figure F depicts a repair plan that includes all areas observed outside of this criteria for consideration only. We recommend the following:

- Install a push pier / helical pier system to stabilize and potentially lift the structure (Figure-F & G).
- Install a SmartJack system to stabilize and potentially lift the interior floor framing (Figure-F).
- Pier & SmartJack layout and quantities are based on bringing the structure up to a level condition per industry standards where industry standards are understood to be 0.5" of settlement over a 10' span.
- It is recommended to perform an elevation survey of the floor after installation of SmartJacks and/or piers to determine the necessity of installing add'l SmartJacks to support the floor framing.
- Inject PolyLevel to fill all voids potentially re-level any concrete slabs and walkways.
- Ensure that all drainage properly discharge away from structure.

1. INDICATES (E) CMU STEMWALL W/ BRICK VENEER ON (E) CONC FOOTING (CONTRACTOR TO VERIFY 8"Wx4'-6"H (E) CMU STEMWALL AND 1'-4"Wx10"DP (E) CONC FOOTING MIN TYP (NOTIFY ENGINEER OF RECORD IF FIELD CONDITIONS DIFFER IN THE AREA OF WORK))
2. INDICATES LOCATION OF FSI 288 PUSH PIER W/ FSI FS288BL FOUNDATION BRACKET ((10) TOTAL)
3. INDICATES LOCATION OF SJQ350 SMARTJACK W/ 18"SQx6"DP RBC EZ CRETE WHEEL FTG ON 2'-0"SQx6"DP COMPACTED CRUSHED STONE FILL TYP ((18) TOTAL)
4. REPLACE "IN-KIND" ALL (E) WOOD MEMBERS (JOISTS, PURLINS, SUBPURLINS, SHEATHING, STUDS, WALL PLATES) WHICH SHOW SIGNS OF DRY ROT OR STRUCTURAL DAMAGE
5. ENSURE THAT ALL STORMWATER DRAINAGE PROPERLY DISCHARGE AWAY FROM STRUCTURE
6. FILL ALL VISIBLE CRACKS IN THE FOUNDATION WALL WITH HYDRAULIC CEMENT OR EPOXY
